Failure Case Studies in Civil Engineering

Structures, Foundations,
and the Geoenvironment

FAILURE CASE STUDIES IN CIVIL ENGINEERING

Technical Council on Forensic Engineering
of the American Society of Civil Engineers

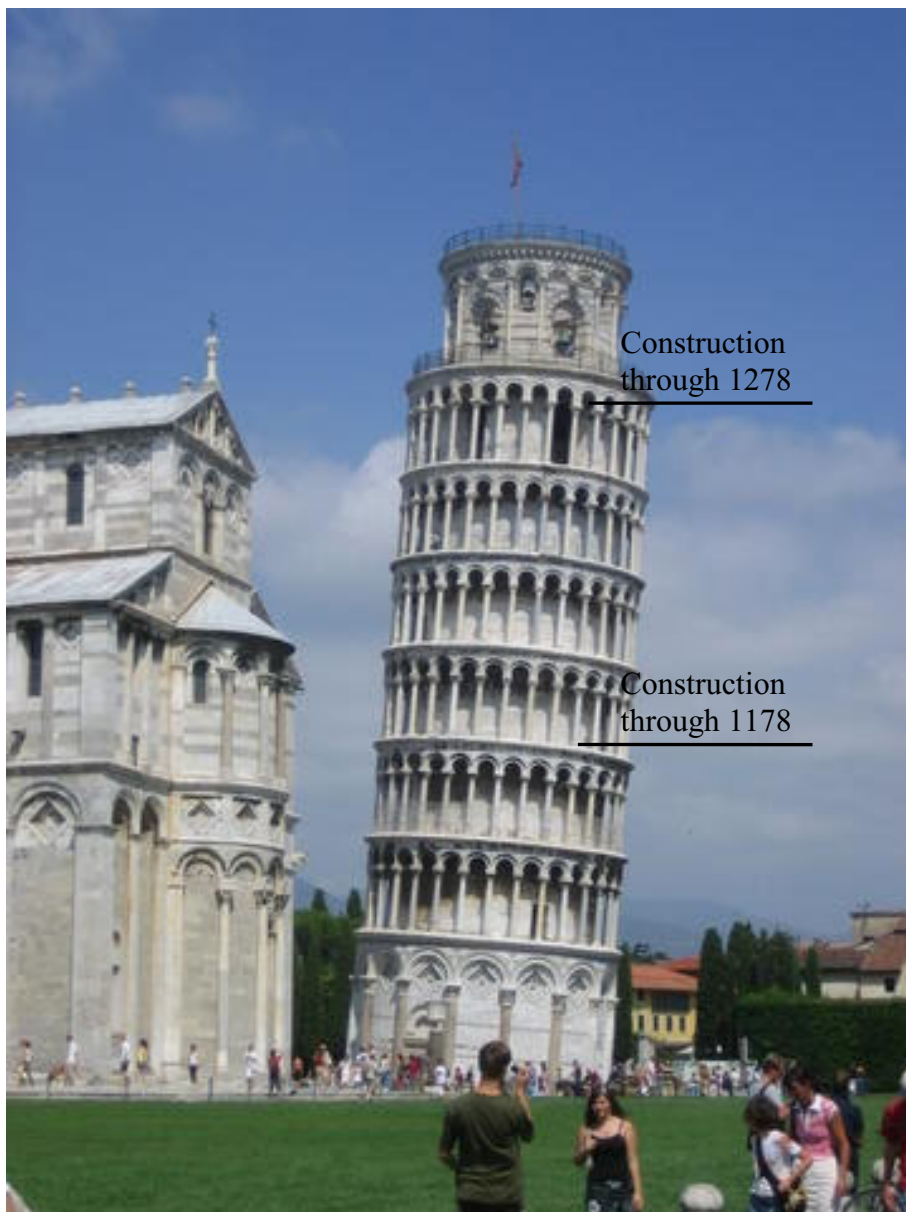
The failure of the Tower of Pisa is unique for a number of reasons. It is a failure that has occurred on a continuous basis for more than 800 years. Despite the extensive investigations and analyses conducted over the past 60 years, there is still no consensus on the cause of failure. What is significant however is that finally, after 8 centuries, the tower has been effectively stabilized.

Figure 1-1. Tower of Pisa.

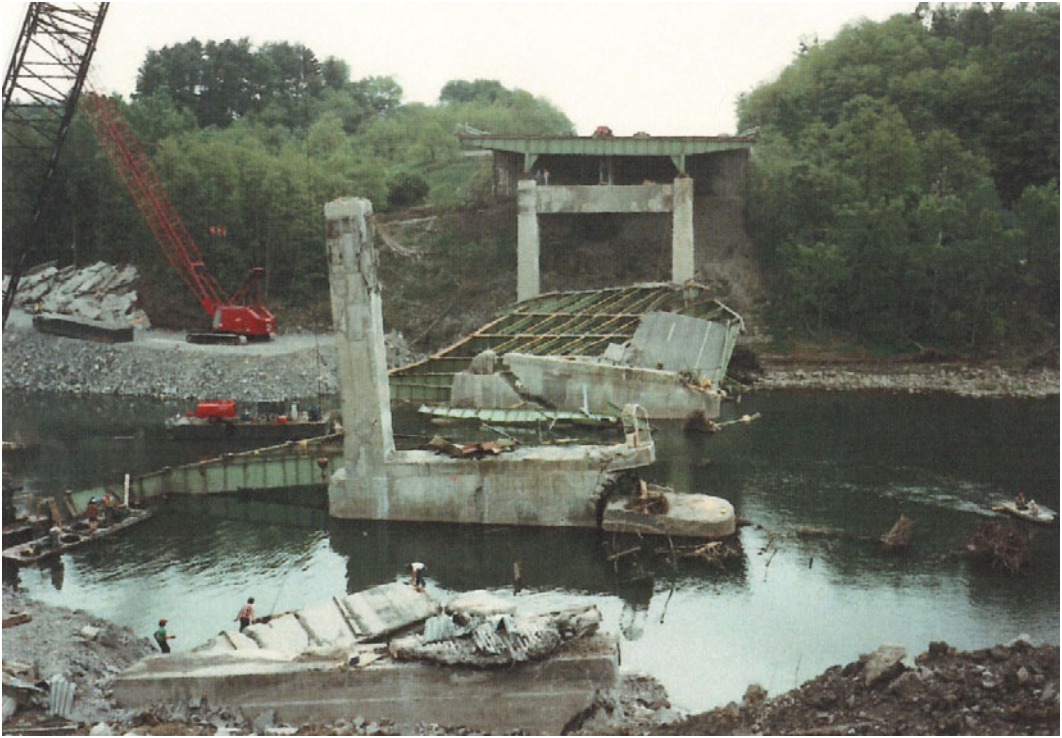
Figure 1-4. Schoharie Creek Bridge collapsed spans.

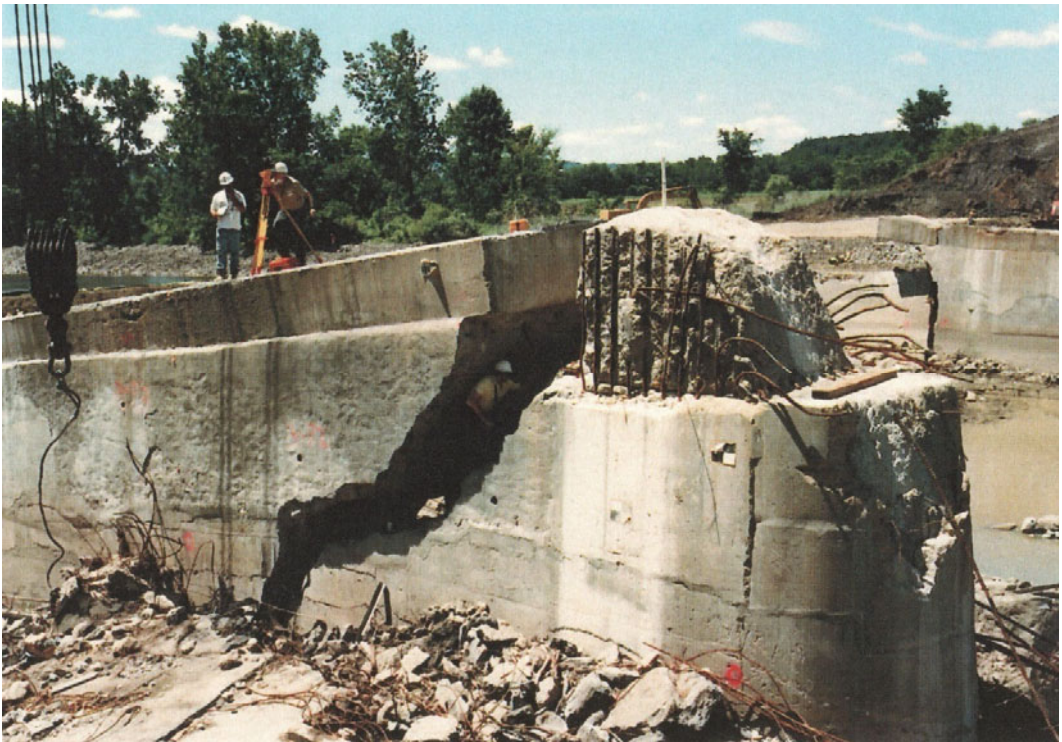
Figure 1-5. Schoharie Creek Bridge failed plinth.

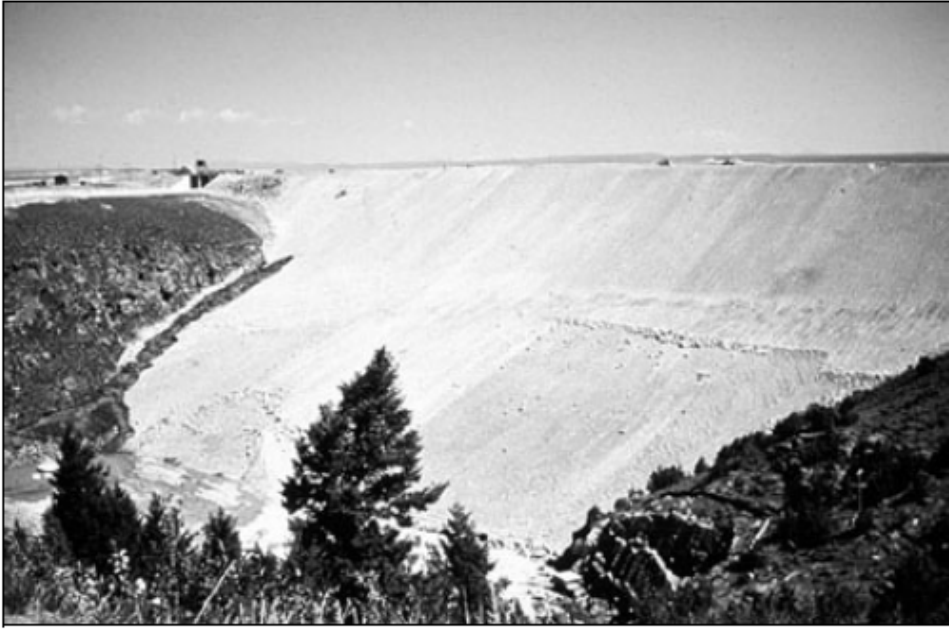
Figure 2-6. Teton Dam Failure Sequence, Initial Erosion.

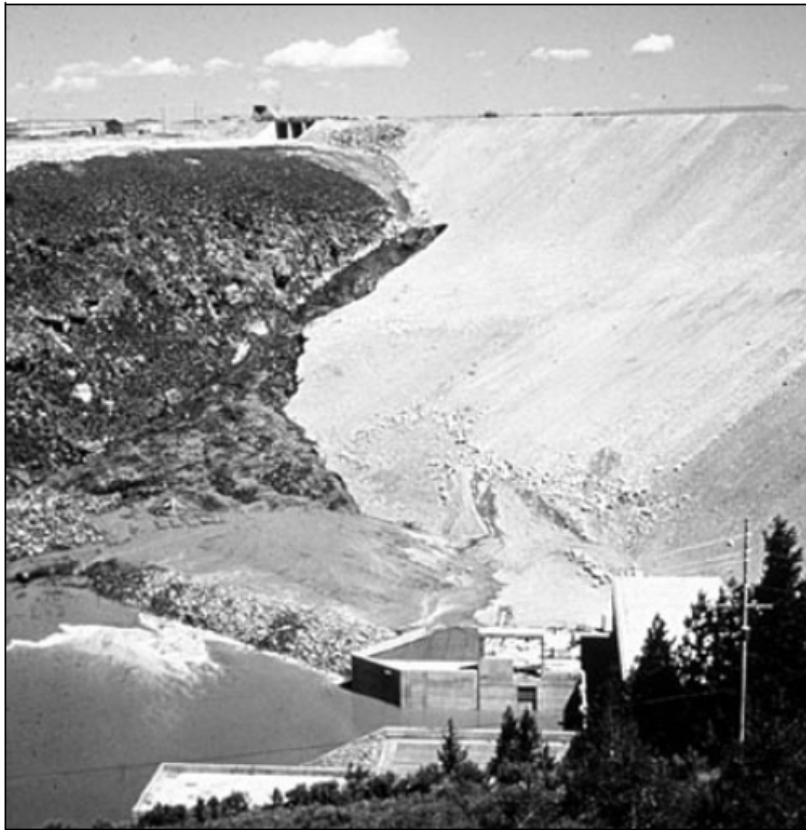
Figure 2-7. Teton Dam Failure Sequence, the Seepage Widens.

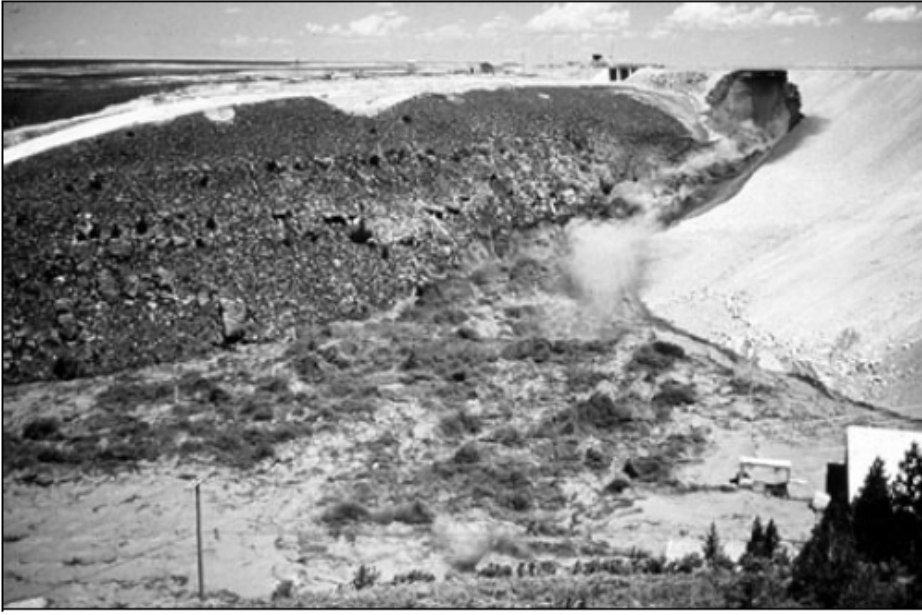
Figure 2-8. Teton Dam Failure Sequence, Beginning of Final Failure.
Source: Independent Panel (1976).

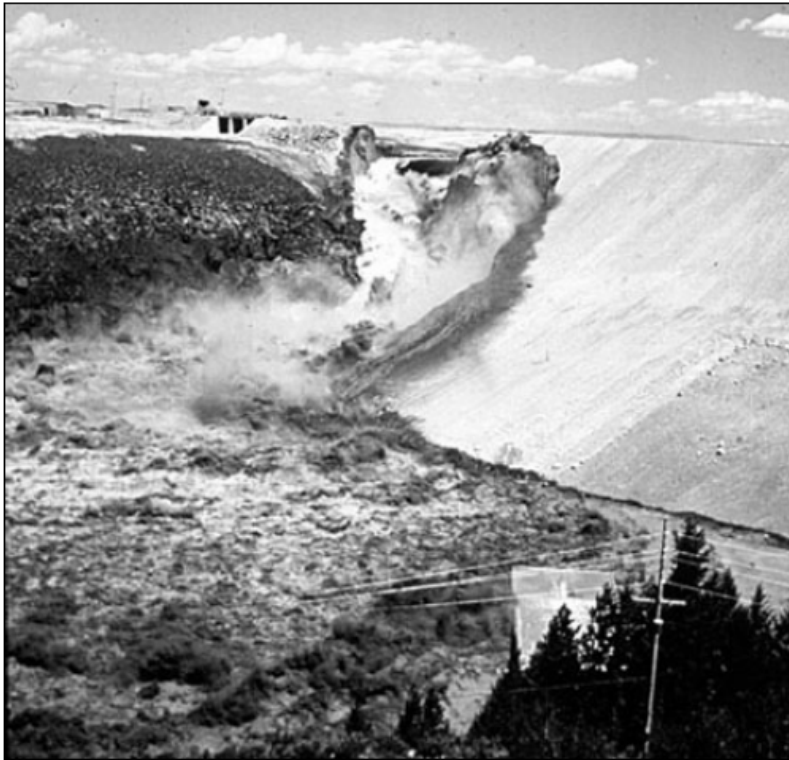
Figure 2-9. Teton Dam Failure Sequence, Failure of the Dam.
Source: Independent Panel (1976).

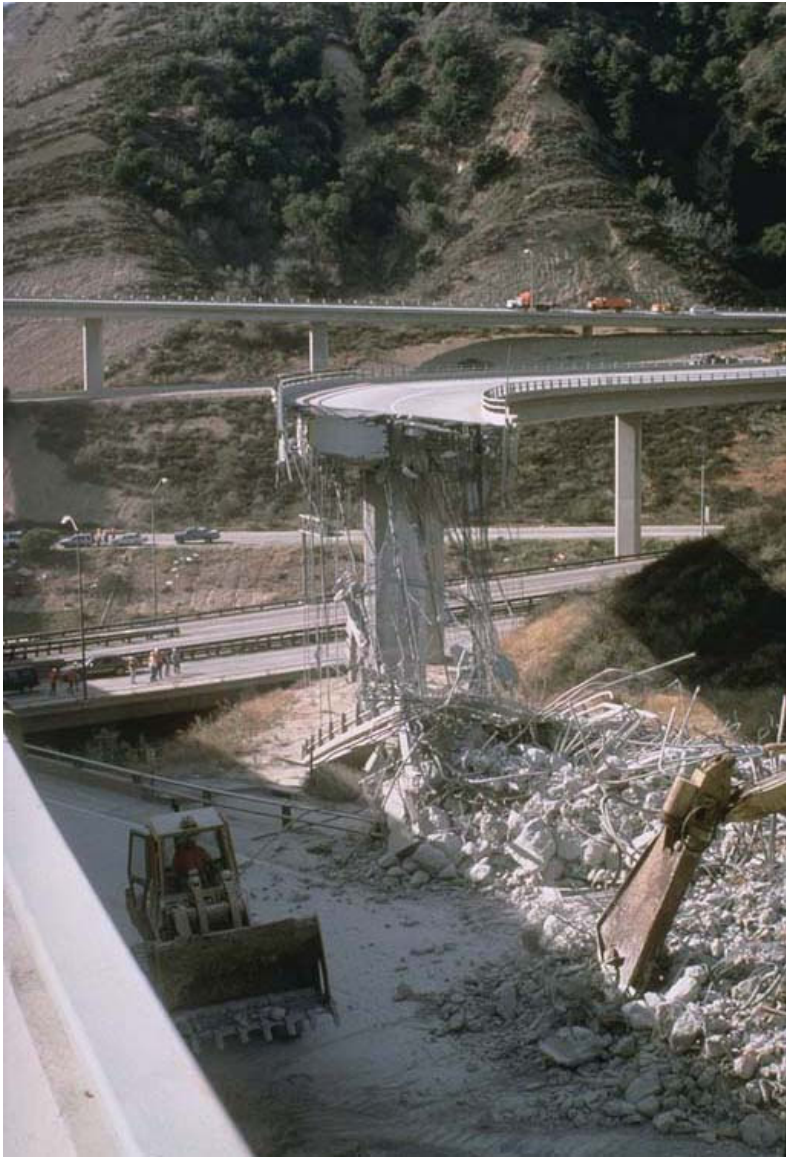
Figure 4-1. Antelope Valley – Interstate 5 Freeway Interchange Failure – 1994.
Source: J. Dewey, USGS.

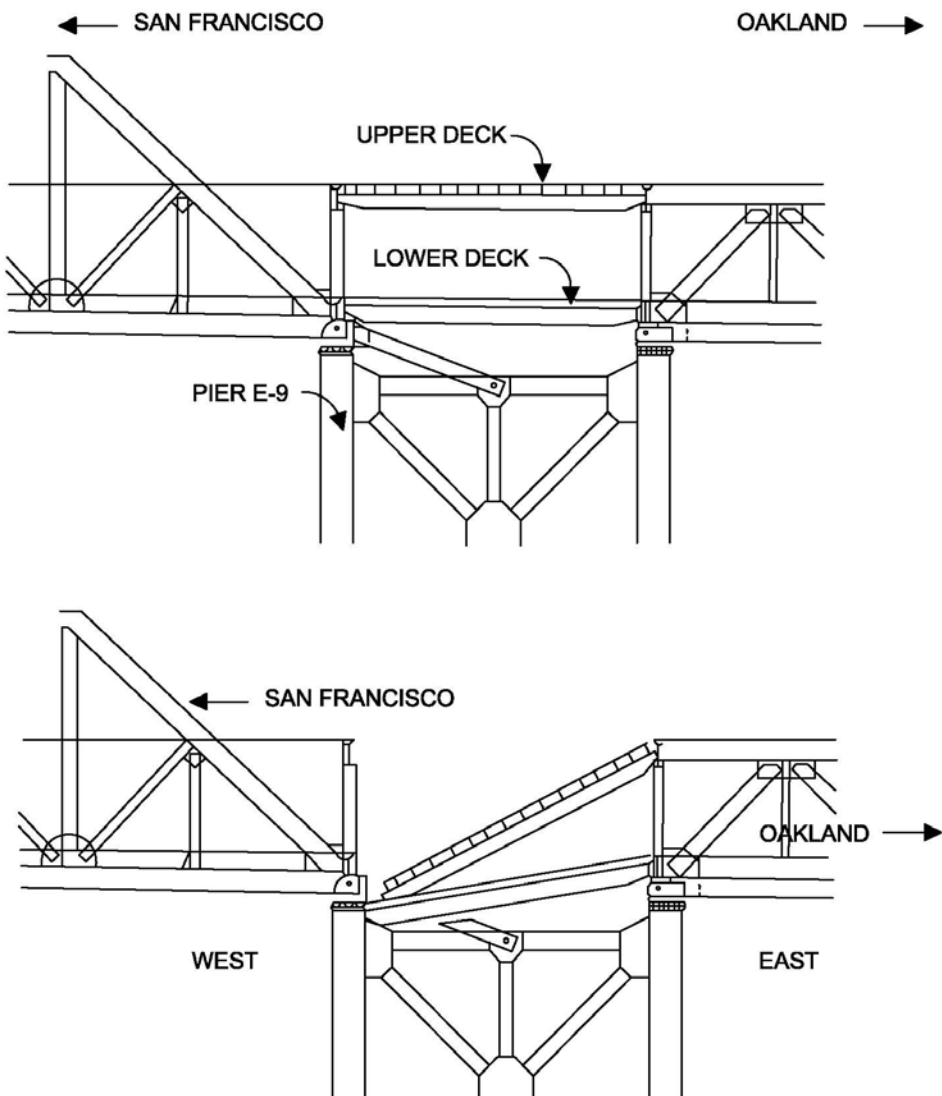
Figure 4-2. Detail of Collapse of Span of San Francisco-Oakland Bay Bridge.

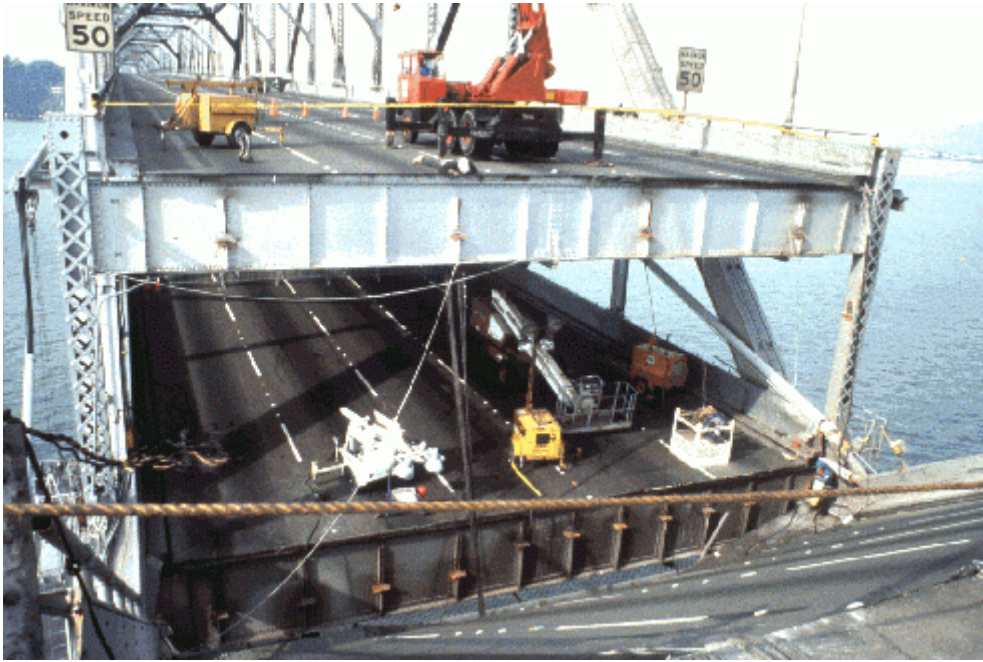
Figure 4-3. Damage to San Francisco-Oakland Bay Bridge.

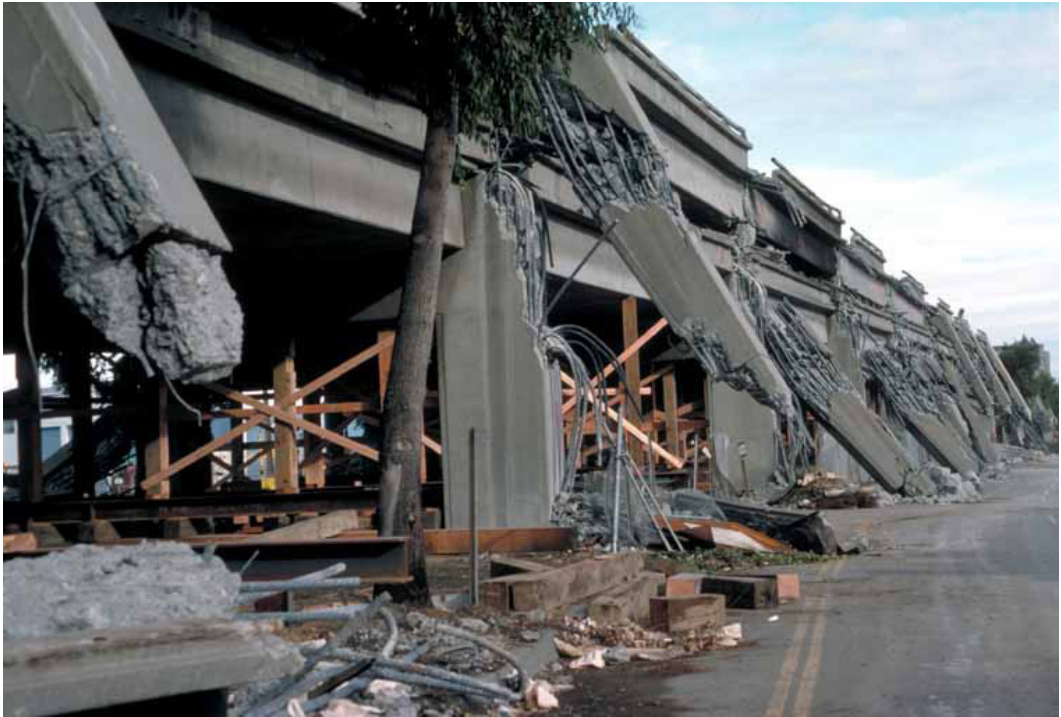
Figure 4-4. Cypress Viaduct Support Column Failure.

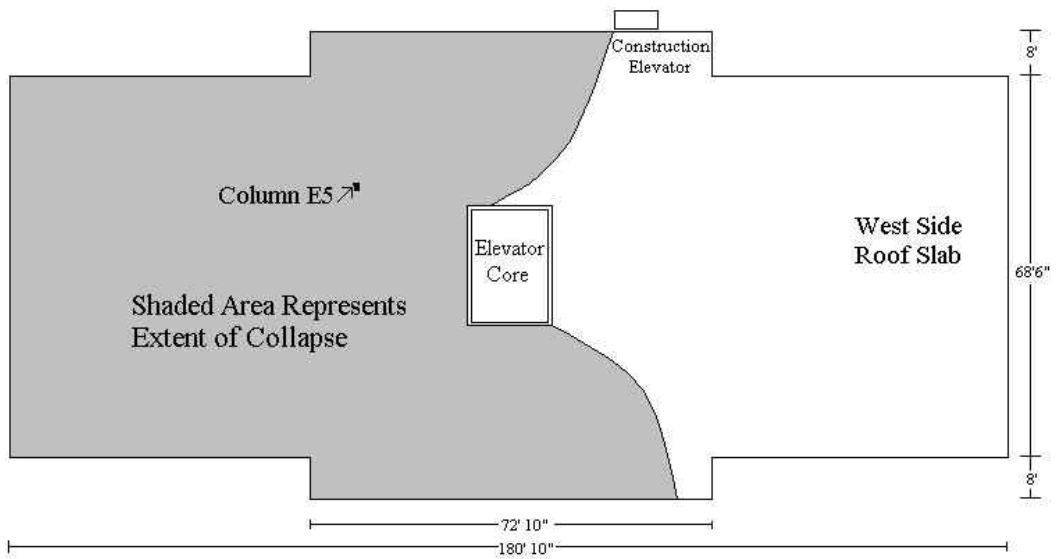
Figure 5-6. 2000 Commonwealth Avenue Building Extent of Collapse.

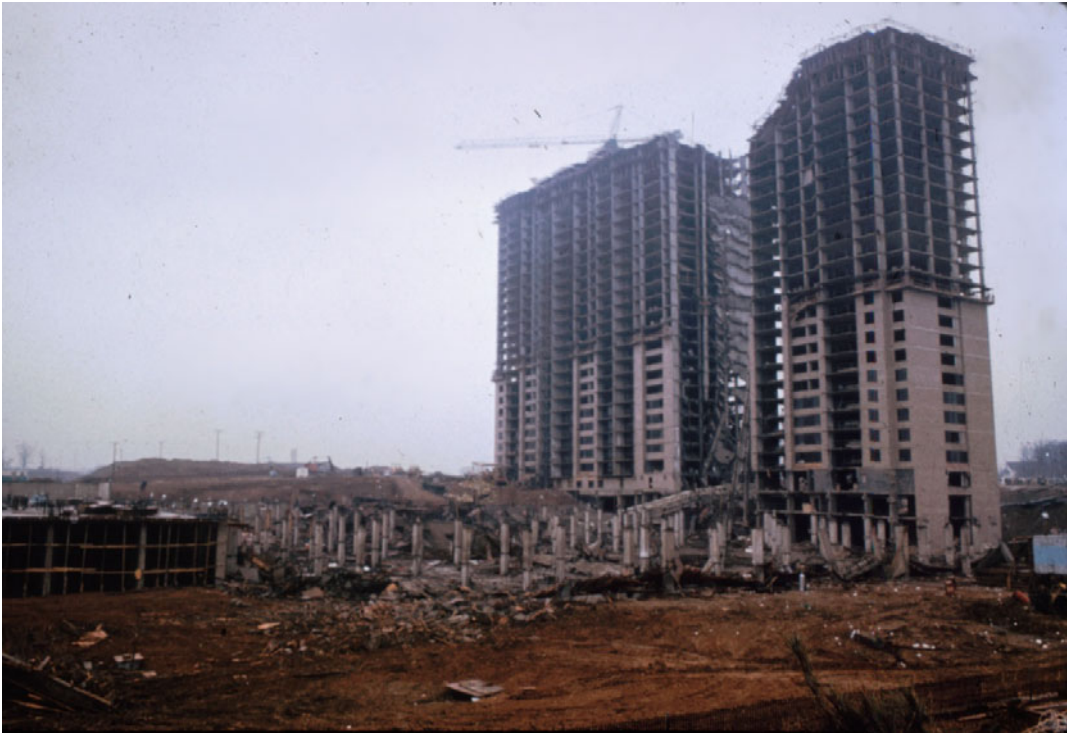
Figure 5-7. Overview of the Skyline Plaza Collapse at Bailey's Crossroads.

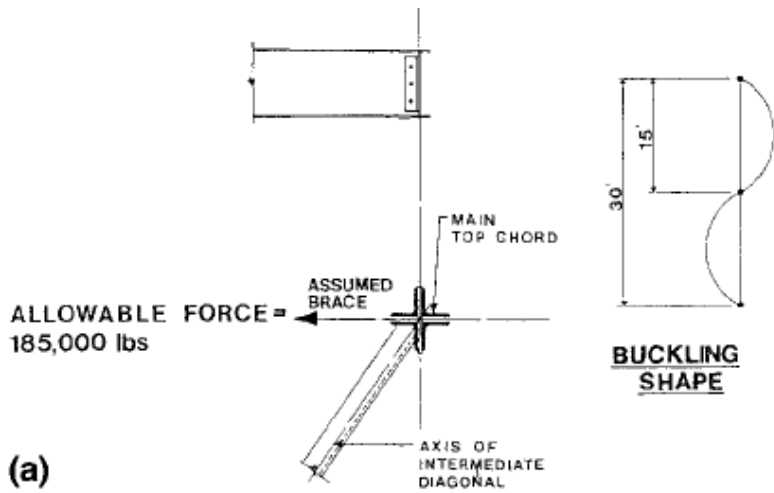
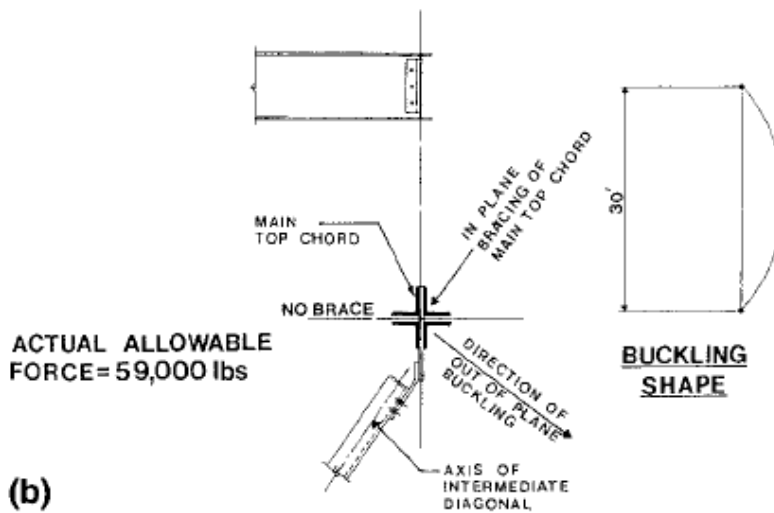
Figure 5-9. Effect of assumed (hard) versus actual (spring) bracing condition.

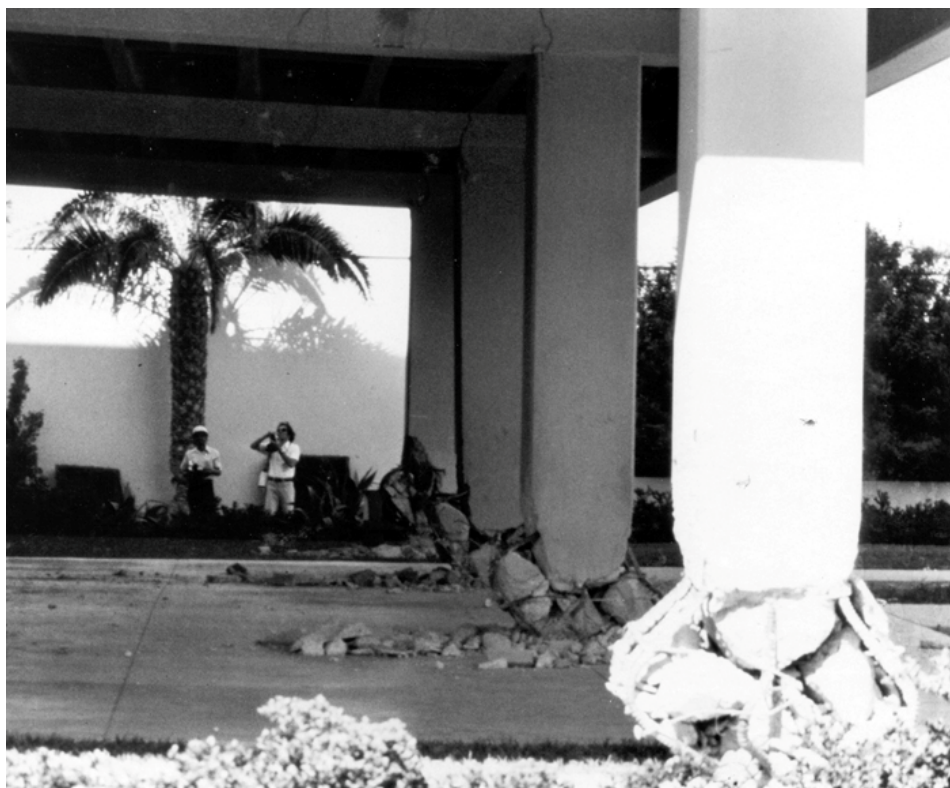
Figure 5-11. Column of Imperial County Services Building.

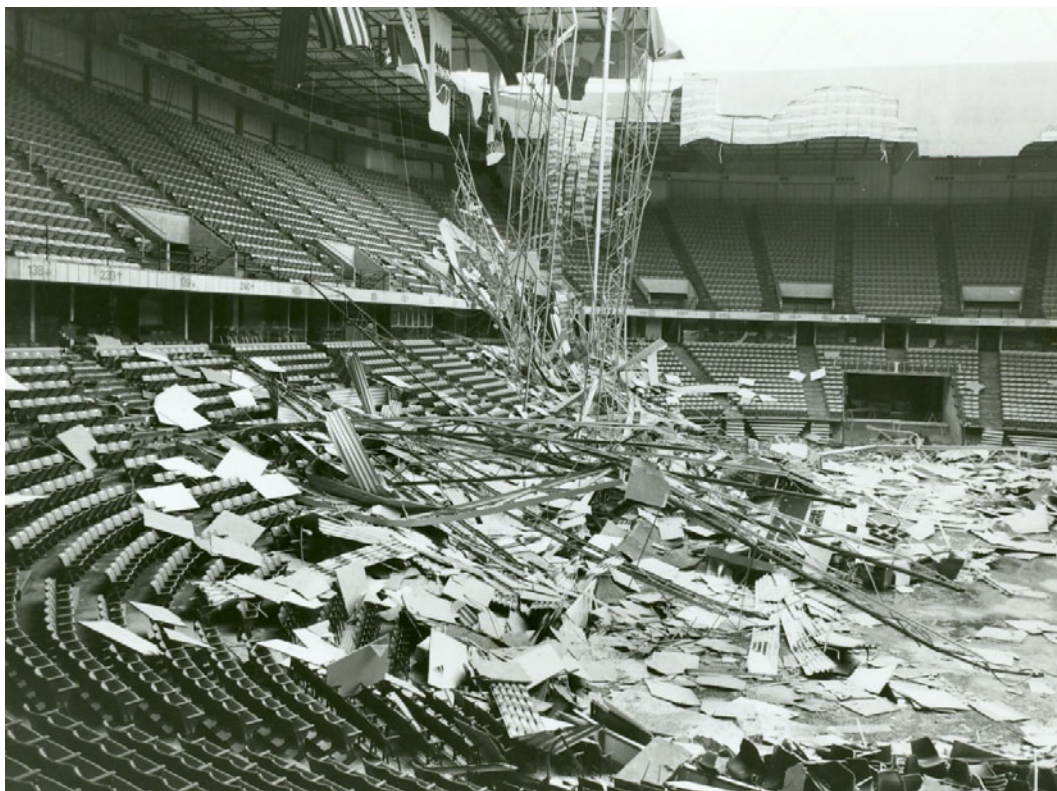
Figure 5-12. Kemper roof debris litters seats below shortly after the collapse.

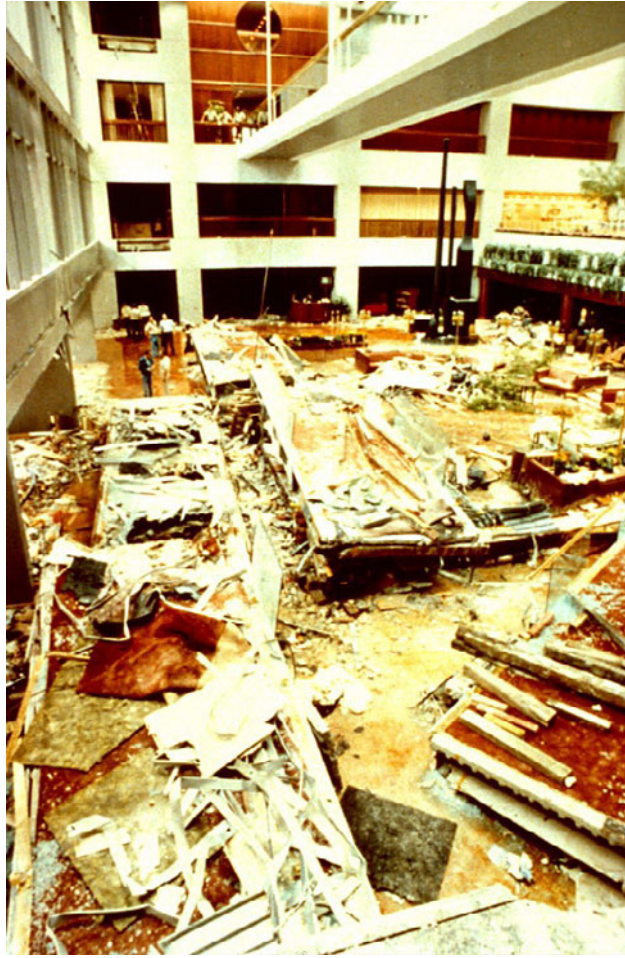
Figure 5-13. Second and Fourth Floor Skywalks collapsed in lobby.
Source: Courtesy of Wiss, Janney, Elstner Associates, Inc.

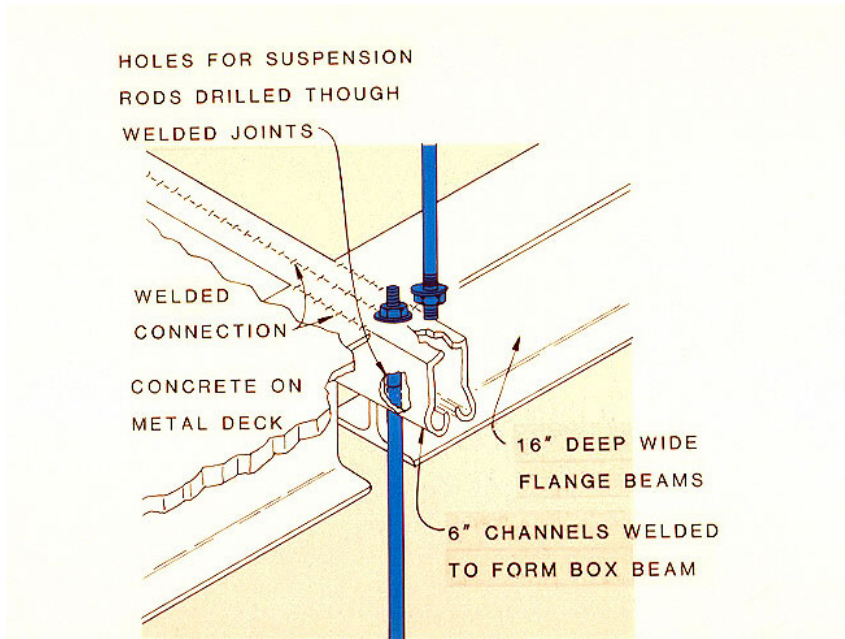
Figure 5-14. Detail of deficient connection and collapse mechanism.

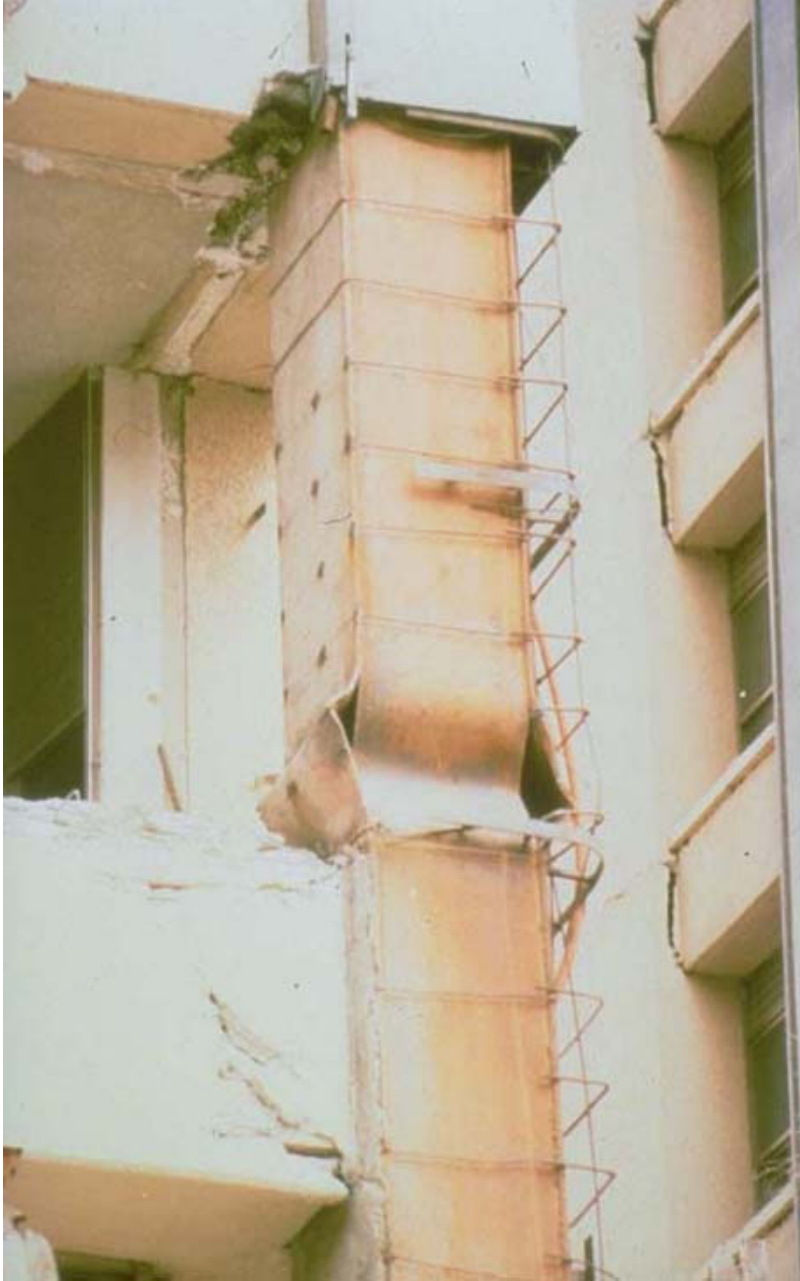
Figure 5-15. Pino Suarez Buckled Column.

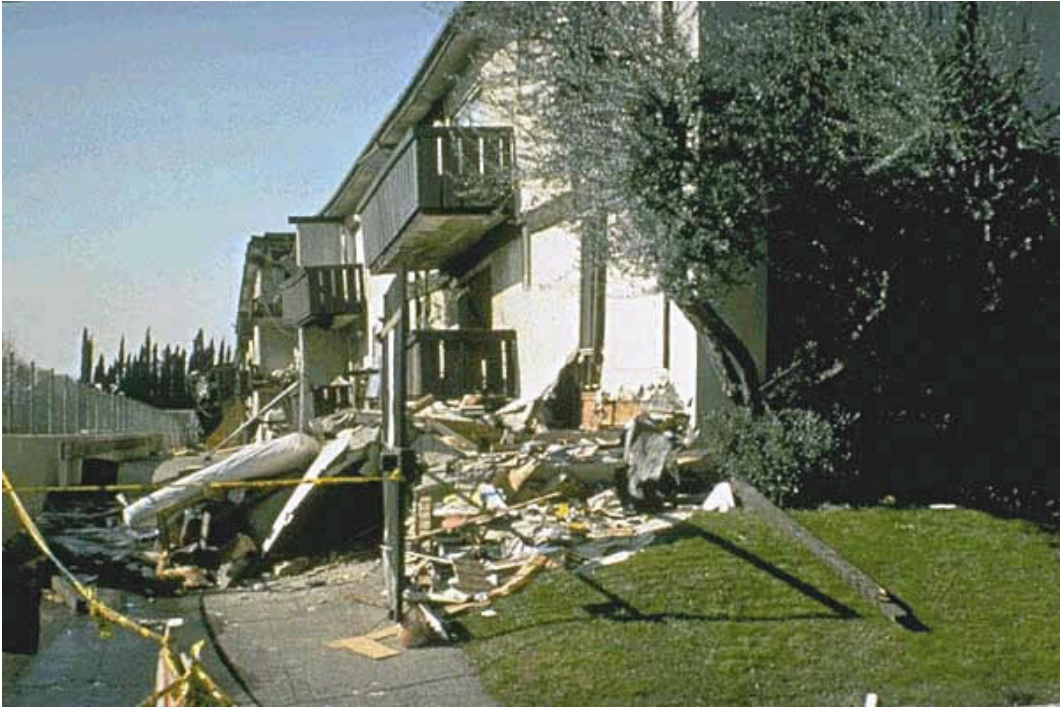
Figure 5-20. Collapsed first floor of Northridge Meadows Apartment.

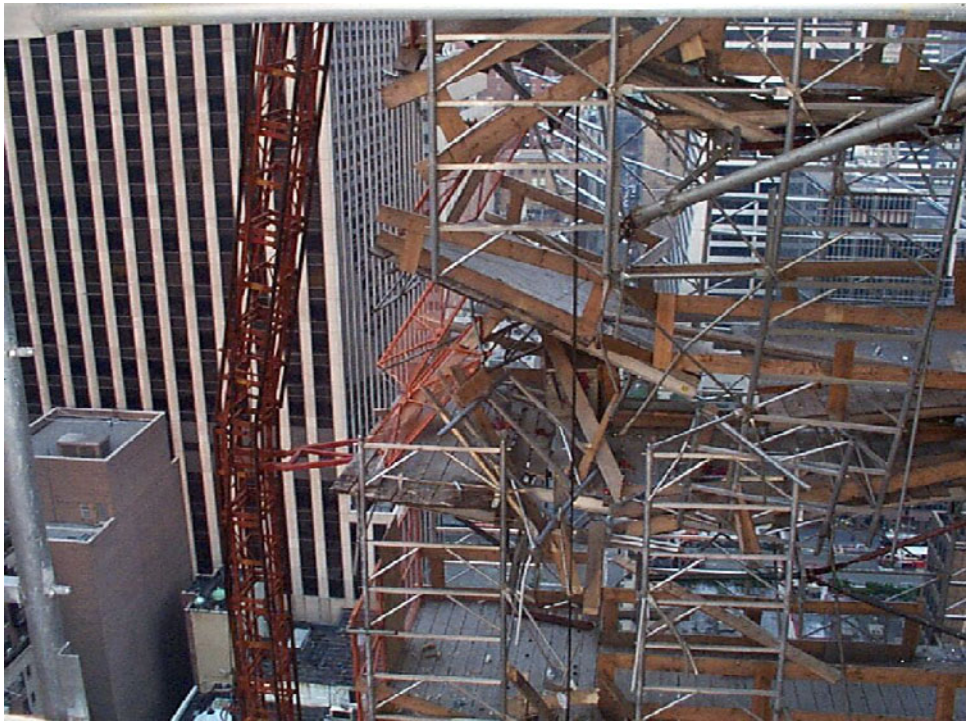
Figure 5-21. Collapse of scaffolding of Four Times Square.

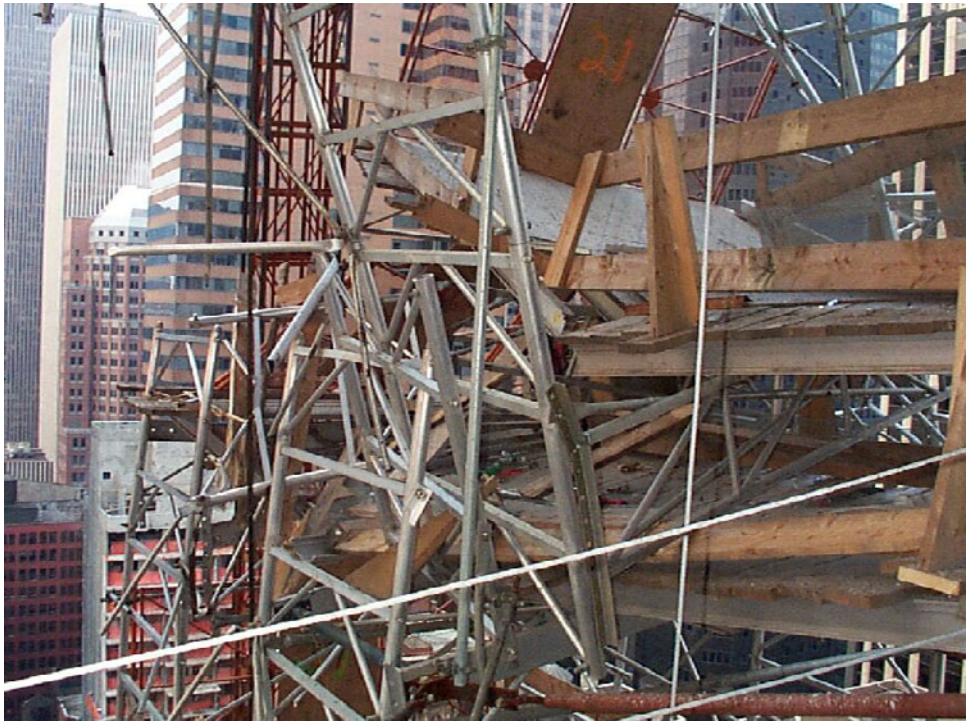
Figure 5-22. Collapse of scaffolding of Four Times Square.
