# BUILDING SURVEYS & REPORTS

*4<sup>th</sup> Edition*

**James Douglas BSc, MRICS, MBEng, FHEA  
and Edward A. Noy FASI, ARSH**

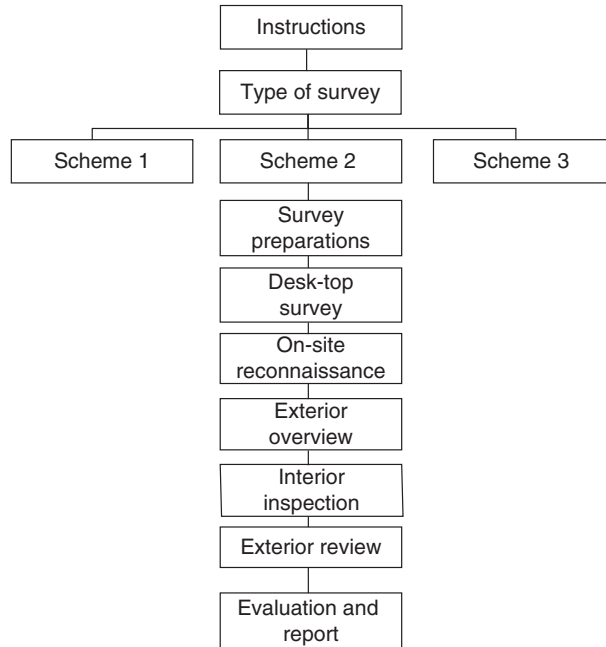
**Figure 2.1 The main stages in the building survey process**

In summary the main stages of the process of surveying a building are shown in Figure 2.1.

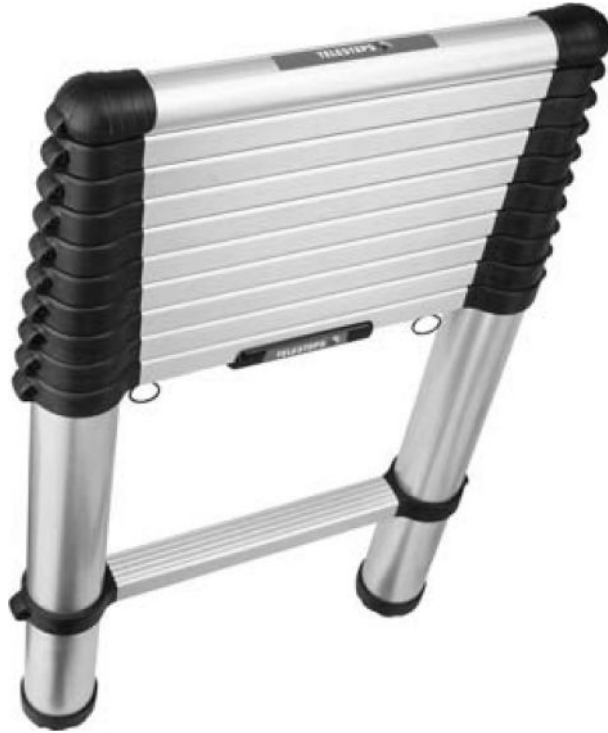
**Figure 2.2** Telesteps® telescopic ladder (courtesy of The Telescopic Ladder Company Ltd).

- When no builder is involved it is often necessary to gain access to high ceilings and roof spaces. A telescopic aluminium ladder capable of extending to about 3 m will meet this need, and will be found useful for most surveys. This type of ladder is usually about 1 m long when retracted and can easily fit into a car (see Figure 2.2).

- Telescopic ladder (around £200 at 2010 prices) (Figure 2.2). A fairly recent innovation is the use of a telescopic ladder for building inspection purposes. It is only about 0.75 m in height when closed but can stretch to 3.3 m when fully extended.
- Electronic moisture-reading meter (around £350 at 2010 prices) (Figure 2.3).
- 2 m folding rule and 5–8 m retractable steel tape.
- Laser distance measuring meter – 30 m range (accurate to  $\pm 1$  mm).
- Torch (5 million candle strength) for attic/sub-floor inspections.
- 20× magnification (minimum) binoculars to facilitate inspection of roofs and chimneys.
- Digital camera (5 million pixel minimum).
- Spirit level to check levels of floor.
- Plumb bob to check verticality of walls and columns.

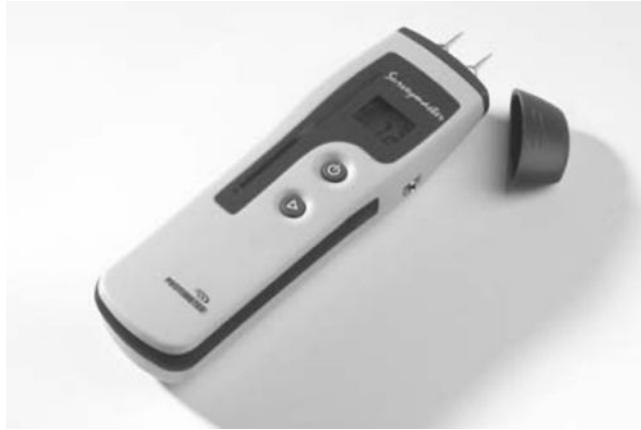
**Figure 2.3** ‘Protimeter Surveymaster SM’ moisture-reading meter (courtesy GE Sensing Infrastructure, Inc)

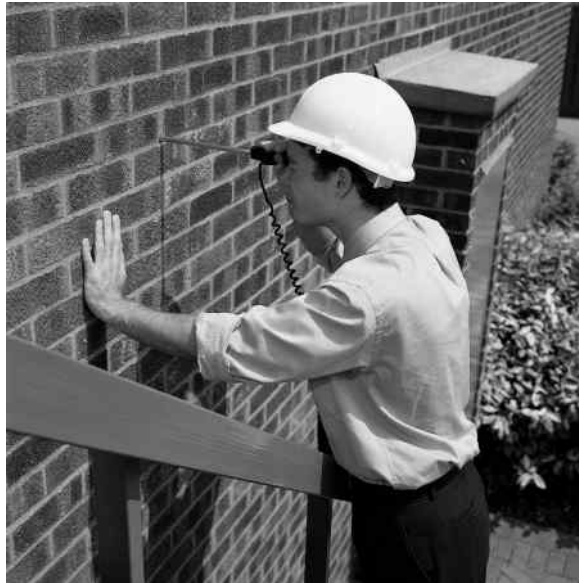
**Figure 2.4** Surveyor using a borescope (courtesy of Olympus Industrial)

- (1) Endoscopy: a fibre-optic borescope (Figure 2.4) is a useful tool for building surveyors to inspect hidden voids and cavities for problems such as bridging, wall-tie corrosion and fungal attack (Hollis, 2005) (around £1500–£4000 at 2010 prices).
- (2) Electric drill.
- (3) Electronic hygrometer (Figure 2.5): this instrument is essential for investigating condensation dampness (around £350 at 2010 prices).

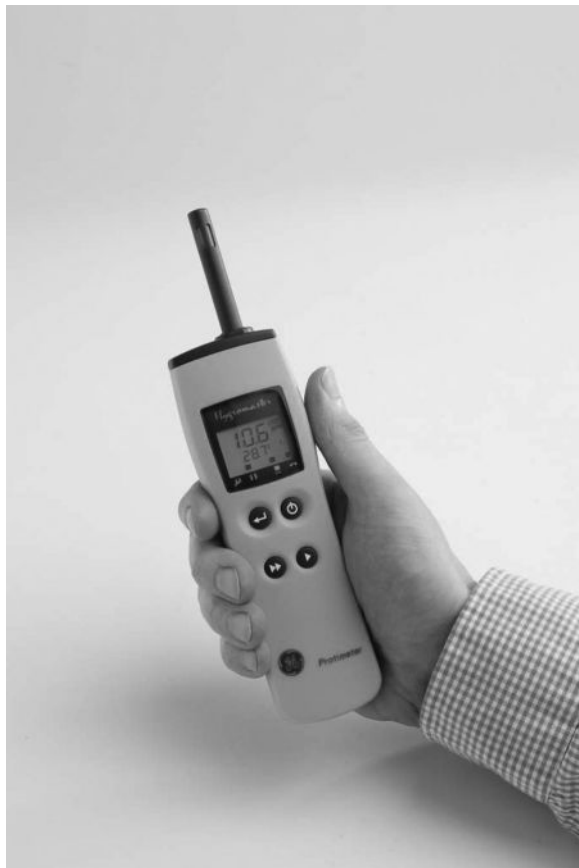
**Figure 2.5** 'Protimeter Hygromaster' hygrometer (courtesy GE Sensing Infrastructure, Inc)

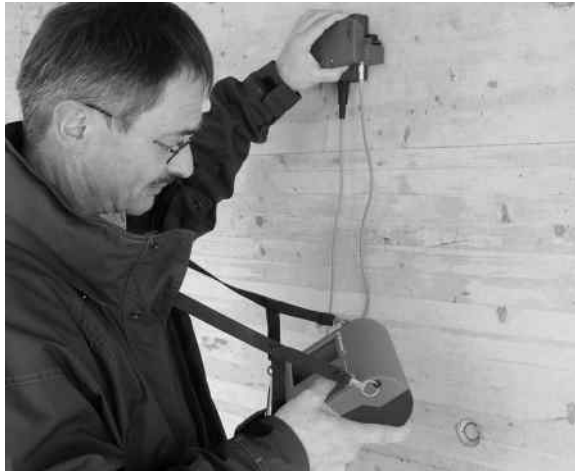
**Figure 2.6** Reinforcement detector and analysis and cover meter (courtesy of Proceq)

- (4) Cover meter (Figure 2.6): engineers and surveyors use this inspection tool to detect the presence and depth of steel bars in reinforced concrete (around £1500 at 2010 prices)

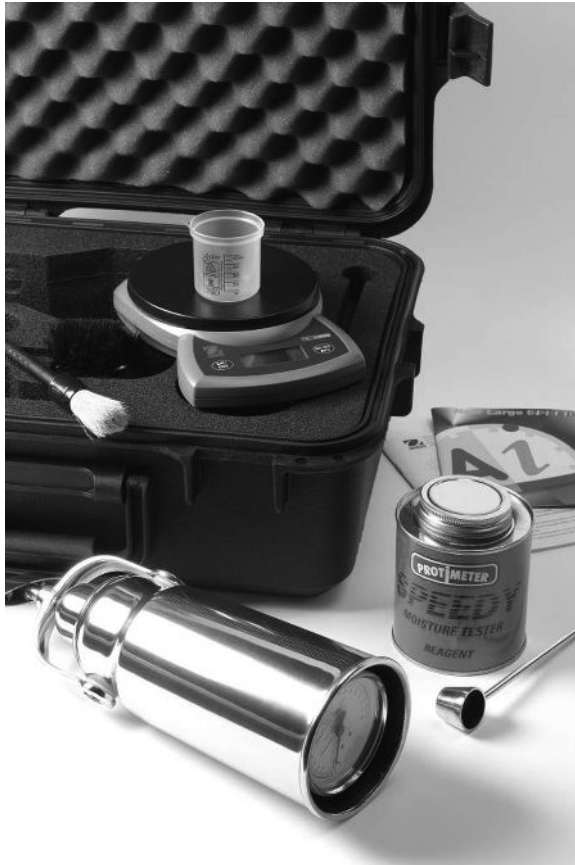
**Figure 2.7** 'Protimeter Speedy Moisture Tester' carbide meter (courtesy GE Sensing Infrastructure, Inc)

- (5) Calcium carbide ('Speedy') moisture meter (Figure 2.7): this instrument is used to ascertain on site the moisture content of particulate building materials such as mortar, brick, stone and concrete (around £700 at 2010 prices).

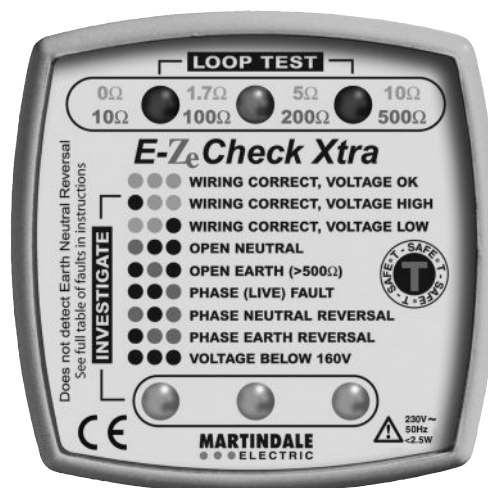
Figure 2.8 Earth loop impedance socket tester (courtesy of Martindale-Electric)

- (7) Socket tester (Figure 2.8): for use in undertaking earth safety test, voltage and wiring checks (around £50 at 2010 prices).
- (8) Micro-drilling: this is an expensive but very effective tool to determine the presence of decay in structural timbers using a special low-voltage hand-held drill that gives the result in the form of a resistograph (around £3500 at 2010 prices). Sorbus International Ltd can supply such a drill – IML-RESI F-series (<http://www.sorbus-intl.co.uk/resif-microdrill-kit.htm>).

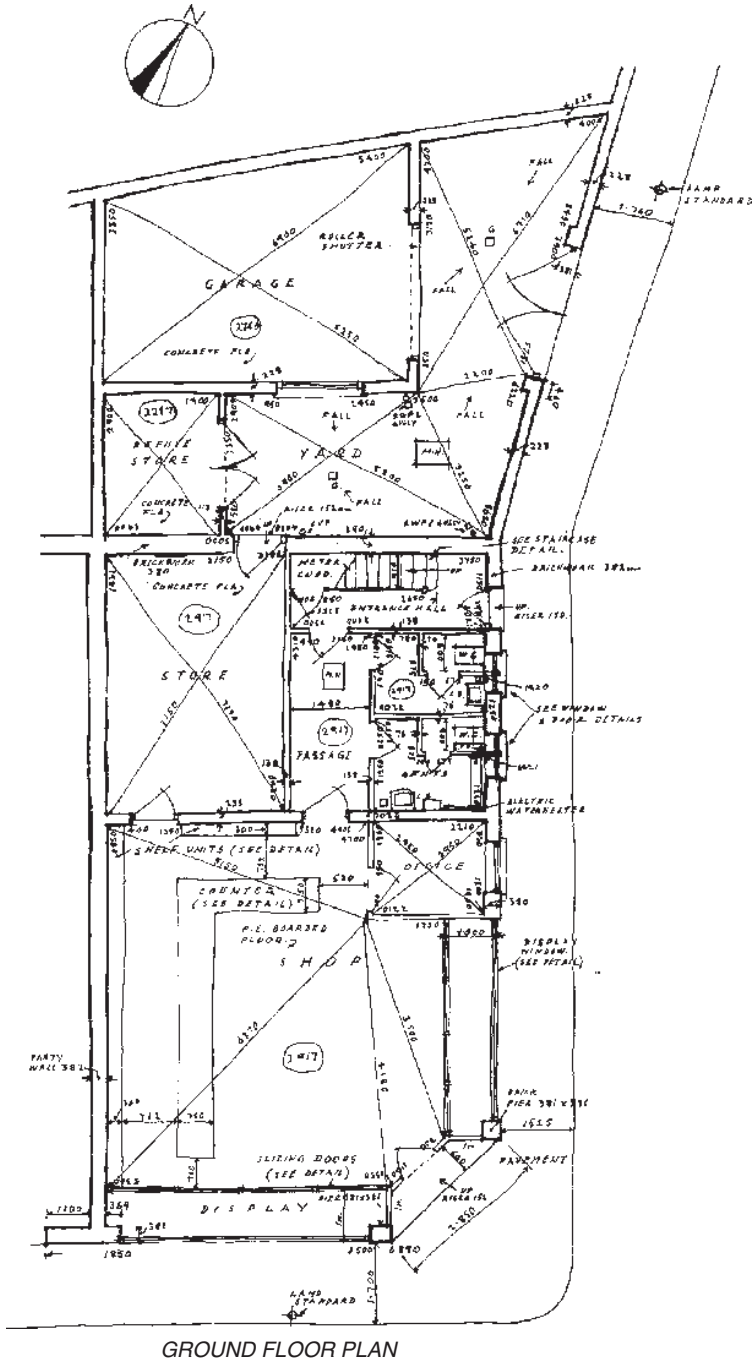
**Figure 3.1 Survey of ground floor shop premises**

*Internal finishes to rooms facing rear yard**Entrance hall**Floor* s.w./p.e. flooring in 152 mm widths. sound condition.*Skirting* 152 × 25. s.w. painted. F.G. condition.*Walls* plastered & painted. Minor cracks on outer wall. General condition F.G.*Staircase* All s.w. painted with polished hardwood handrail – solid panelled balustrade painted. Stair treads & nosing slightly worn. Decorative condition fairly good.*Ceiling* plastered & painted with 150-cove cornice. Minor plaster cracks around front entrance. General condition F.G.*Doors* Two flush s.w. doors to passage & meter cupboard and two panelled entrance door with glazed top panel & fanlight. All doors, frames & architraves are s.w. painted in good condition.*Store**Floor* Concrete screeded. F.G. condition. A few minor cracks in screed.*Skirting* 100 × 25. s.w. with rounded top edge painted. Timber sound paintwork in poor condition.*Walls* Plastered & painted. Plaster in F.G. condition paintwork poor.*Ceiling* Plastered & painted. Plaster sound paintwork poor.*Doors* Internal door s.w. flush. s.w. frame & architrave. Timber & paintwork in F.G. condition. External door s.w. two panelled & one glazed top panel. Timber & paintwork F.G. condition.*Refuse store**Floor* Concrete. F.G. condition.*Walls* Fair face brickwork. Pointing & brickwork in good condition.*Roof* Open timber joists (no ceiling) supporting boarded and felt roof. Joists 150 × 50 treated with preservative. All in good condition.*Double doors* s.w. framed doors lined with matchboarding. Evidence of movement in tenon joints & minor wet rot in bottom rails. Paintwork poor. Feet of s.w. frame shows evidence of wet rot.*Garage**Floor* Concrete. No serious defects apart from oil staining.*Walls* Fair face brickwork. Brickwork sound, pointing in poor condition.*Roof* R.c. slab. No defects.*Roller shutter* Laths & winding gear in F.G. condition. But requires overhaul.*Metal window* Metalwork sound. Paintwork poor.**Figure 3.1 (cont'd)**

Always take dimensions in a clockwise direction and the figures on the tape will be the right way up. It is better to measure the building to a set pattern in order to avoid omitting important dimensions. Measure along walls and partitions on the plaster face including door and window openings and piers etc. 'Running' dimensions should be taken; it is far more accurate and saves time. For example, a wall of a room 5 m long containing a 1 m wide door opening in the centre would not be measured in three separate dimensions 2 m, 1 m and 2 m. By using one length of tape the dimensions are booked 2 m, 3 m and 5 m. The dimension of the door opening should be in the actual door size. When booking running dimensions each figure should be booked near the end of the length to which it refers (see Figure 3.1).

In old buildings floor to ceiling heights are often found to vary. The heights can be booked in the centre of the room, and enclosed in a circle (see Figure 3.1). It is often difficult to take the height of a room against the wall where there is a large moulded cornice. In such cases it is easy to obtain the room height by measuring down from the ceiling to the top edge of an open door and adding this dimension to the height of the door. Industrial and warehouse buildings frequently have exposed steel roof trusses supported on stanchions. Measure from centre to centre of all stanchions and at the same time taking a note of their sizes. By using a ladder, details of the truss members and bearing connections etc. can be taken. At the same time the height from floor to the lowest horizontal truss member and the height to the apex can be obtained by using the steel tape.

If alterations or additions are contemplated a careful note should be made of the type and condition of the internal and external finishings adjoining the area of the proposed alterations. It is quite extraordinary how often this type of information is wanted. These details can be booked on a separate sheet or written at the side of the sketches as shown in Figure 3.1 which describes the internal finishes to the rear rooms of the ground floor plan.

At this stage, care should be taken not to overcrowd the sketch sheets. It is often wise to plot the drainage details on a separate sheet thus avoiding confusion when the survey reaches the plotting stage. This is why the drainage system has been omitted in the yard of Figure 3.1. Large irregular areas are often found around the boundaries of a site as shown in the yard of Figure 3.1. These are measured by taking diagonals as explained earlier in this chapter.

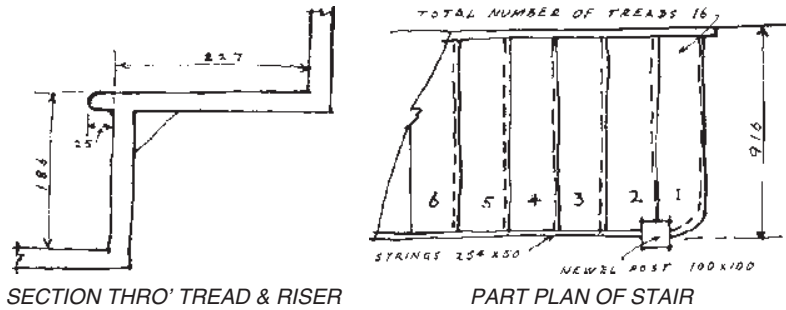
**Figure 3.3** Sketch of stair details

face of the lower riser to the face of the top riser. Enter this dimension with the number of treads on the survey sketch. The risers are similarly measured from tread to tread (see Figure 3.3). The plan and the section shown should be sufficient for a 1:50 or 1:100 scale, but details of newel posts and balustrade will probably require a larger scale.

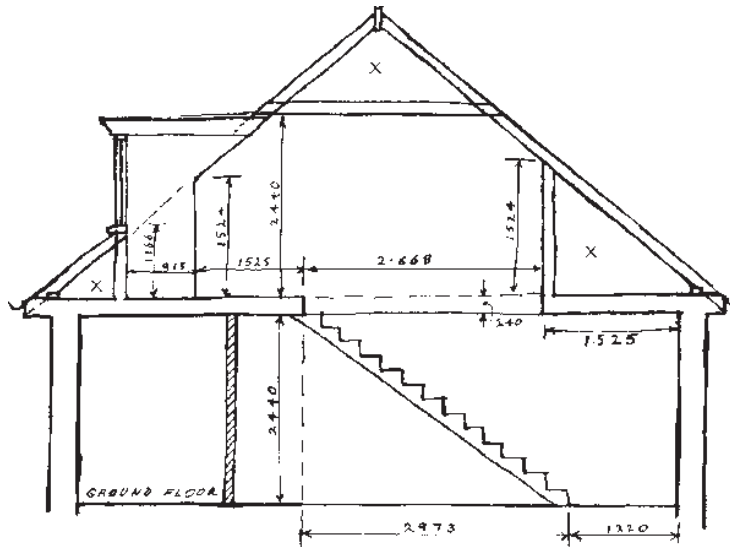
SECTION THRO' ROOF SPACE & GROUND FLOOR.  
(X=VOID SPACES, WHICH SHOULD BE VENTILATED).

**Figure 3.4** Section through roof space and ground floor

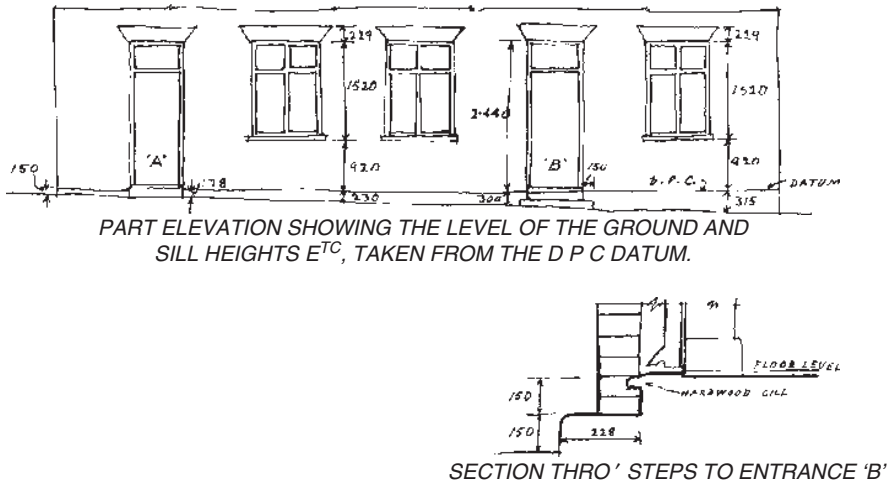
**Figure 3.5** Part elevation showing the level of the ground and sill heights etc. taken from the damp-proof course datum

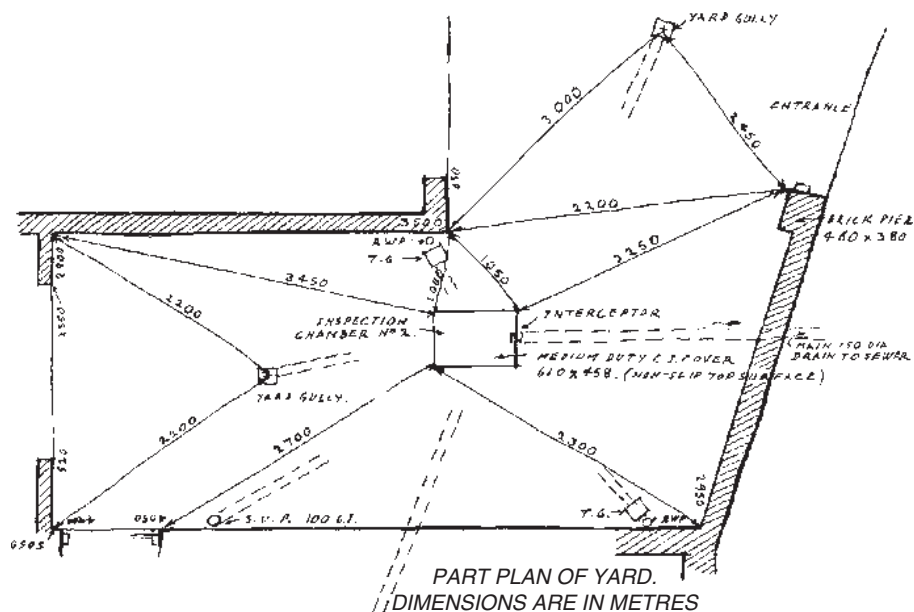
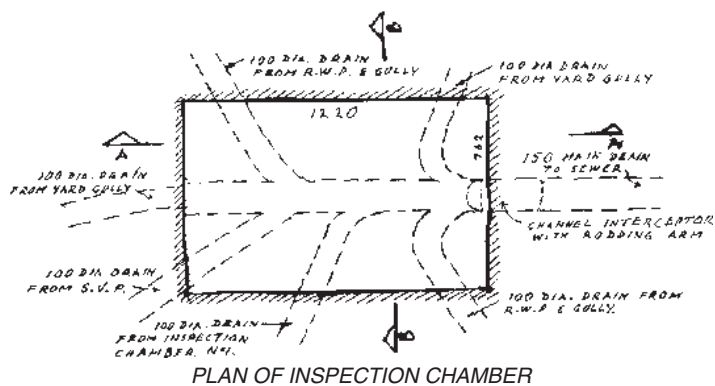
Figure 3.6 Drainage details

Inspection chamber positions can be established by taking measurements to suitable points on the external or boundary walls of the building. Figure 3.6 shows an enlarged survey sketch of the drainage system taken from the yard survey in Figure 3.1. The inspection chamber cover should be removed and the internal measurements of the chamber taken, together with the depth from cover to invert and the position and size of all pipe runs. Do not assume that the inspection chamber is the same size as the cover, as large inspection chambers are often corbelled over at the top and fitted with a small cover as shown in Figure 3.6. Trace all the drain branches by flushing WCs and running taps in basins and sinks so that every run is accounted for and at the same time note the condition of the installation.

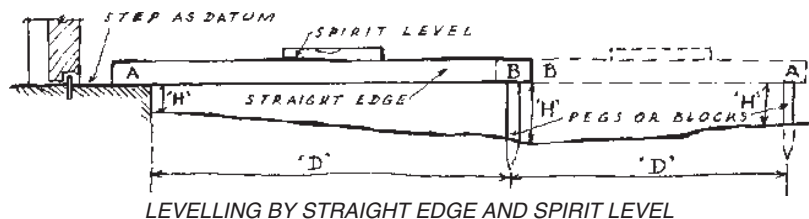
Figure 3.7 Levelling by straight edge and spirit level

as indicated by the letters 'A' and 'B' at each end of the board. By reversing the board and level any error will be minimised. The distance between the pegs or block and their height can then be measured, as indicated by the letters 'D' and 'H' on the sketch.

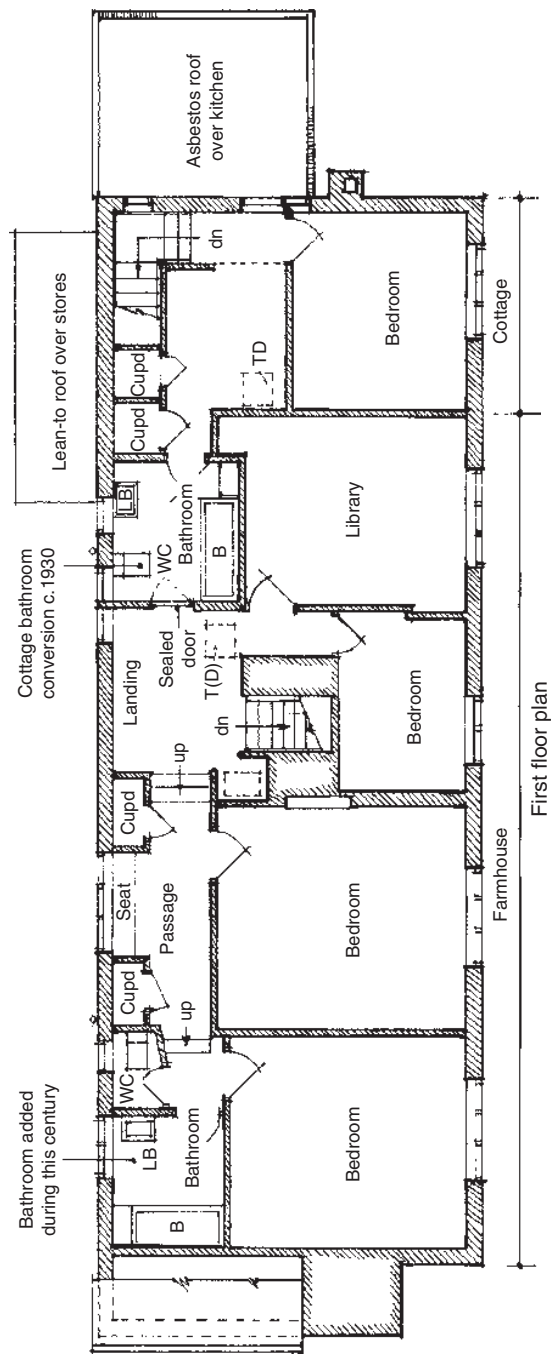
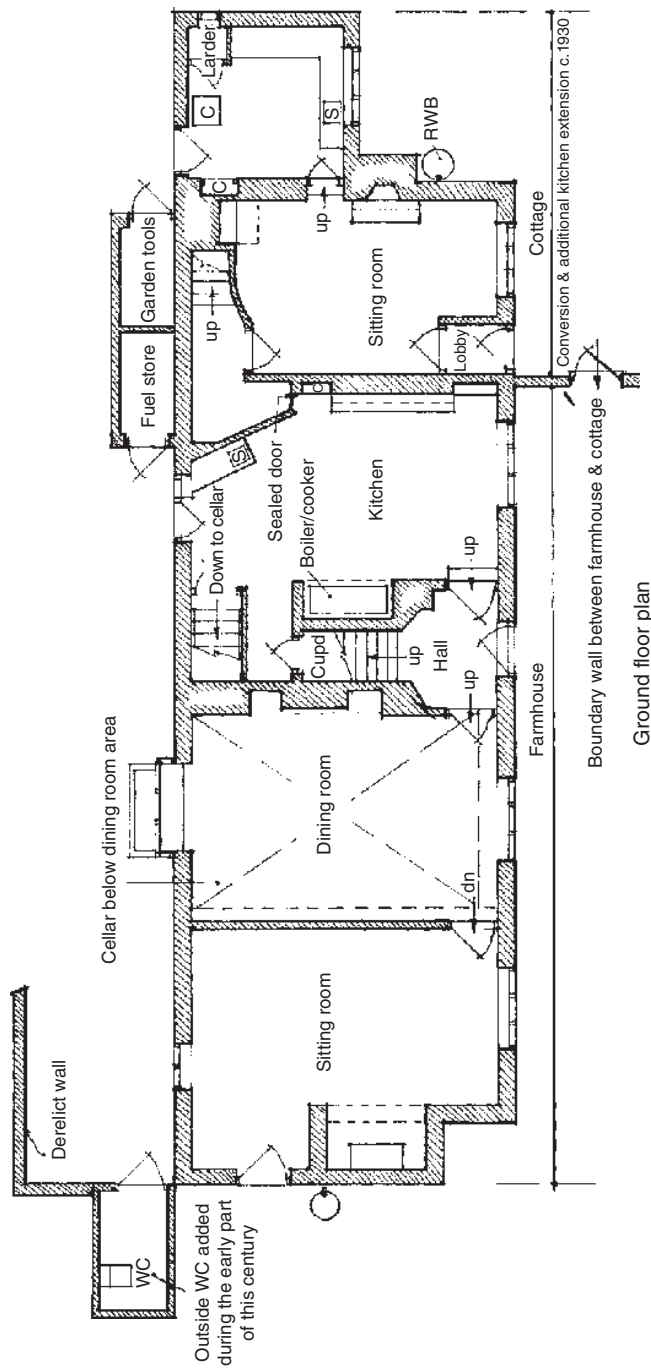
Figure 4.1 Plans

Figures 4.1, 4.2 and 4.3 show the elevations, plans and notes of an eighteenth century listed country farmhouse and cottage in Kent. This information is sufficient for a superficial layout as described above. Surveys of historic buildings for repair or restoration purposes will require more detailed information (Dallas, 2003). The primary object of this type of survey is to assist accurate diagnosis as a basis for a specification. All available evidence must be collected together and critically examined before conclusions are reached. Measured plans, elevations and sections will be required including all the items mentioned above.

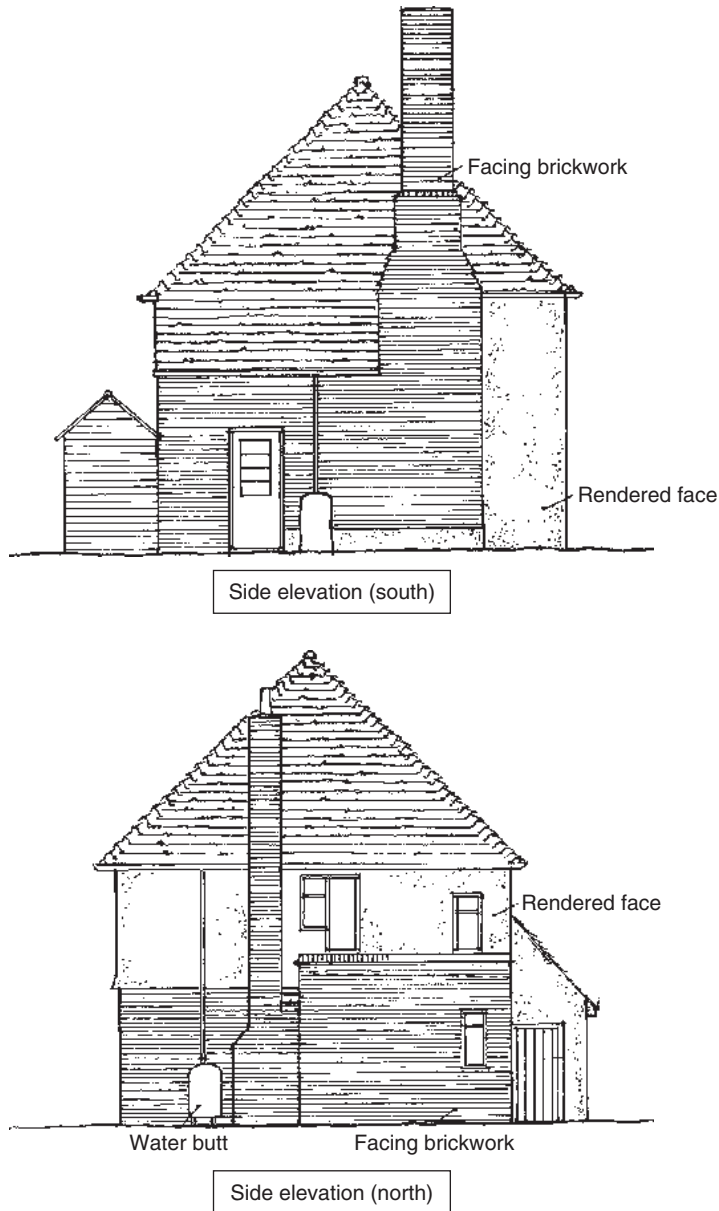
**Figure 4.2 Side elevations**

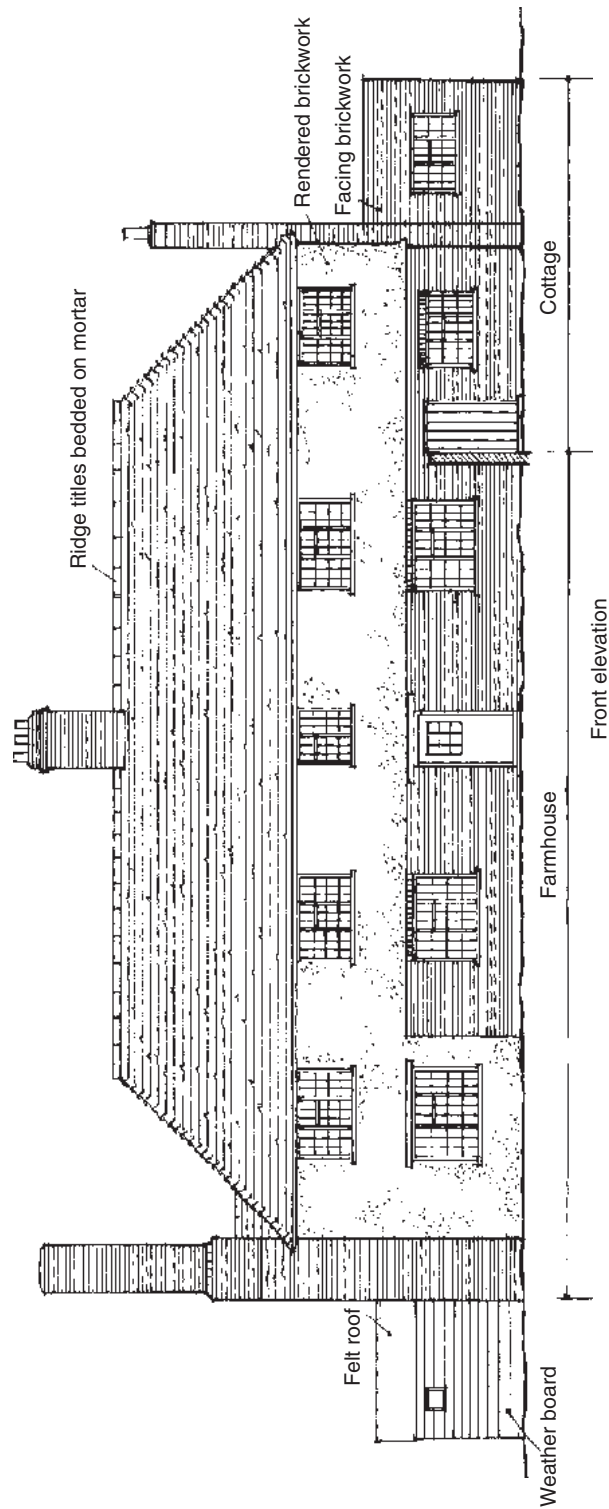
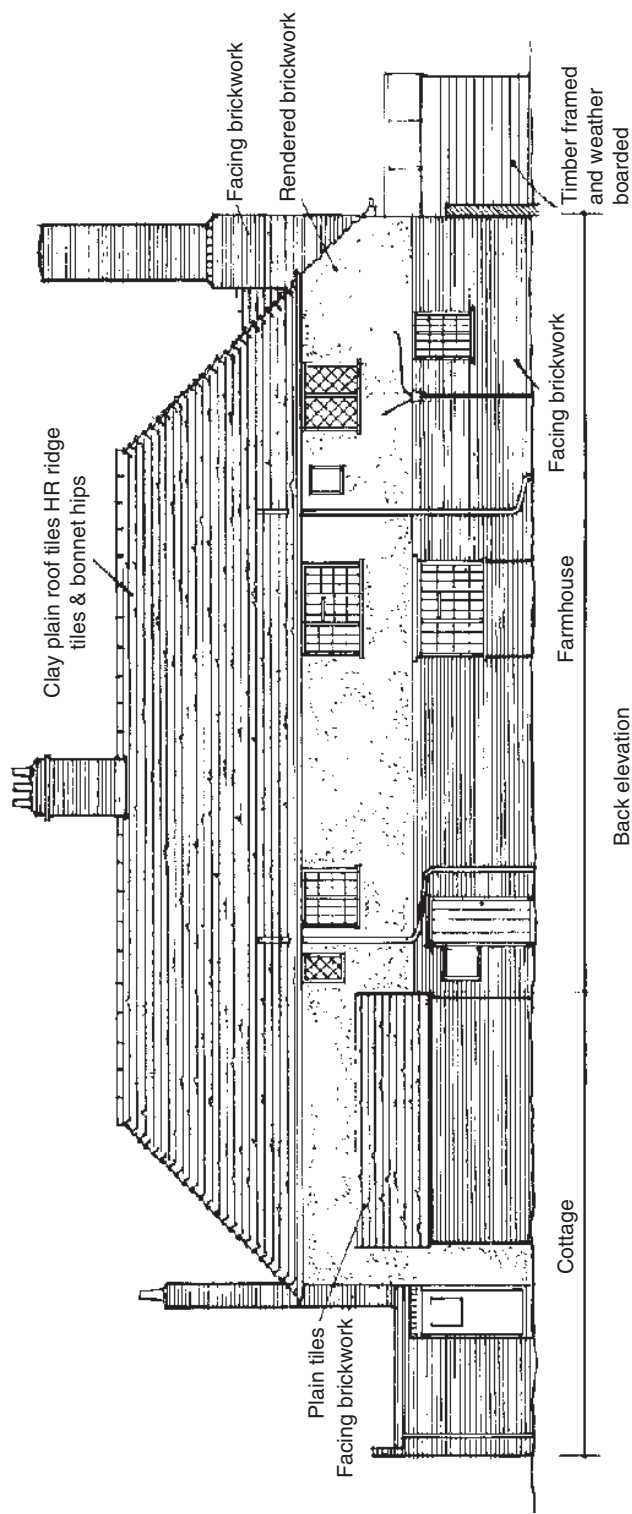
Figure 4.3 Front and back elevations

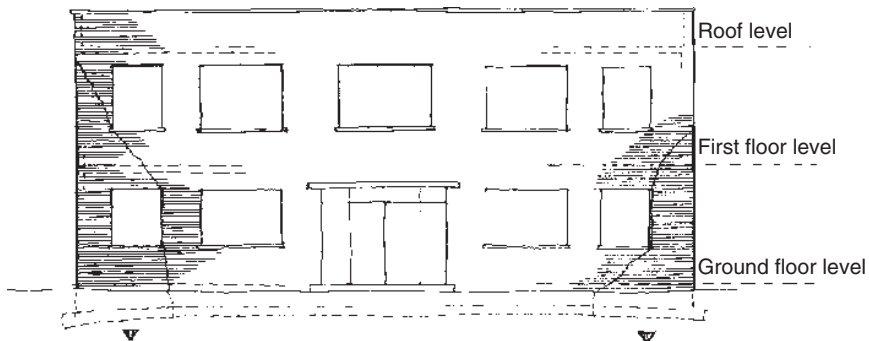
**Figure 5.1** Example of differential settlement. Settlement in end walls with centre portion stable. Cracks increase in width with height, and appear to be interrupted by the windows, but in fact extend round the openings forming a gap between window frame and brickwork. The movement is at its maximum at roof level and could cause loss of bearing in the roof slab

Excavating the ground and placing substantial loads on it is sufficient to cause a slight movement as the ground below is compressed to resist the load. Provided the settlement is uniform over the building area the movement does little damage. Alternatively, there may be differential movement where part of the foundation remains stable while the remainder moves (Richardson, 2000). A typical example of differential movement is shown in Figure 5.1 where settlement occurred in the end walls with the centre portion stable. The cracks are usually vertical or diagonal and are often interrupted by window or door openings. In such cases a gap is formed between the frame and brickwork.

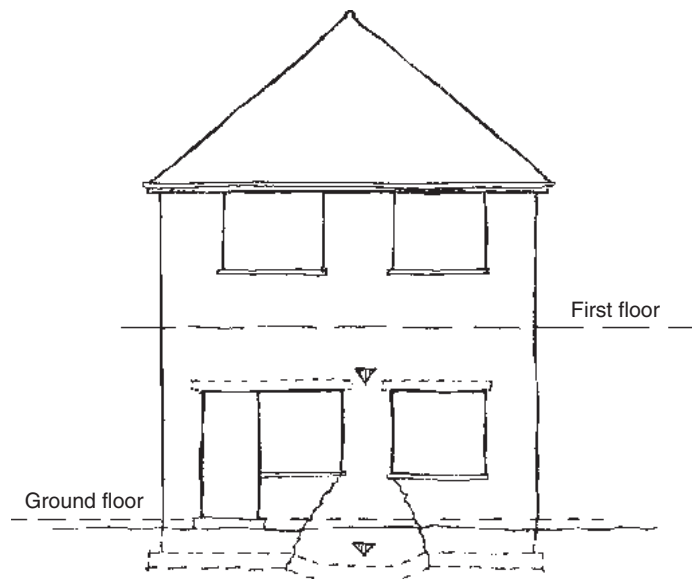
**Figure 5.2** Example of overloading. Settlement in the centre of a wall with ends stable. Heavy loads from first floor, roofs and walls above are transferred to a narrow pier of brickwork causing cracks in the wall and foundation settlement. With this type of settlement cracks decrease in width with height

Every building has its own pattern of loading. Where internal alterations have taken place in the original building or additional loads have been applied due to a change of use, then the loads placed on the subsoils are greater than was originally allowed for. Overloading can also occur where door or window openings have been enlarged which may result in a heavier load being transferred to an adjacent section of brickwork consisting of a narrow pier. Again, the load imposed upon the subsoil is greater than originally allowed for, causing the pier to settle (see Figure 5.2).

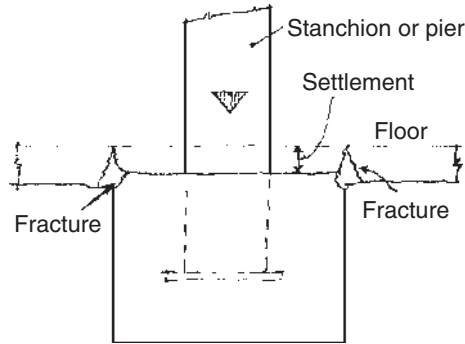
**Figure 5.3** Differential settlement under the point load of a stanchion

Under concentrated loads such as an overloaded pier or stanchion on shallow foundations will often show movement cracks between floor and foundation where the foundation has been ‘punched’ downwards sometimes several centimetres (see Figure 5.3).

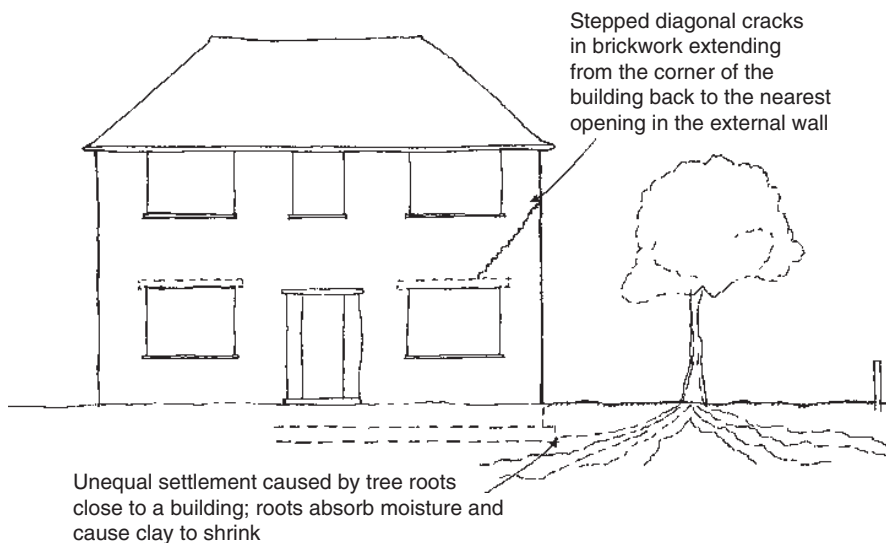
**Figure 5.4** Unequal settlement caused by tree roots

Fast growing trees close to buildings can cause unequal settlement when active tree roots dry out the soil causing differential soil shrinkage (BRE Digest 298, 1999). Shrinking clays affect the bearing capacity and lead to movement in the building, especially in shallow foundations. Tree roots can extend over a considerable distance and can extract moisture from as deep as 6 m below the surface. It is, therefore, necessary to make an accurate survey of their position and obtain details of the type of tree, and at the same time establish that the tree is the cause of the damage (see Figure 5.4). Poplars and elms with fast growing root systems can be expected to cause serious seasonal movements.

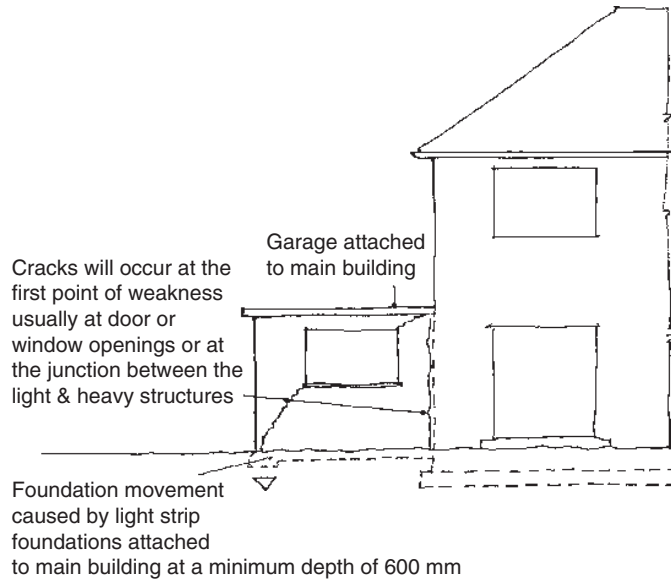
**Figure 5.5 Diagonal fracture between light and heavy structure**

The surveyor will often find that foundation movement in older domestic properties can be caused by light strip foundations attached to the main building supporting porches, bay windows and garages. There is a common misconception that these lightweight structures do not need deep foundations as does the main building. If this type of foundation is not carried down sufficiently deep to avoid movement by atmospheric action, the junction between the light and heavy parts of the structure will often show a diagonal crack running down from the lower corner of the rear window as shown in Figure 5.5.

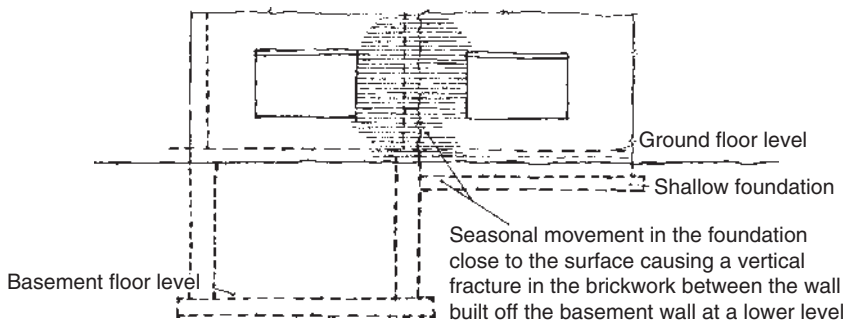
**Figure 5.6 Unequal settlement between basement and ground floor walls**

Another common example is when part of a building has a basement with foundations set in deep geological beds. Seasonal movement will often take place in the foundations close to the surface causing a vertical fracture at the junction between the walls built off the basement wall and the ground floor. The heavier walls to the basement area will settle relatively more causing movement cracks between the light and heavily loaded walls as shown in Figure 5.6. This is more noticeable when the ground floor structure is built on shallow foundations in a clay subsoil.

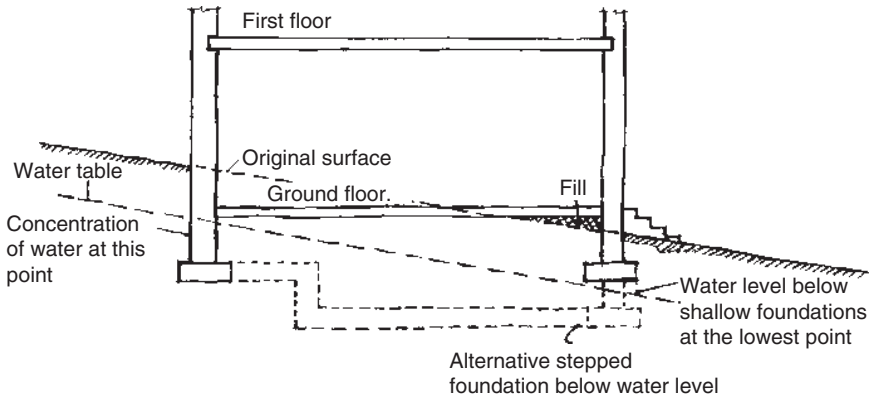
**Figure 5.7 Building on sloping clay site**

Buildings on sloping clay sites can often present difficulties (IstructE, 2000). The water table on sloping sites tends to follow the topography of the surface and if the natural contours of the site change it does not necessarily alter this line. Where the foundations have been set at a constant depth from the stepped level surface the concentrations of water may affect the foundations at the lowest point causing differential settlement. Figure 5.7 shows such a case where the water table is above the foundation at the highest point and beneath a shallow foundation at the lowest

point. In such cases it would have been advisable to form stepped foundations as shown in the sketch in order to be below the water level.

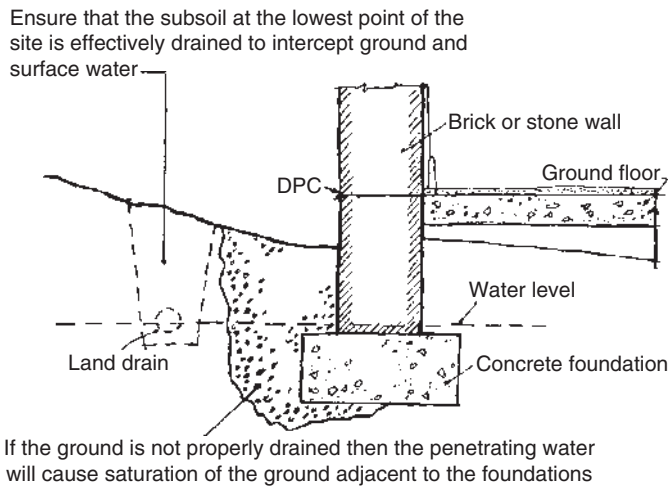
**Figure 5.8 Building at the lowest point of a sloping site**

If a building is erected at the lowest point of a sloping site, natural drainage of the water to the lower points can cause saturation of the ground around the base of the wall and foundations thus lowering the bearing capacity (see Figure 5.8). In both the above cases it is advisable to check that the subsoil is effectively drained at the highest level in order to protect the building against damage by water penetration. The surveyor will often find that surface water drainage has been omitted especially in ancient buildings.

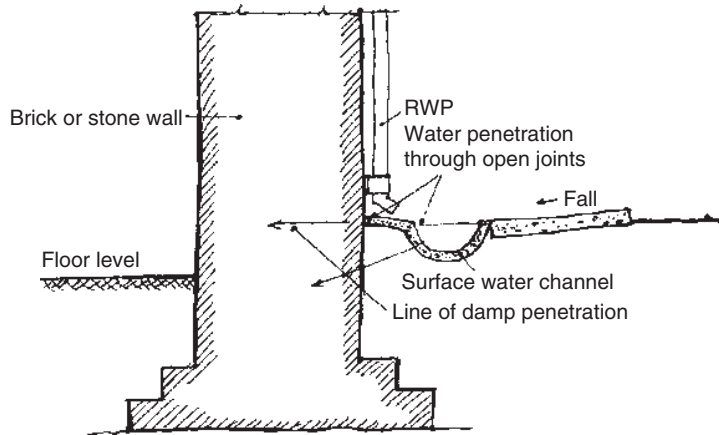
**Figure 5.9** Water penetration around base of external walls where the ground floor level is below the ground level

surveyor will probably notice that clayware or concrete channels have been inserted around the base of the wall to collect rainwater from the roofs and a certain amount of surface water from paved areas around the building. The channels tend to move with the seasonal changes in the subsoil causing the joints to open, thus allowing water to percolate through to the subsoil and the base of the wall. In such cases there is a risk of uneven movement in the subsoil leading to settlement cracks (see Figure 5.9).

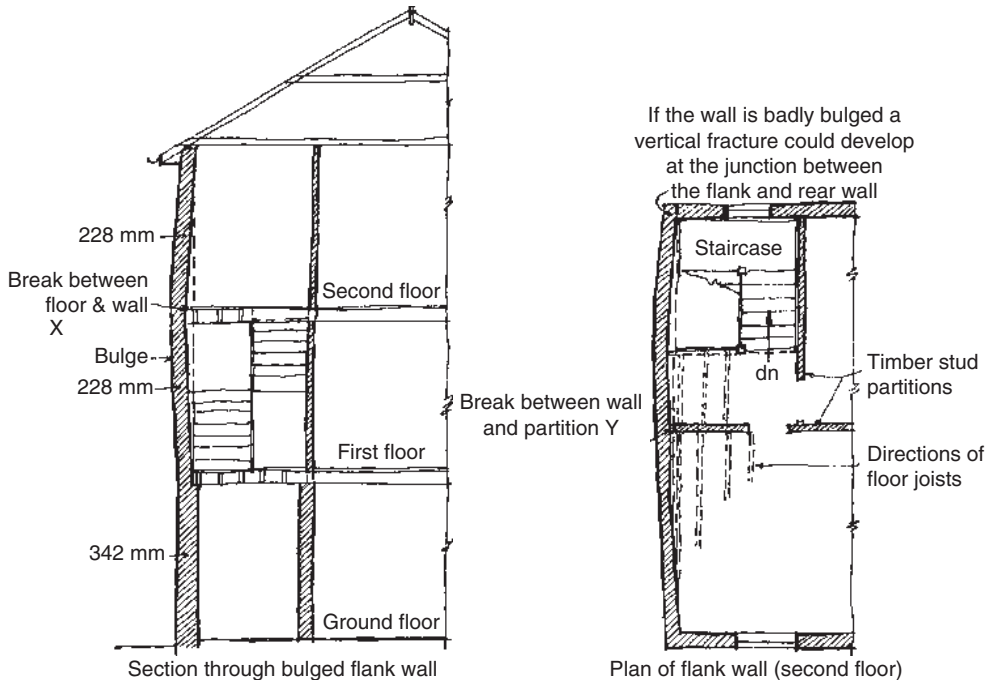
**Figure 6.1 Bulging due to inadequate thickness and lack of restraint in walls**

of brick walls that some form of restraint should be provided to prevent lateral movement. This is achieved by building in floor joists or by bonding in partitions at right angles to the wall. In Figure 6.1 the wall is only 228 mm thick at first and second floor levels, and the floor joists run parallel to the flank wall, and do not provide a tie to the external wall. Furthermore, the staircase is positioned against the flank wall so that there is minimal restraint between flank and rear walls. If the brickwork at the junction marked 'X' on the sketch is weak a vertical fracture could develop. The flank wall will also tend to pull away from the timber stud partition as shown on the plan view marked 'Y'. These defects are common in properties built pre-1914 end-of-terrace or semi-detached three-storey houses. Figure 6.2 shows an unrestrained flank gable wall where the shortest span for the first floor and ceiling joists is front to rear. The danger in such cases is the loss of bearing to the ridge.

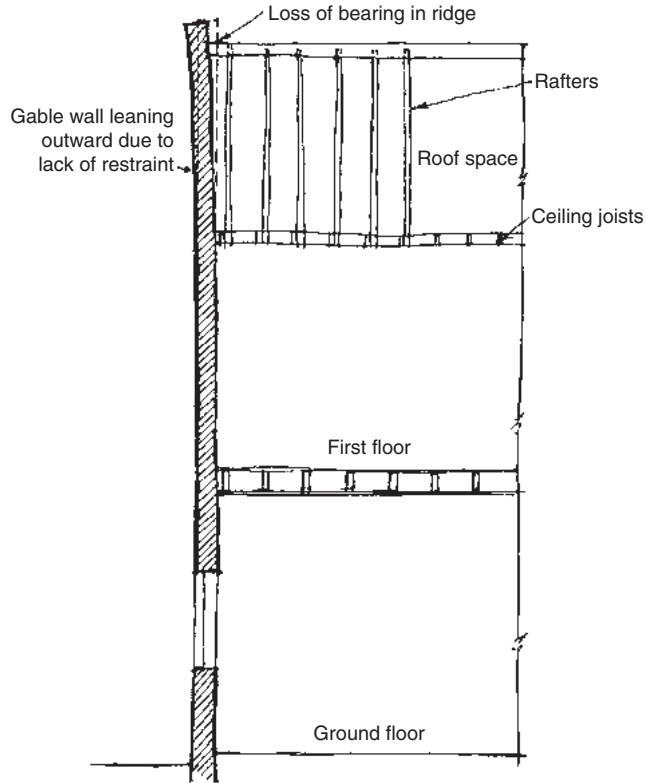
**Figure 6.2 Unrestrained flank gable wall**

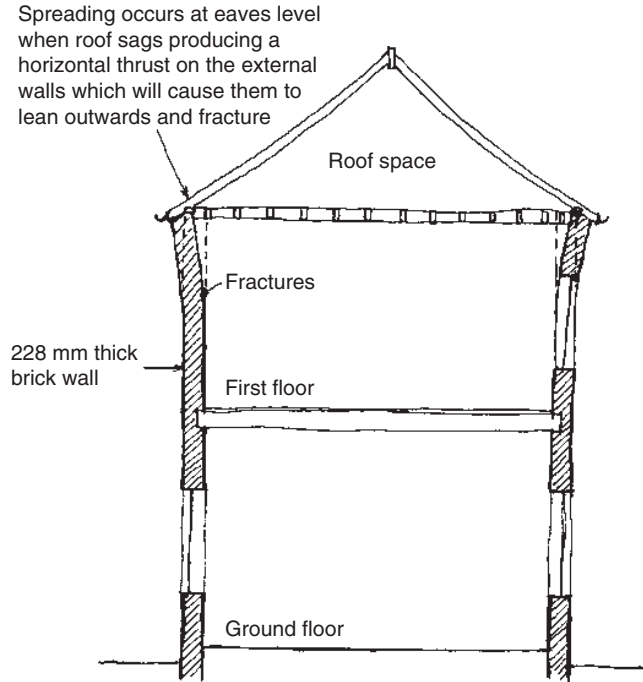
**Figure 6.3 Untied roof causing rafters to spread**

Figure 6.3 is an example of an untied roof causing the roof to sag. The sagging produces a horizontal thrust on the external walls which may cause them to lean and fracture. With all bulging and leaning defects evidence can also be seen internally by way of cracks in the ceilings, particularly at the junction of wall and ceiling, and where the partitions meet at right angles to the external wall.

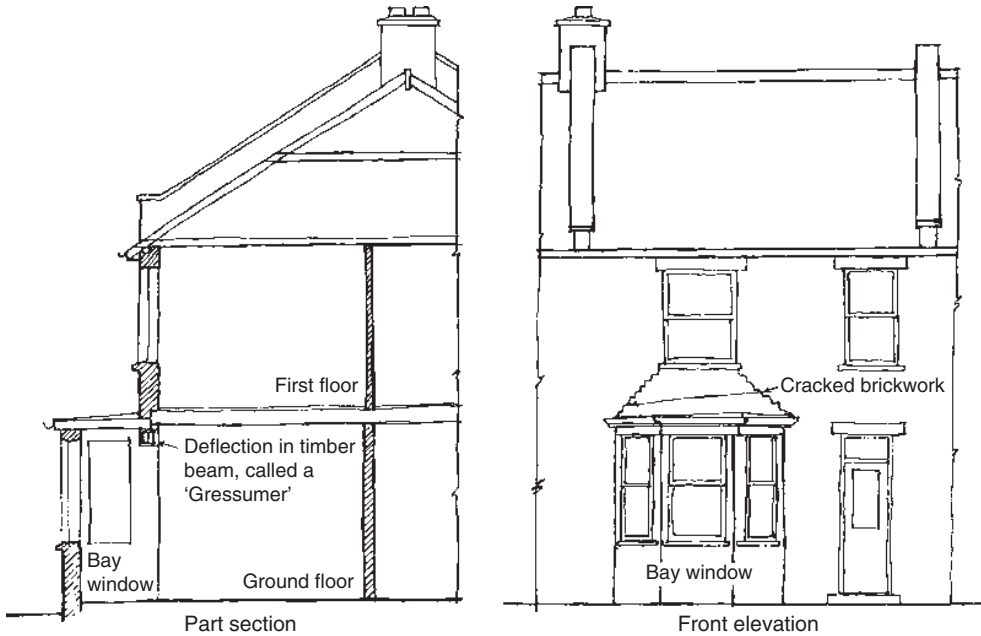
**Figure 6.4** Typical case of overloading in older domestic property where about a quarter of the total load above ground is carried on the timber beam over the bay window

Excess loads on roofs can also affect brickwork causing bowing or crushing. An example of overloading is shown in Figure 6.4 and is caused by faulty design; this is typical of many Victorian domestic properties where about a quarter of the total loading above ground level is carried on the timber beams over the bay window producing a deflection in the beam, and cracked brickwork as shown in the sketch.

When investigating such defects it is quite usual to find that the timber beam consists of two floor joists bolted at intervals and because of their slenderness they are readily overloaded. The bearing ends will be embedded into the brickwork with very little protection against moisture penetration. The bearing ends will require close inspection for signs of decay which will entail removing some plasterwork so that observation can be made. Timber may appear to be rotten on the surface, but it is wise to test with a gimlet before assuming that it is so throughout. Woodworm is also found to be particularly active around the bearing ends of beams.

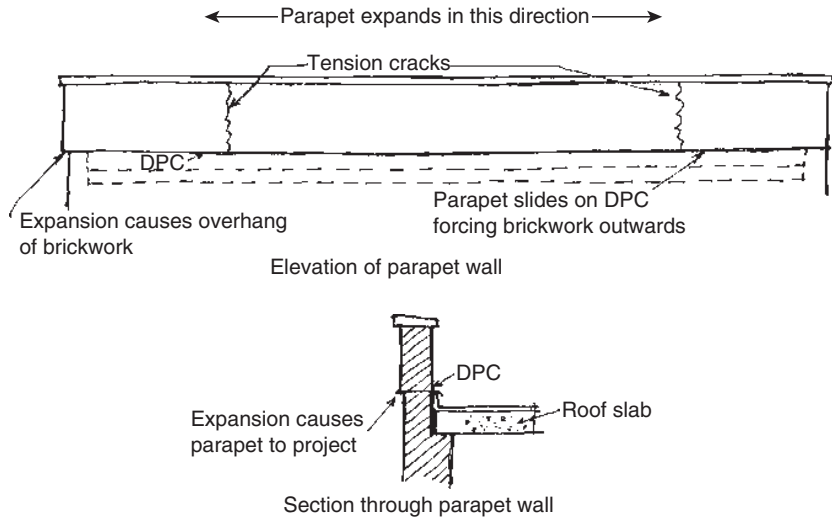
**Figure 6.5 Thermal movement of brickwork**

Experience has shown that cracks due to thermal and moisture movement tend to act in a vertical direction and are of equal width throughout. They are also localised at the weakest points in the structure, such as around door and window openings. Water will also tend to run downwards from defective window sills to the DPC.

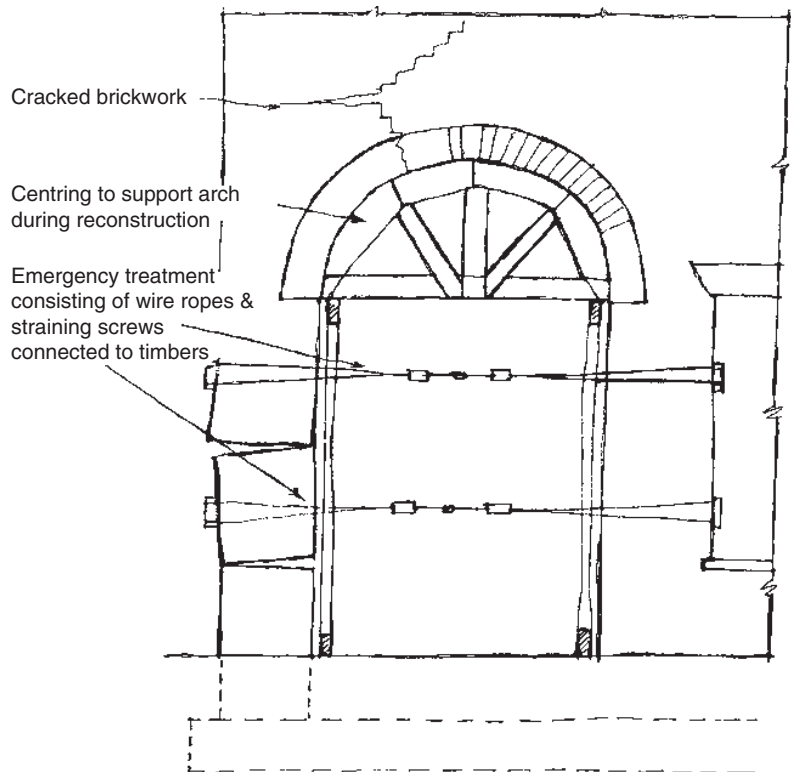
Figure 6.6 Damage to abutments due to inadequacy of the pier

Settlement cracks usually arise from the inadequacy in size of the abutments causing the brickwork to thrust outwards as shown in Figure 6.6 where the opening is too near the corner of the building. If the surveyor considers the fractures to be

serious and requiring emergency treatment, the first step is to tie the abutments together by using two or three wire ropes and straining screws connected to timbers through the nearest opening. The arch will also require support by erecting centring similar to that used in the construction of new arches. This will relieve the arch of its load and enable the necessary repairs to be carried out. Alternatively, a raking shore should be erected against the fractured abutment to resist any further movement. A similar problem can arise from the excessive deflection of a lintel, causing converging cracks to run upwards as shown in Figure 6.7.
