# BUILDING SURVEYS & REPORTS

*4<sup>th</sup> Edition*

**James Douglas BSc, MRICS, MBEng, FHEA  
and Edward A. Noy FASI, ARSH**

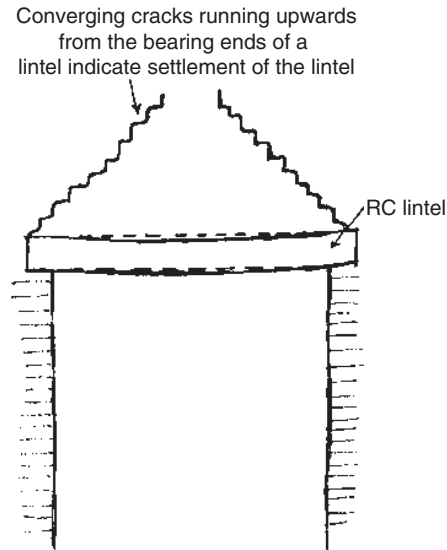
**Figure 6.7 Cracked brickwork due to lintel failure**

serious and requiring emergency treatment, the first step is to tie the abutments together by using two or three wire ropes and straining screws connected to timbers through the nearest opening. The arch will also require support by erecting centring similar to that used in the construction of new arches. This will relieve the arch of its load and enable the necessary repairs to be carried out. Alternatively, a raking shore should be erected against the fractured abutment to resist any further movement. A similar problem can arise from the excessive deflection of a lintel, causing converging cracks to run upwards as shown in Figure 6.7.

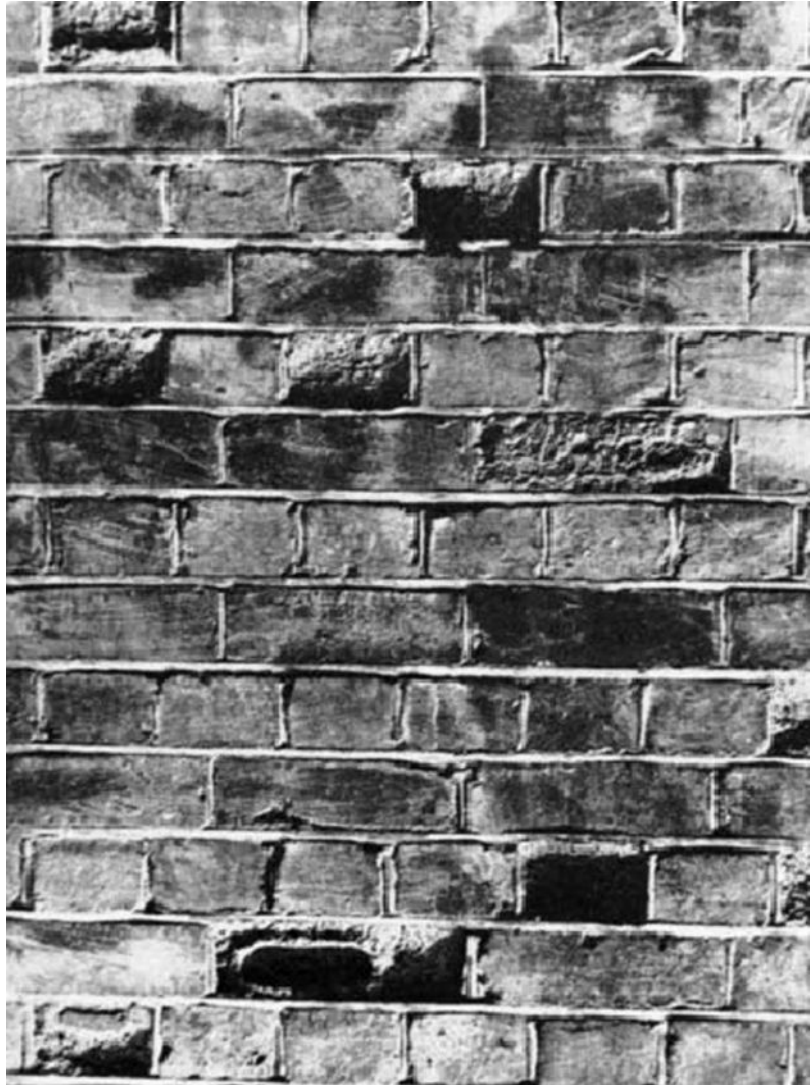
**Figure 6.8** Surface decay of brickwork due to crystallisation of salts

The majority of clay bricks contain sulphate salts. These salts are soluble in water and when walls are erected the moisture reacts to form a solution which travels by capillary action through the brickwork. The salts form a white deposit on the surface known as efflorescence which is usually harmless and will gradually diminish by the action of rain and wind. This defect is usually found in fairly new buildings (say up to 4 years old). With older buildings soluble salts will have worked themselves out of the brickwork. A type of salt known as magnesium sulphate may crystallise beneath the surface of the brick causing surface erosion and the outer skin to split away as shown in Figure 6.8. Portland cement contains tricalcium aluminate in varying amounts. Wet clay bricks in contact with mortar based on Portland cement will form calcium sulphoaluminate, the crystal of which causes considerable expansion and disintegration of the mortar joints. This expansion produces horizontal cracks in the mortar joints and leaning or bulging sections of brickwork which in time will impair the stability of the wall. This defect is particularly noticeable if the brickwork is restrained at top and bottom or in exposed positions such as parapet walls, retaining walls and chimney stacks. If walls are saturated on one side, then expansion will occur on that side causing the wall to curve. Figures 6.9a and b show two typical examples of sulphate attack to a parapet wall and retaining wall where continued saturation has caused the brickwork to bend away towards the dry side. The problem for the surveyor is to decide what remedial work is necessary to eliminate the source of moisture and whether or not the affected brickwork should be rebuilt. The surveyor should also check wall surfaces internally and externally between the eaves and the DPC to ascertain that the external walls have been properly designed and to ensure that DPCs and flashings etc. are effective.

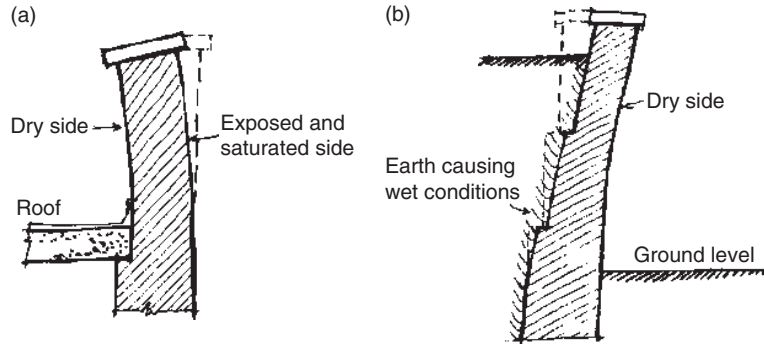
**Figure 6.9 Sulphate attack (a) in parapet wall and (b) brick retaining wall**

First, the surveyor must remember that there are three contributory factors that cause sulphate attack: a combination of Portland cement, soluble sulphate salts and water. Sulphate attack cannot occur in the absence of one of these factors.

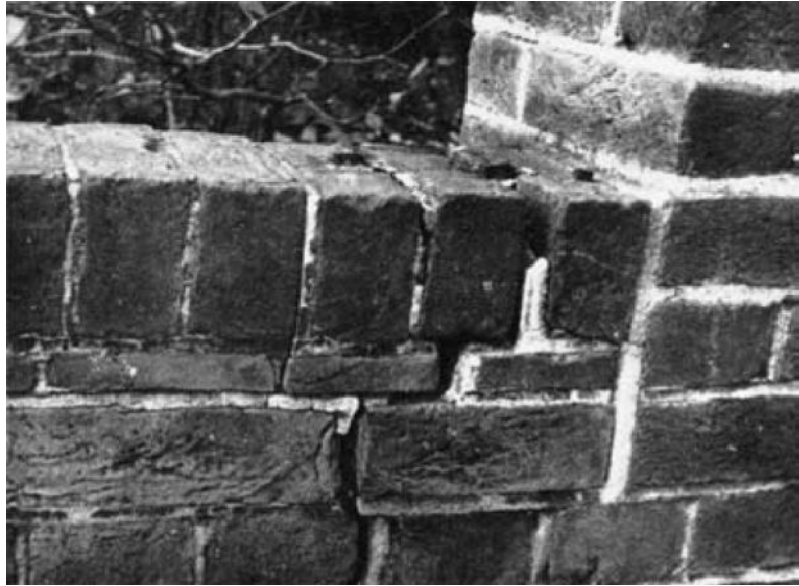
**Figure 6.10 Cracking of brickwork due to corrosion of embedded steel**

Iron and steel members embedded in brickwork can well be affected by corrosion causing the surrounding brickwork to fracture and loosen. In order to diagnose the full extent of the problem, the surveyor will usually find it necessary to remove the surrounding brickwork in order to gain access to the metalwork. Figure 6.10 shows a typical example. Rusting steel stanchions encased in brick cladding may produce vertical cracks.

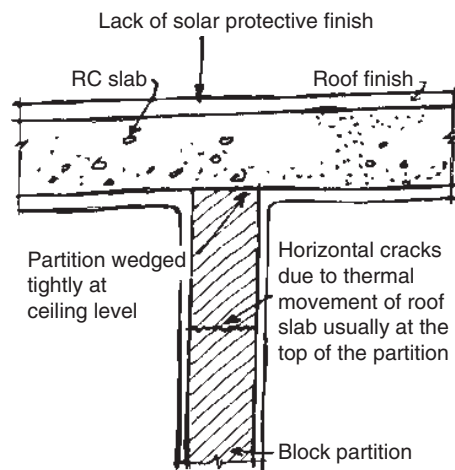
Figure 6.11 Partition failure due to thermal expansion of roof slab

Another type of failure is associated with the thermal expansion of a concrete roof slab to which the flat roof system is prone. This occurs where the partition has been wedged tightly at ceiling level without allowance in the design for the differential movement between the roof slab and partition. The thermal movements of the slab produce horizontal cracks near the top of the partition as shown in Figure 6.11. This failure is also due to the lack of solar-protective finish on the roof covering; if adequate this would reduce the amount of heat absorbed by the roof slab.

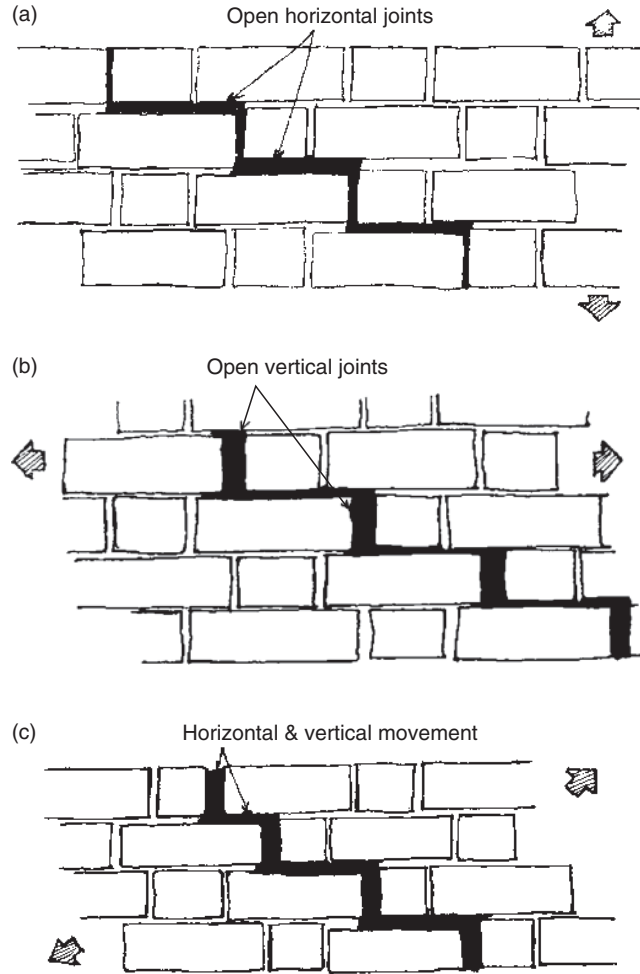
**Figure 6.12 Assessment of cracks. (a) Vertical settlement, (b) horizontal movement and (c) transverse failure**

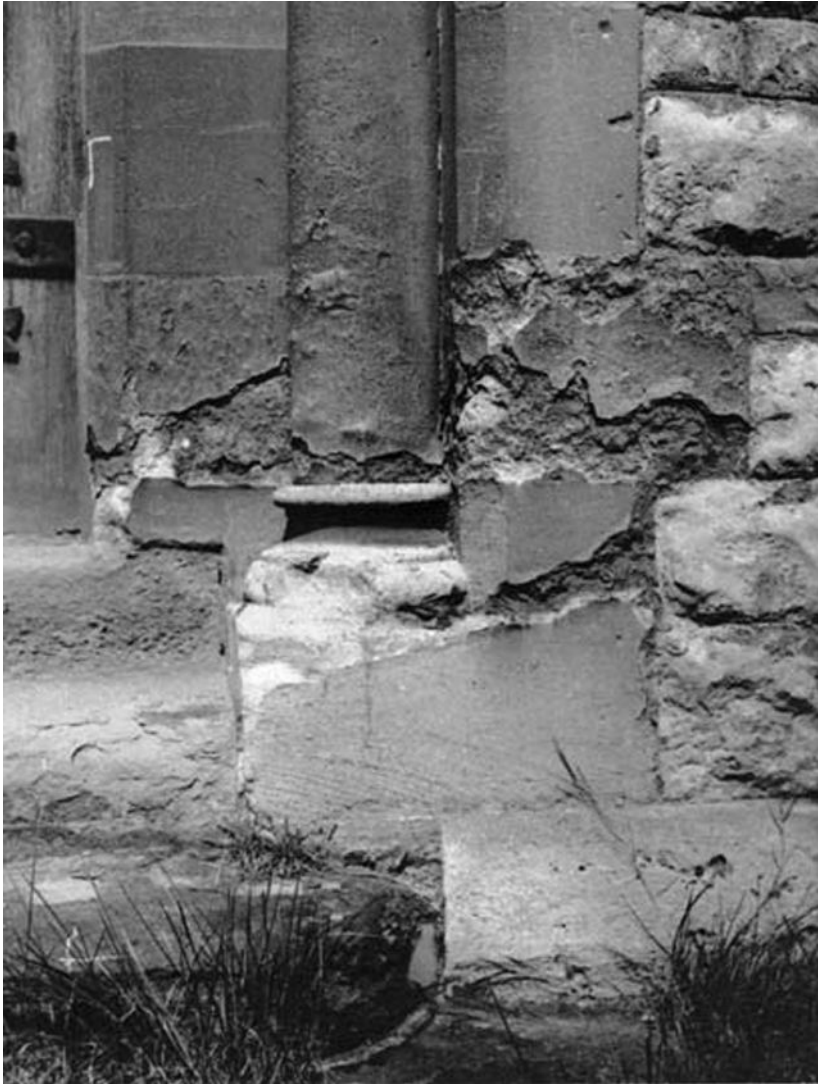
**Figure 6.13** Surface blistering of Bath stone and Kentish rag stone due to atmospheric pollution

Atmospheric pollution is the principal cause of deterioration of limestone and sandstones (Richardson, 2001). Air usually contains impurities of sulphur and carbon. Sulphuric gases in the atmosphere dissolve in rainwater to form acid solutions and, when not freely washed away by rain, these form a hard skin on the limestone eventually causing surface blistering, scaling and the formation of cracks at arrises (Cook & Gibbs, 1993). When the surface blistering breaks off, it pulls away some of the limestone with it. Sulphur gases can also attack calcareous sandstone in a similar manner. Pollution deposits are widely dispersed and travel with the wind and rain, although the effect is more noticeable in urban and industrial districts. Figure 6.13 shows an example of surface blistering of Bath stone and Kentish rag stone due to atmospheric pollution.

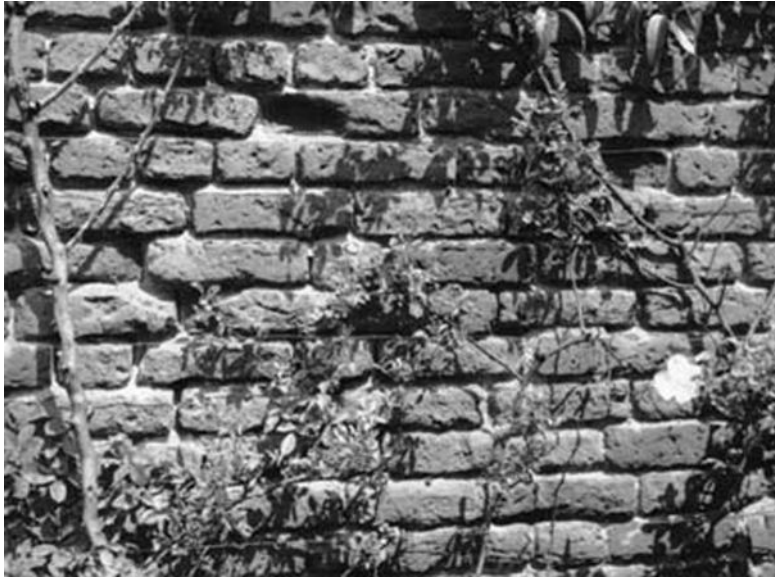
**Figure 6.14** A fairly common defect caused by shrubs sending their roots into brick joints

Ivy, honeysuckle and wisteria can cause severe damage. They keep the wall damp, and joints are forced apart by the expanding roots which eventually dislodge the stones. Some clinging creepers such as Virginia creeper attach themselves to stonework by suckers, but in many cases are harmless though they do keep the wall damp. In general, most plant growths should be discouraged for if they are allowed to cover a whole wall surface, they are apt to reach the roofs, the most vulnerable part of the building, and lead to blockage of gutters and down-pipes. Figure 6.14 shows a fairly common defect caused by shrubs sending their roots into brick joints.

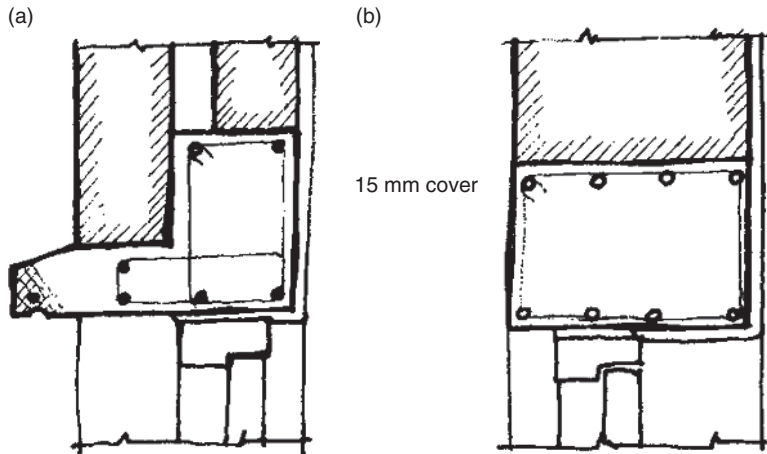
**Figure 7.1** (a) Cracking of concrete in projecting nib of lintel. Reinforcement not required to projecting nib. Damp penetration will cause corrosion and spalling of concrete. (b) Reinforcing bars too near the surface causing concrete to crack and bars to corrode. In both cases cracking of the concrete will occur allowing moisture to penetrate and concrete to spall off

It is important that the surveyor checks the depth of the cover, especially in small members such as window sills, string courses and projecting nibs to reinforced concrete lintels as shown in Figure 7.1a. If the reinforcing bars are too near the surface the concrete will crack and the bars corrode. Loose portions of concrete can be removed fairly easily and should not present the surveyor with any difficulty. When dealing with cracks it is often necessary to enlarge the crack to gain access to the steelwork before a correct diagnosis can be obtained.

In some cases it may be found that the reinforcing bars are too close together to allow the aggregate to pass freely between the bars and formwork as shown in Figure 7.1b. Figure 7.2 shows an example of reinforcement corrosion causing cracks to appear in the concrete cover. Cracks can also be caused by structural movement or defects in the foundations; if the cracks continue down below the ground this would suggest some defect in the foundations, possibly due to settlement.

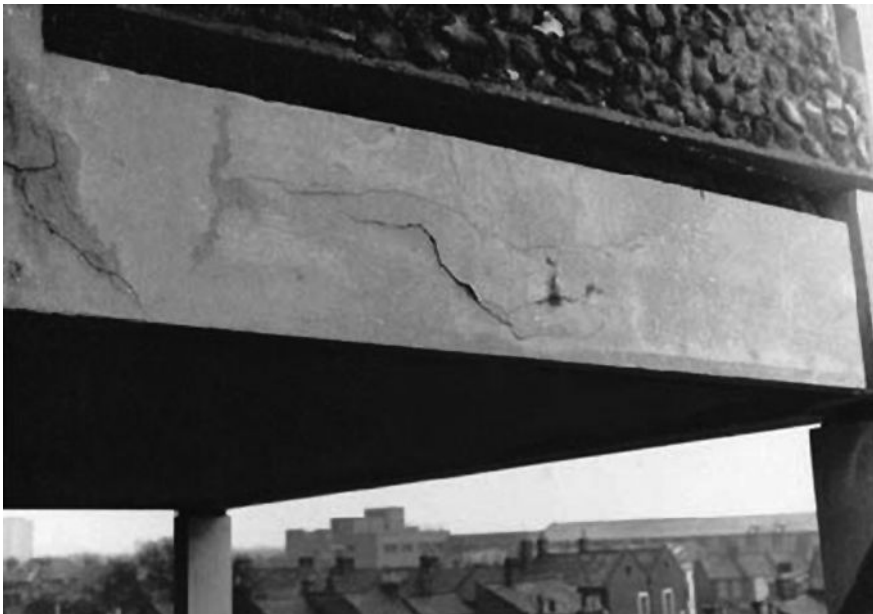
**Figure 7.2** Corrosion of reinforcement causing cracking of concrete. Reproduced by permission of Harsco Infrastructure

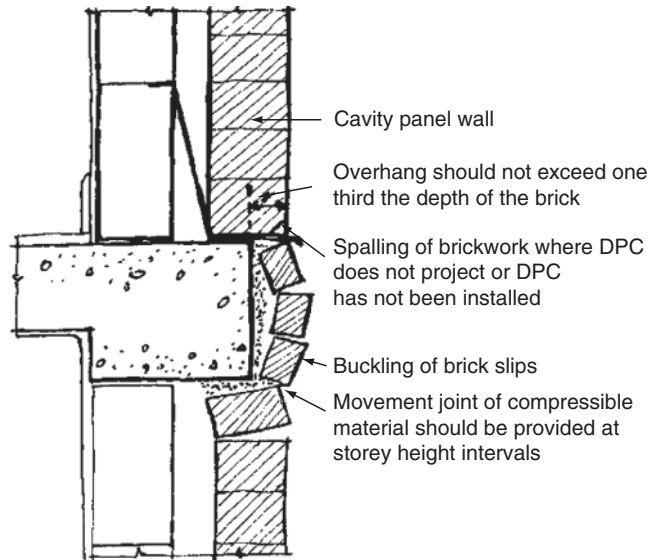
**Figure 7.3** Movement in concrete structure due to creep of concrete frame and expansion of brick panel walls

Where brickwork is supported on reinforced concrete beams or 'nibs', brick slips are often used to cover the edge of the beam. In recent years there have been a number of failures due to the brick slips buckling. It is usually attributed to the expansion of the brickwork or 'creep' of the concrete frame (see Figure 7.3). Conventional mortars and adhesive have proved inadequate for fixing the brick slips. A considerable amount of research has been carried out in this field by the Brick Development Association (BDA) and the use of special mortars such as polyester resin or styrene butadiene rubber (SBR) emulsion is now recommended. If the brick slips are to be replaced it is advisable to recommend that they should be isolated by compression joints from the brick panels. One of the important points that should be checked is the overhang of the outer skin of brickwork as shown in Figure 7.3. The overhang should not exceed one third the depth of the brick. The position of the DPC is also important and should project beyond the outer face of the brickwork to prevent spalling of the lower edge of the brick.

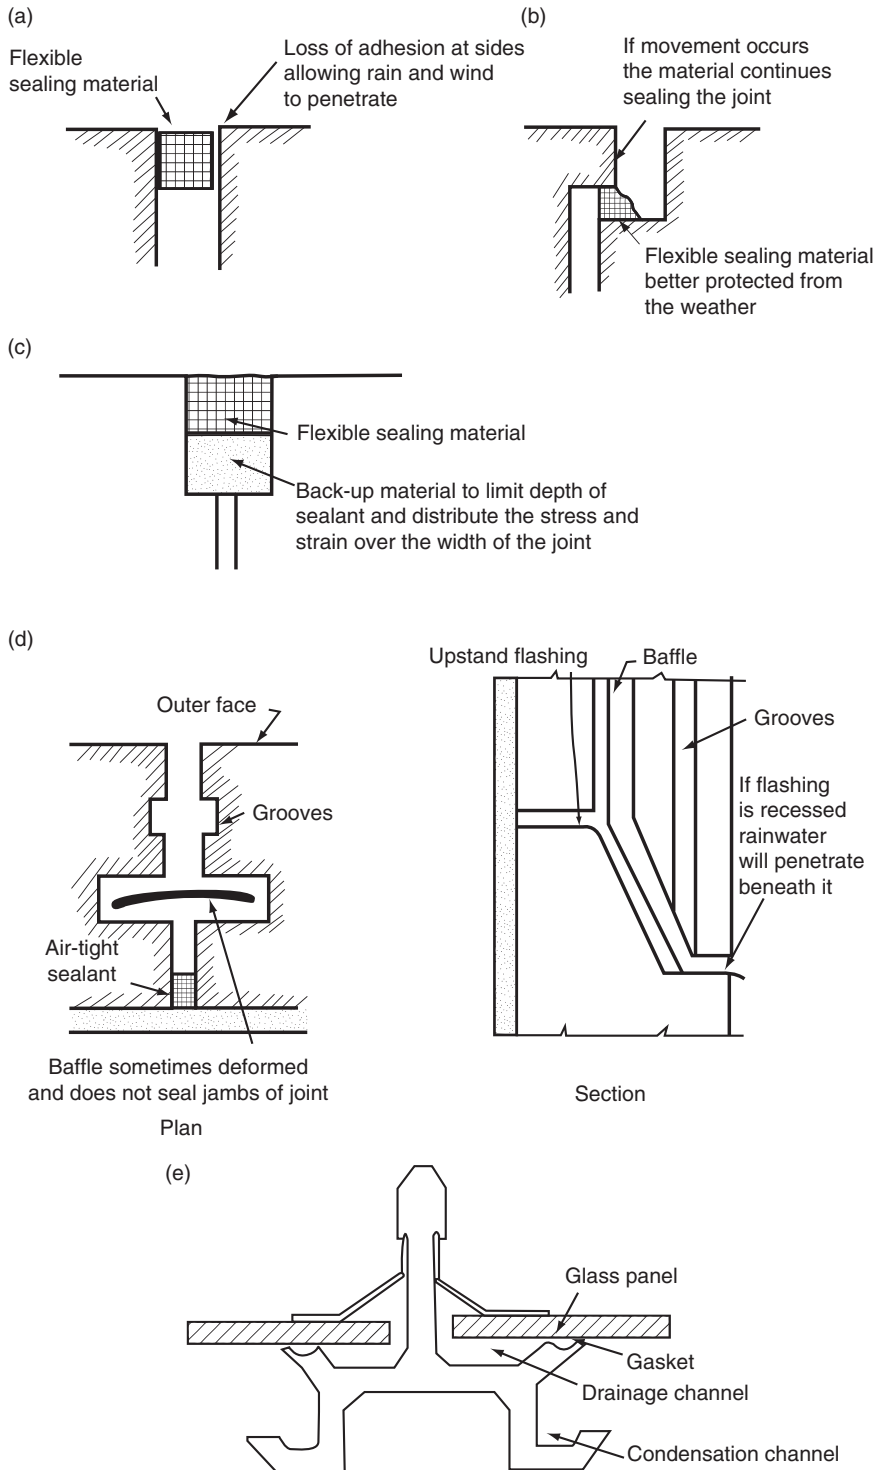
Figure 7.4 Joint problems. (a) Butt joint, (b) lap joint, (c) back-up material, (d) drained joint and (e) vertical gasket joint in patent glazing

Accurate assembly of the cladding units is essential and the movement expected between the sides of the joint must be properly calculated. Unfortunately, there have been many failures of sealants, some of which are caused by butt joints which are too deep and too narrow causing loss of adhesion at the sides of the joint (see Figure 7.4a) or loss of cohesion in the sealant. If the sealant material is unduly

stressed it will tend to break down. The lap joint shown in Figure 7.4b is often preferred because it is better protected from the rain, snow and wind and therefore imposes less strain on the sealant. In order to limit the depth of the sealant and distribute the stress and strain over the width of the joint, a back-up material is often used. The back-up materials usually consist of expanded plastics or fibre building board, but if butyl mastics are used as a sealant then it is usual to use a polyurethane sponge (see Figure 7.4c).

One of the most successful concrete cladding joints is the open drained joint which reduces the risk of rainwater penetration. The vertical joints between the panels shown in Figure 7.4d usually consist of an outer groove to trap rainwater which discharges over an upstand flashing at the base of the panel. The centre portion consists of a baffle which if deformed does not form a satisfactory seal at the jambs of the recessed joint. If rainwater penetrates the grooves in the outer face and the defective baffle there is only the inner barrier consisting of a sealant to prevent damage to the inner face of the cladding. The inner sealant must be air- and weather-tight. Flashings at the lower edges direct any rainwater to the outside face which may have penetrated the baffle. One common failure is that the flashing may be recessed behind the panel face allowing rainwater to penetrate beneath it. Gaskets are preformed materials extruded from plastics or rubber, and widely used for securing glass panels and for waterproofing a joint (see Figure 7.4e). They do not depend on adhesion, but on pressure against the joint surfaces to provide a seal. Gaskets cannot adjust well to rough surfaces, and are, therefore, best used between smooth surfaces. One of the difficulties in forming a gasket joint on site is the mitre at the corners. This is a joint that should be carefully checked during the site investigation. Points of weakness are also likely to be found where there is a change in the construction of the cladding or where window or door openings occur. Sills should be carefully checked to ensure that they throw rainwater clear of the cladding below.

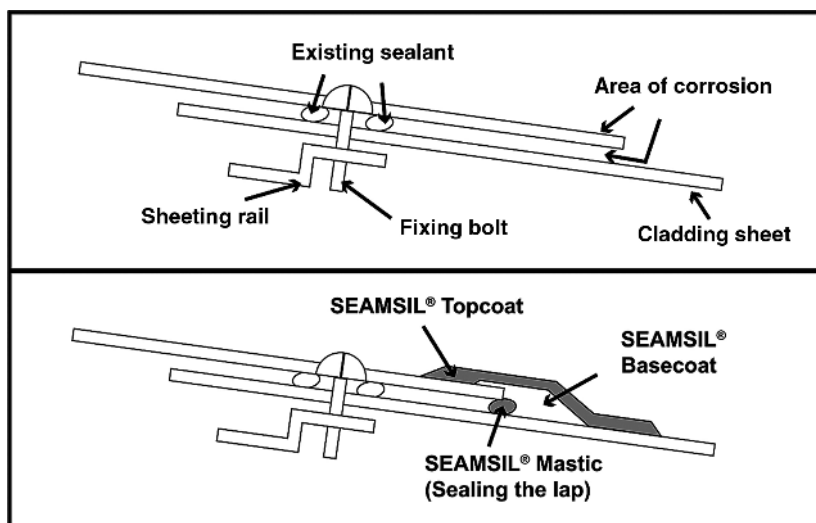
**Figure 7.5** Before and after SEAMSIL® overlap detail (courtesy of Delvemade Ltd)

There are now several proprietary treatments of edge corrosion available (see Figure 7.5). Delvemade Ltd is one such system ([www.delvemade.co.uk](http://www.delvemade.co.uk)), which uses an alkoxy silicone (non-acidic) sealer application. An alkoxy silicone should be odourless and have a low modulus of elasticity. It is an excellent corrosion coating. If the silicone gives off a vinegar odour it contains an acidic rather than an alkoxy base, and therefore should not be used, as it has little resistance to corrosion.

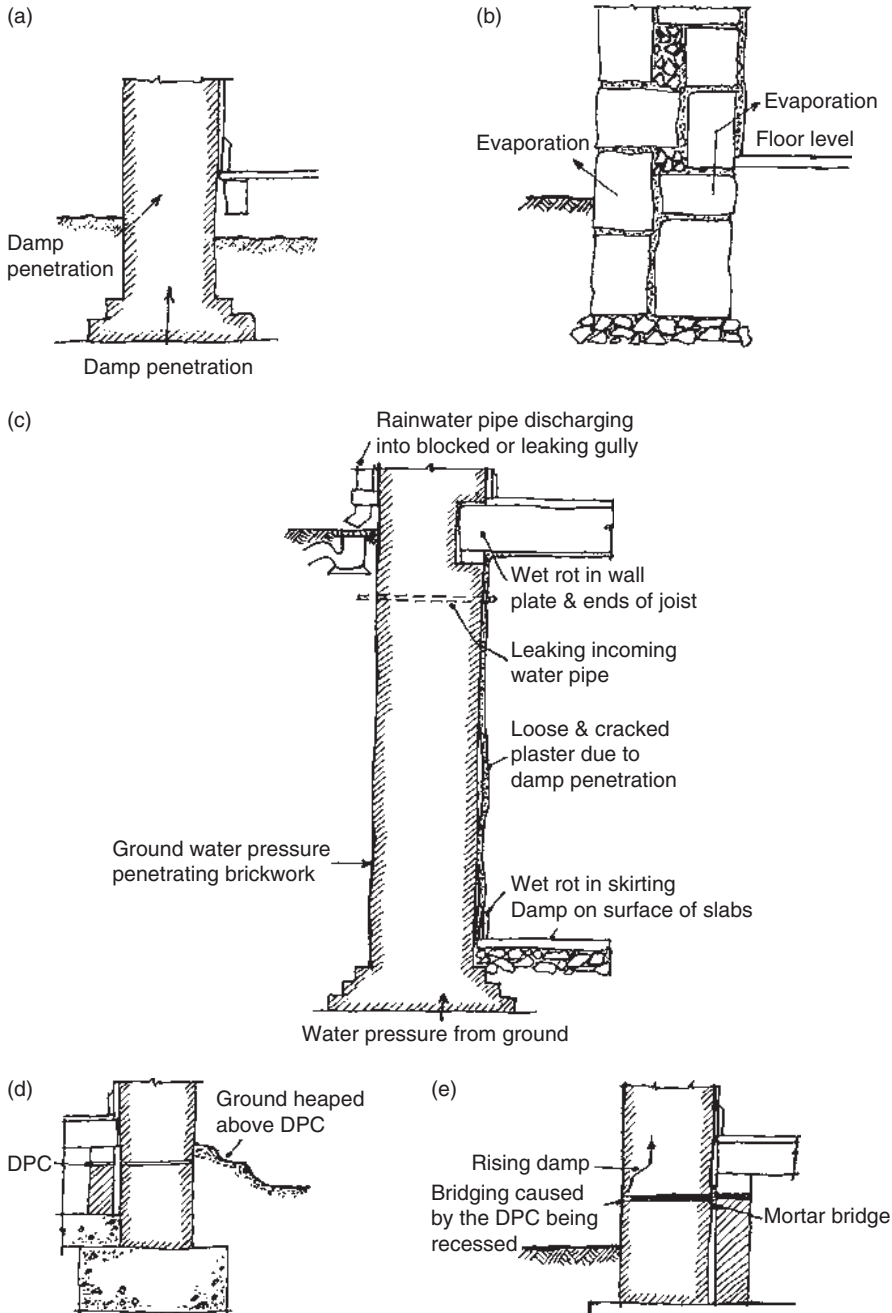
**Figure 8.1** (a) Typical early nineteenth century external wall construction with no DPC. (b) Traditional solid stone wall. No DPC. (c) Typical damp problems in old basement walls. (d) DPC covered by earth. (e) Defects caused by bridging DPC

As mentioned in Section 8.1 the ground around the foundations is often damp; moisture rises into the brick or stonework by capillary attraction and unless a DPC is provided above ground level the moisture can rise, causing considerable dampness to walls and floors. It is, therefore, important that the surveyor makes a careful examination of the base of the wall to ascertain the existence or absence of a DPC. If there is no damp course, dampness will show along the bottom of both external and internal faces causing discoloration, mildew and peeling decorations. The damp will rise in a wall or partition to a height at which there is a balance between the rate of evaporation and the rate which the damp can be drawn up by capillary attraction. The line of dampness due to the absence of DPC is usually continuous and fairly horizontal and in severe cases can reach a height in excess of 1 m (see BRE Digest 245). Figure 8.1a shows a typical early nineteenth century external wall construction with no DPC and no foundation concrete.

The important point for the surveyor to remember is that any treatment which prevents evaporation such as waterproof rendering internally or externally, will only cause the damp to rise higher before it can evaporate, causing more problems (Massari & Massari, 1993)! Any treatment recommended (Burkinshaw, 2009) is a matter requiring careful judgment (see Figure 8.1b).

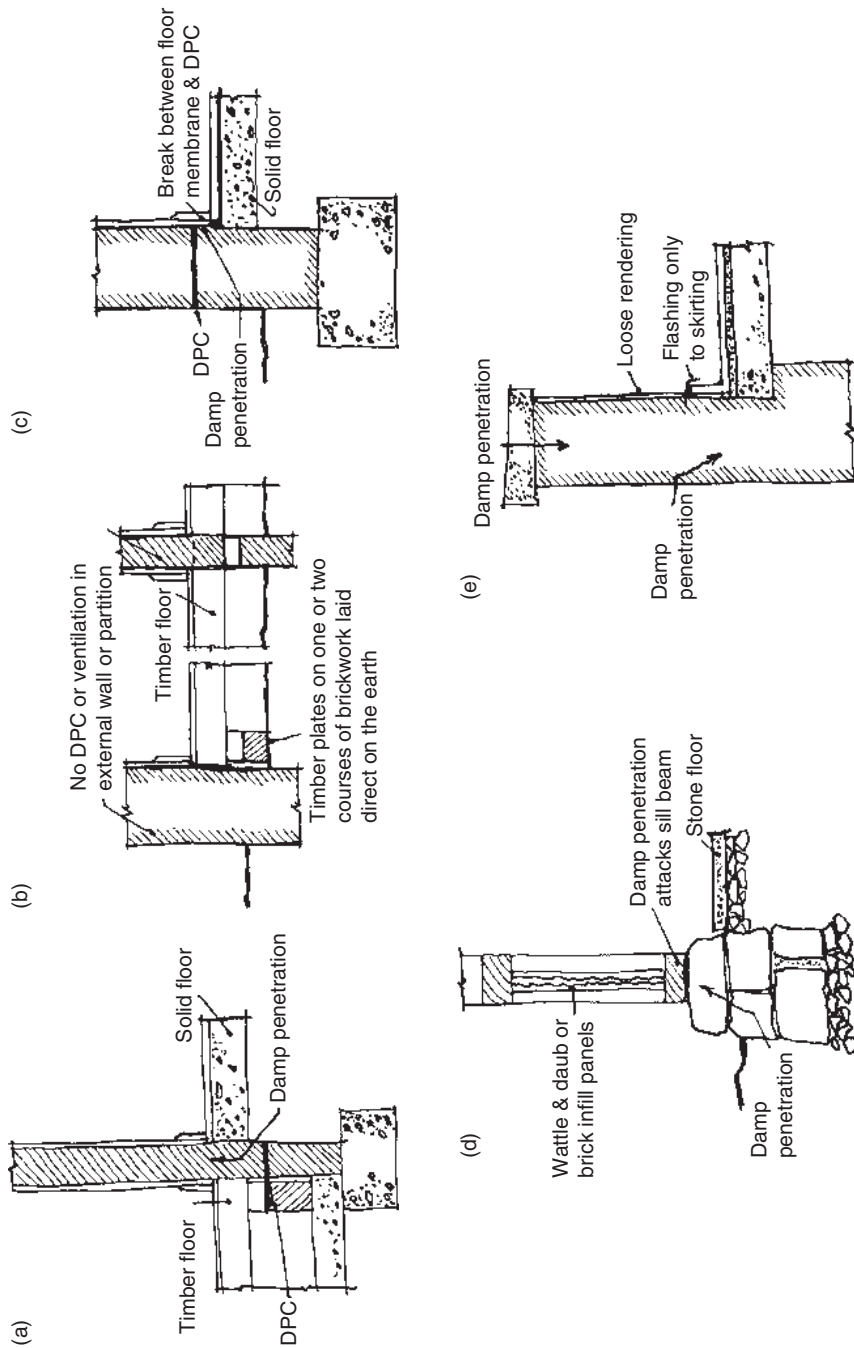
Figure 8.2 (a) Incorrect DPC insertion in partition wall. (b) Typical early nineteenth century timber floor construction. (c) Inadequate jointing between floor membrane and DPC. (d) Typical base detail of timber framed building. (e) Defects caused by the absence of DPCs in parapet wall

Another common defect found in domestic property is a partition wall with a solid floor on one side and a joist floor on the other. If the DPC is a few millimetres below the concrete floor then damp can rise through the unprotected gap (see Figure 8.2a).

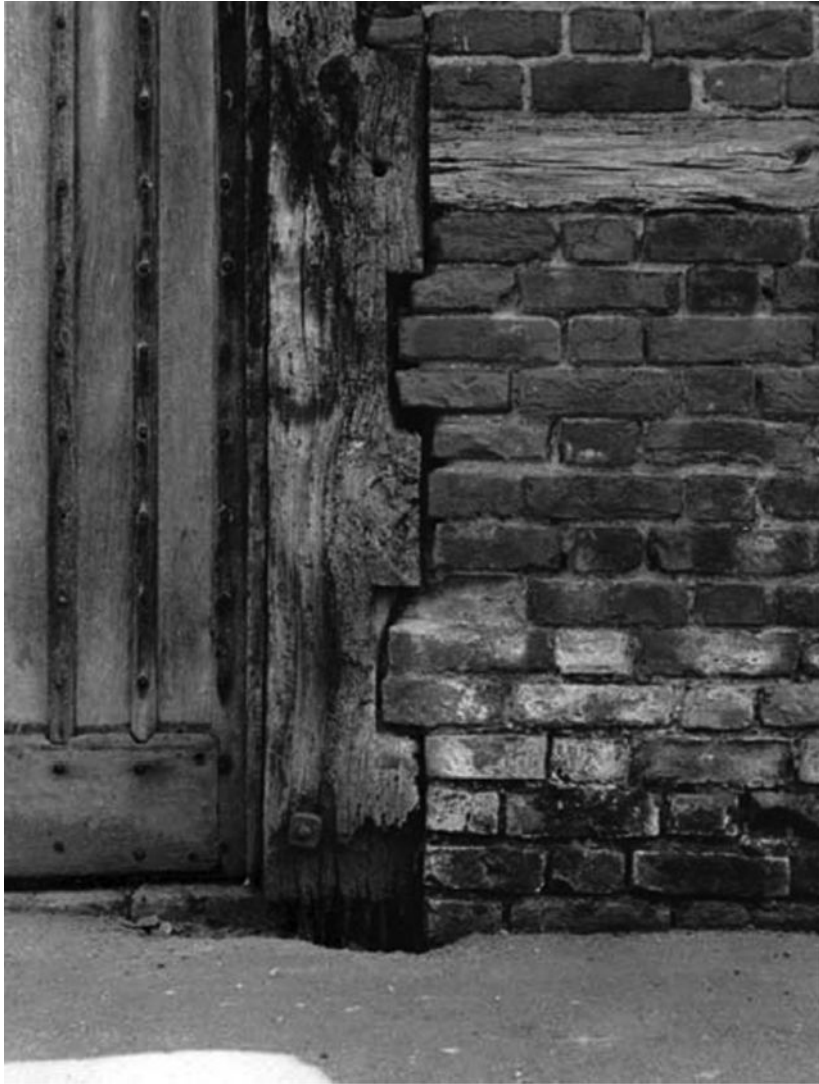
**Figure 8.3** Effects of rising damp and woodworm in a timber-framed building

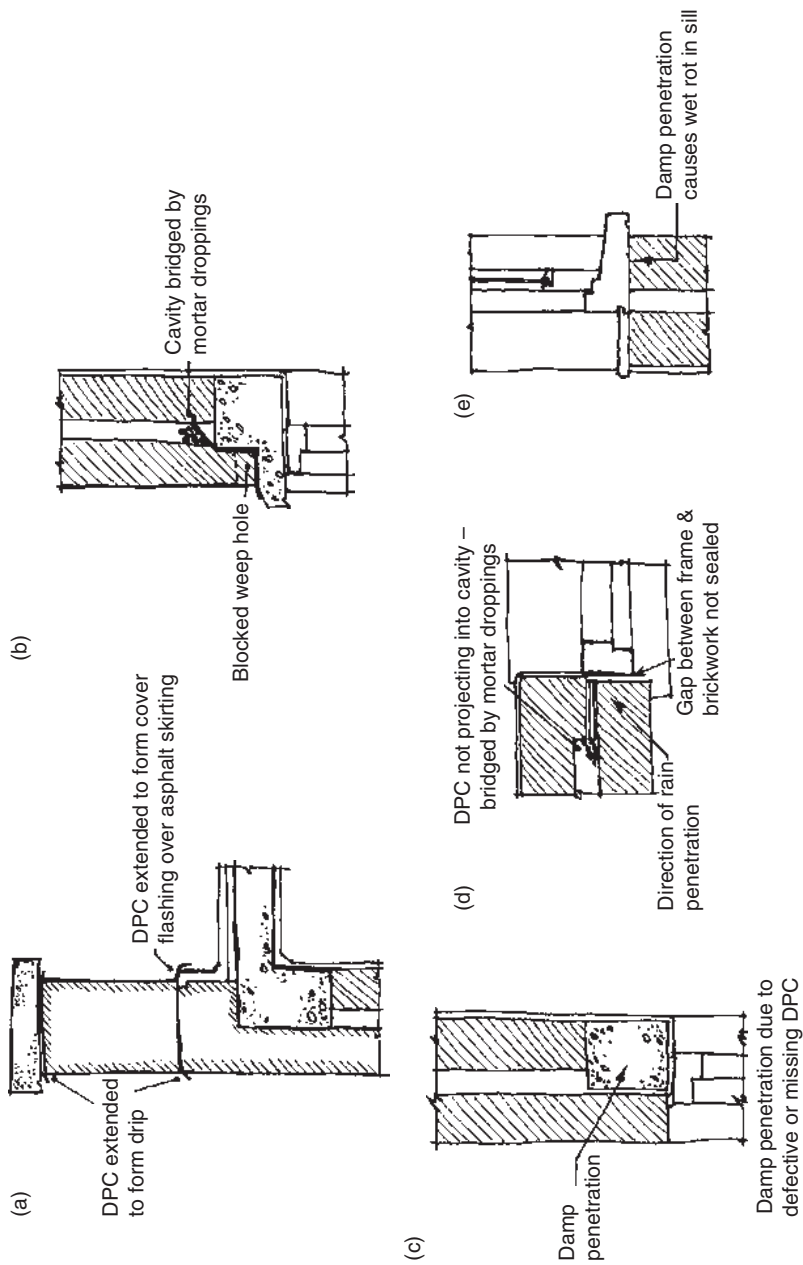
Figure 8.4 (a) Correct detail for DPCs in solid parapet wall. (b) Bridging of DPC over opening. (c) Damp penetration due to defective or missing DPC. (d) Damp penetration due to poor detailing of DPCs and jointing to reveal opening. (e) Damp penetration due to omission of DPC under sill

is also a common fault with DPCs over window and door openings as shown in Figures 8.4b and c where bridging of the cavity is caused by excessive mortar droppings building up off the DPC or due to a faulty or missing damp-proof tray. Damp patches on the plaster about 300 mm above the head of the window usually indicate mortar droppings collecting at the head of the damp-proof tray. The weep holes externally should also be examined to ensure that they are not blocked.

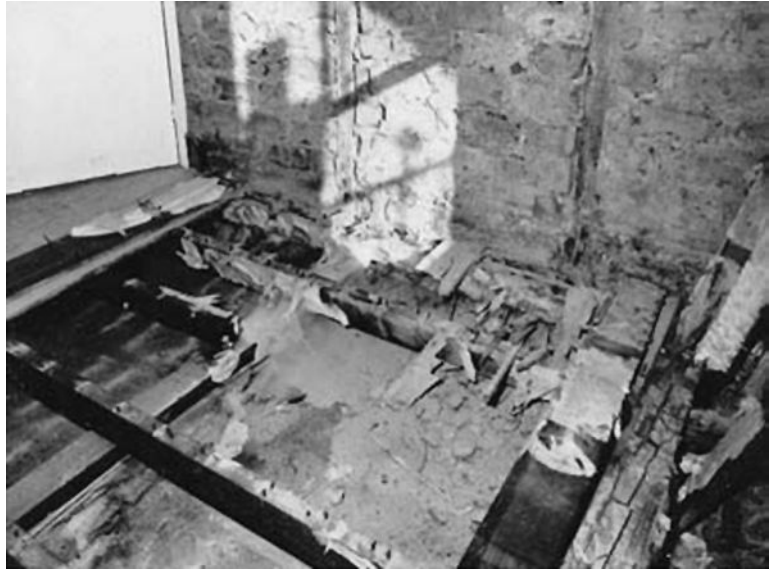
**Figure 9.1** Dry rot spore dust in floor joists and partition. Reproduced by permission of Harsco Infrastructure

In the first case described above the ground floor construction is the most likely place for dry rot to appear. The construction consists of timber joists supported on sleeper walls built of the site concrete. If the sleeper walls are well provided with honeycomb openings, and the external walls have enough air vents, the circulation of air may be sufficient to carry away the moisture and so prevent the fungus starting. However, it often happens in course of time the air vents become clogged or covered with earth (see Chapter 8). Pockets of stagnant air and rising damp through poor quality site concrete or brickwork are the primary contributory causes of fungal decay. The timber will absorb the moisture and so produce the fungi which decompose the wood. Figure 9.1 shows ground floor joists badly affected by dry rot attack.

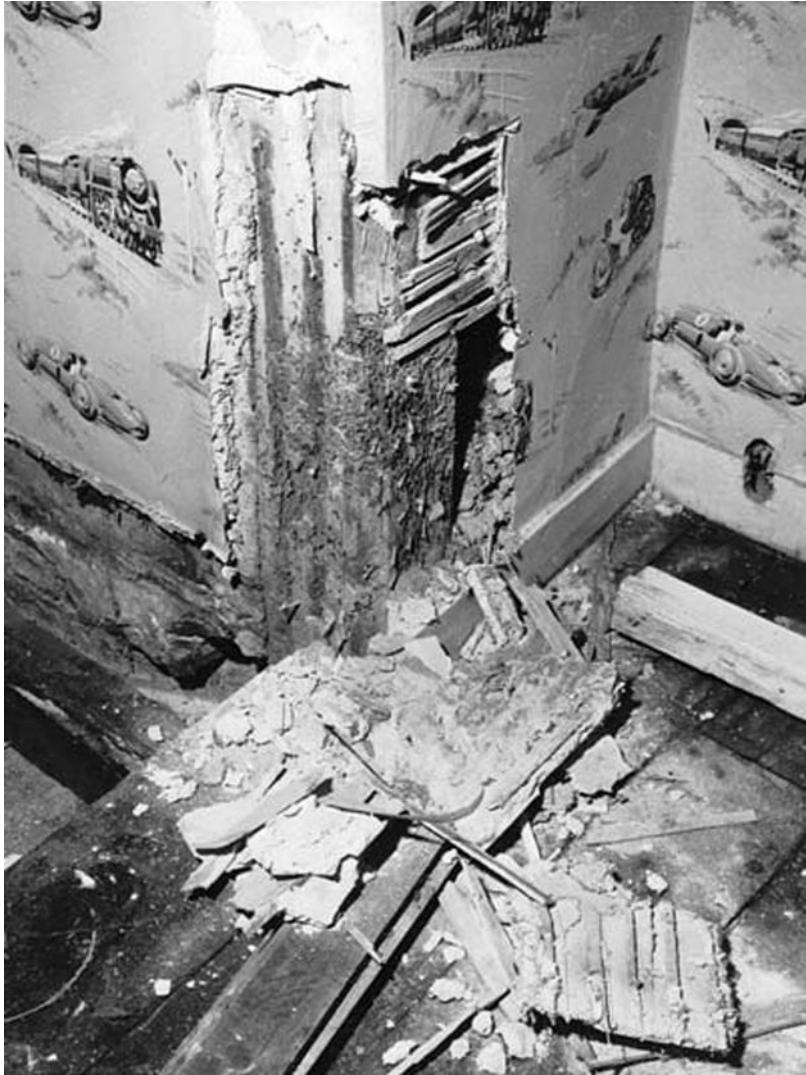
**Figure 9.2** Effects of death watch beetle. Reproduced by permission of Harsco Infrastructure

old hardwoods, usually oak and chestnut, and most damage occurs in built-in parts of a structure such as end beams, wall plates and poorly ventilated places (Figure 9.2).

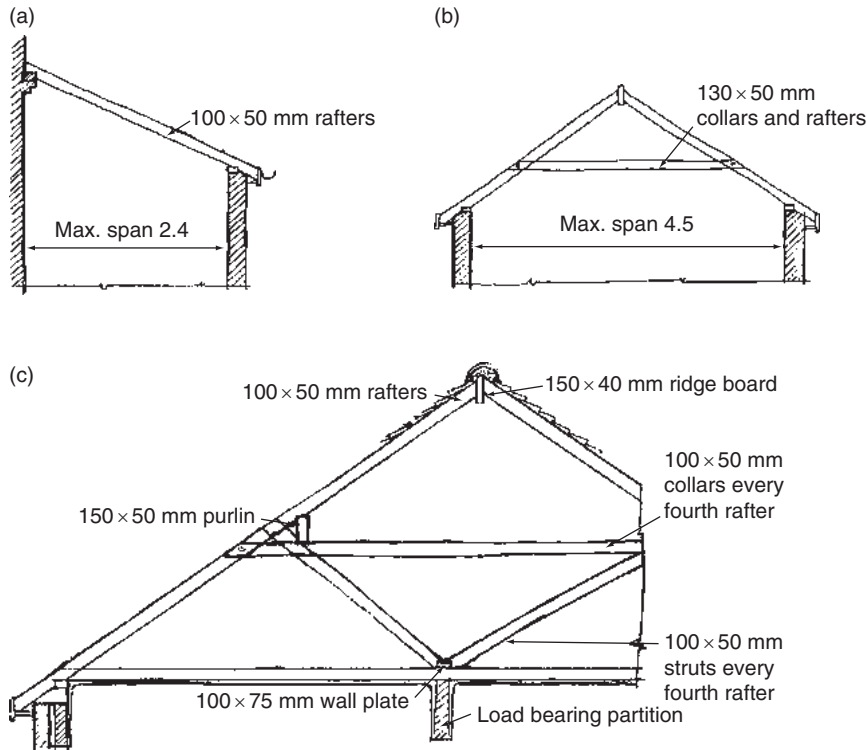
**Figure 10.1** (a) Lean-to roof. (b) Collar roof. (c) Double or purlin roof

The timber lean-to and collar roofs are the simplest type of roofs for short spans and are often found on back additions or on outbuildings to older domestic properties (see Figures 10.1a and b).

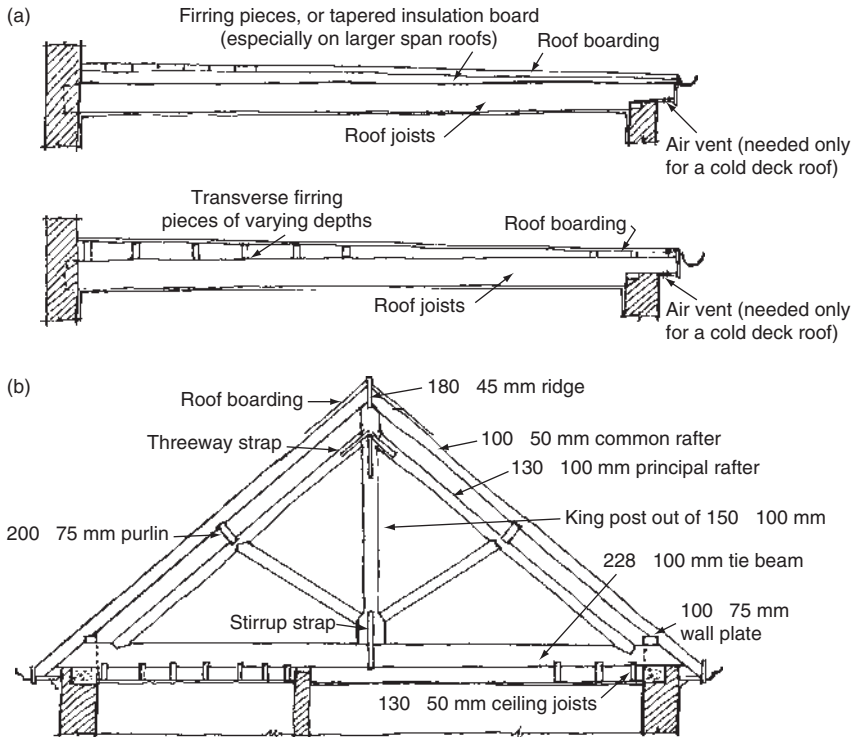
**Figure 10.3 (a) Flat roof construction. (b) King post roof**

Flat roofs for medium spans, say 6–7.5 m, are usually constructed of timber joists which are freely adaptable and are particularly suitable for domestic roofing (see Figure 10.3a).

During the eighteenth and nineteenth centuries larger span roof trusses followed the pattern shown in Figure 10.3b for the majority of the larger domestic dwellings, light industrial and commercial buildings. This type of roof has been included because surveyors are often called upon to examine an old building where this type of construction is met with. The example shown is a king post

truss, but there were many variations and this type together with the queen post reached their ultimate design during the mid-nineteenth century. The truss supports the purlins which in turn support the common rafters. The roofs were usually close boarded and covered with slates making a sound insulated loft. In all cases the joints were strengthened with iron straps and bolts.

Where flat roofs are provided it is usually impossible to inspect the timbers for defects. If the defects are due to water penetration a damp patch or water mark will be seen on the ceiling. If the problem is serious it is likely to be indicated by deflection in the roof timbers, coupled with depressions in the roof covering and cracked or loose ceiling plaster. If the roof covering is seriously defective and will obviously require renewing then it is often possible for the surveyor to arrange for a portion of the roof covering to be removed allowing access to the boarding and joists. As mentioned in Chapter 2, fibre-optic probes and boroscope systems have come to the surveyor's rescue and it is now possible to introduce a 600 mm long boroscope into the roof structure via a small drill hole in order to view the condition of the joists etc. A polaroid camera and attachment can be fitted to this instrument to record the information. Flat roofs need to be laid to adequate falls and to incorporate a vapour barrier. The fall is achieved by either using tapered furring pieces secured to the joists or tapered insulation board on a vapour control layer on the warm side of the timber deck. Various types of boarding are used to support the roof covering, e.g. rough boarding, tongue and groove boarding, blockboard and chipboard may be used. Care should be taken to examine the method of ventilation of the timbers if it is a cold deck flat roof, as shown in Figure 10.3a.

The internal examination of a large roof of an eighteenth or nineteenth century building (see Figure 10.3b) can be a very long and costly operation. If the roof is of the open type with no ceiling then a long extension ladder or tower scaffold is usually required. An inspection of this type of roof will reveal that the greatest number of failures are due to decay of the timbers, often resulting from the deterioration of the roof covering. It is, therefore, necessary to check carefully for evidence of wet rot and woodboring insects. (All these defects have been dealt with in Chapter 9.)

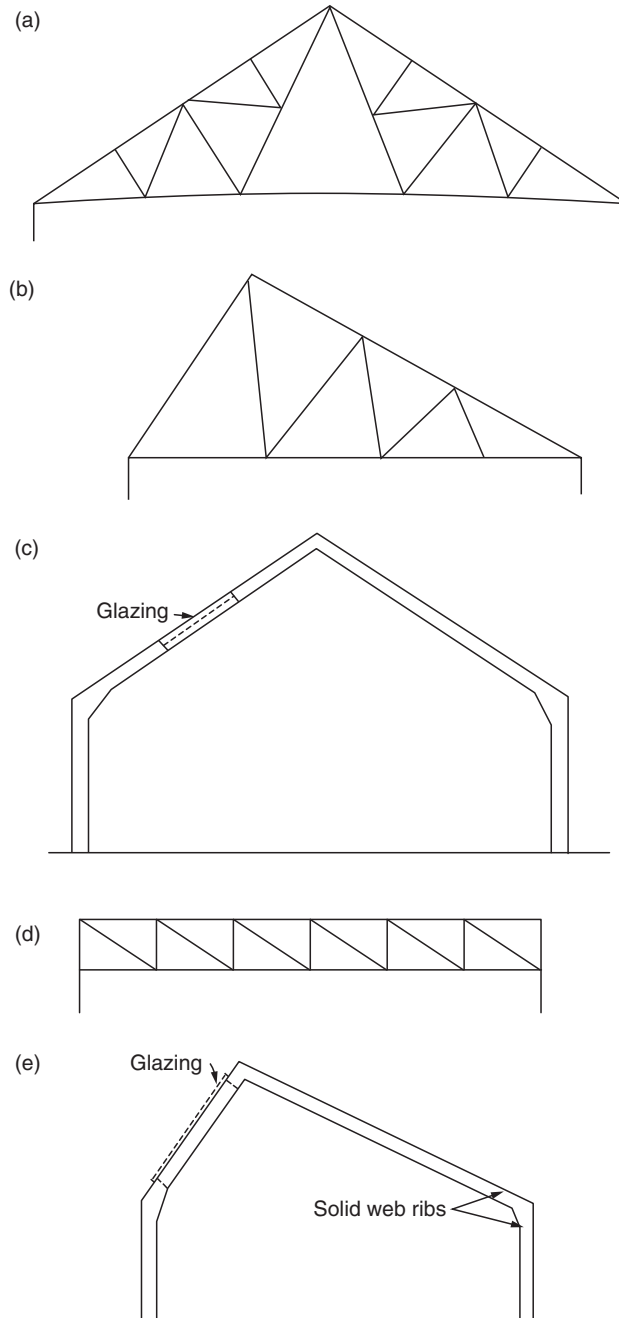
**Figure 10.4** (a) Typical steel truss arrangement for a 25 m span. (b) Typical steel north light truss. (c) Solid web portal frame. (d) Lattice girder for flat roof. (e) North light frame

Medium and long span roofs cover a large variety of single and multi-storey buildings including industrial, commercial, warehouses and assembly halls. Many of these roofs are constructed of steel trusses, lattice girders or portal frames which are fabricated in structural steel sections and assembled by bolts or welding. The variations in design are unlimited. Figures 10.4a–e show the outlines of the various types in common use.

All exposed structural steelwork requires protective treatment either by painting or galvanising and special care should be taken to examine the steel sections for rust. The surveyor's report should include a description of the areas affected and method of preparation and treatment. Painting over rust is undesirable as the paint is likely to deteriorate (see Figures 10.4a–e).

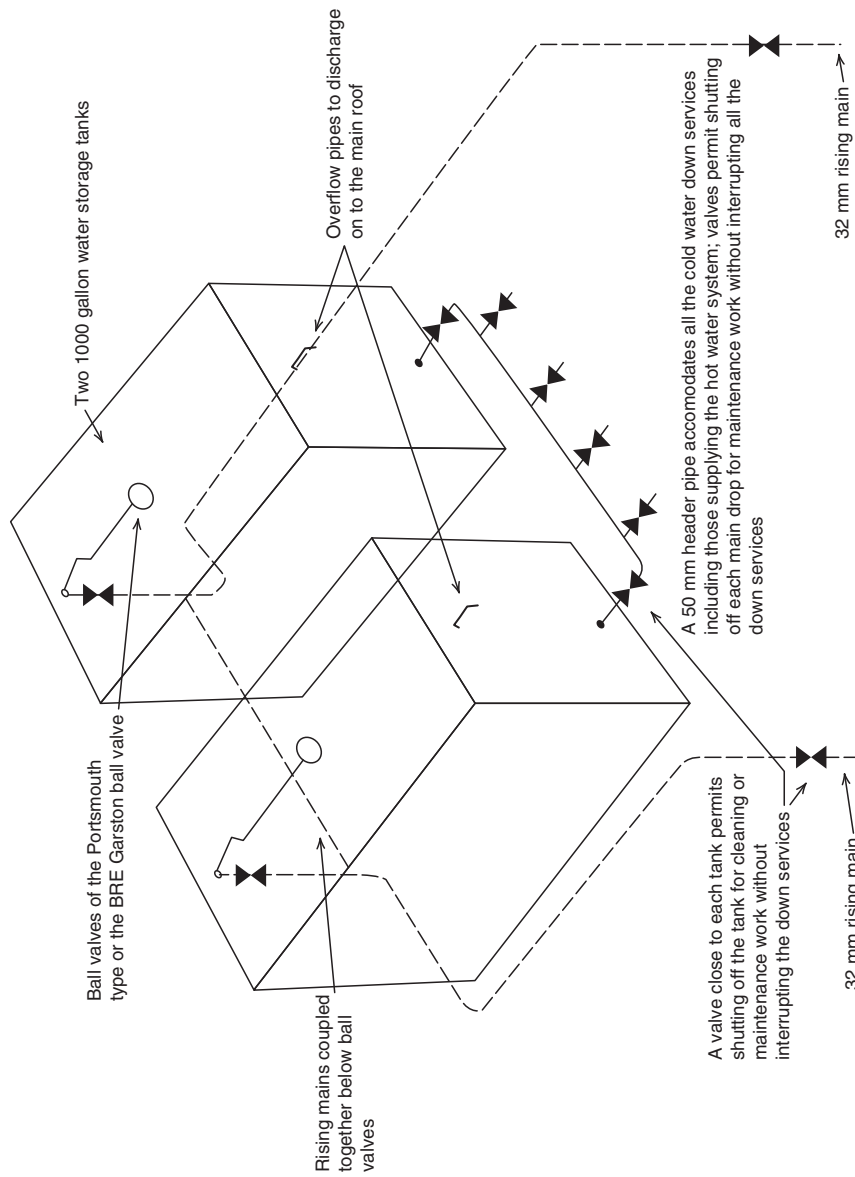
Figure 10.5 Cold water storage system in high buildings

The cold water storage tanks for a large building such as a block of flats or a commercial building are usually situated in a tank room with access from a flat roof. In such cases consumption is calculated either from the number of fittings served or from the number of persons in the building. A typical example of a cold water storage installation for a large building is shown in Figure 10.5. If two rising mains have been installed they are usually coupled together below the ball valves. The two tanks are connected at the base by a larger header pipe. The header accommodates all the cold and hot water connections. A valve should be installed where the header is connected to each tank to permit shutting off any tank for replacement or cleaning without interrupting the supply.

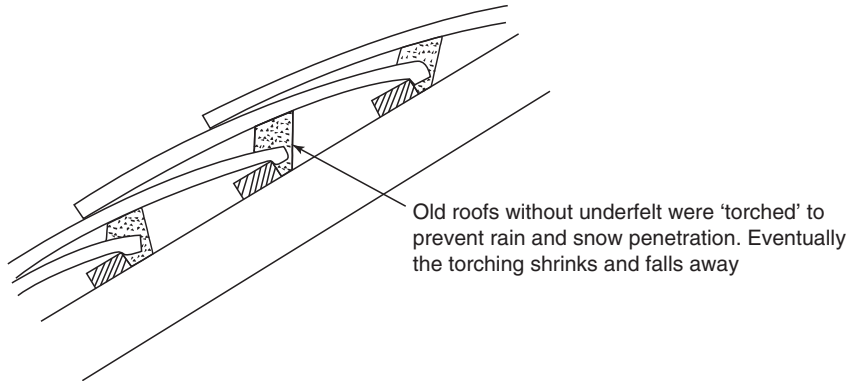
**Figure 10.6 Method of 'torching' to underside of roof tiling**

- A great number of domestic buildings built before 1940 have roofs without either underfelt or boarding. To prevent rain or snow penetration 'torching' has been used on the underside of the tiles and consists of a mixture of lime mortar and cow hair. The mixture was spread behind each batten to fill the space between the tiles. The disadvantage with 'torching' is that it tends to shrink and fall away. The torching should be carefully examined and commented on (Figure 10.6).
