# BUILDING SURVEYS & REPORTS

*4<sup>th</sup> Edition*

**James Douglas BSc, MRICS, MBEng, FHEA  
and Edward A. Noy FASI, ARSH**

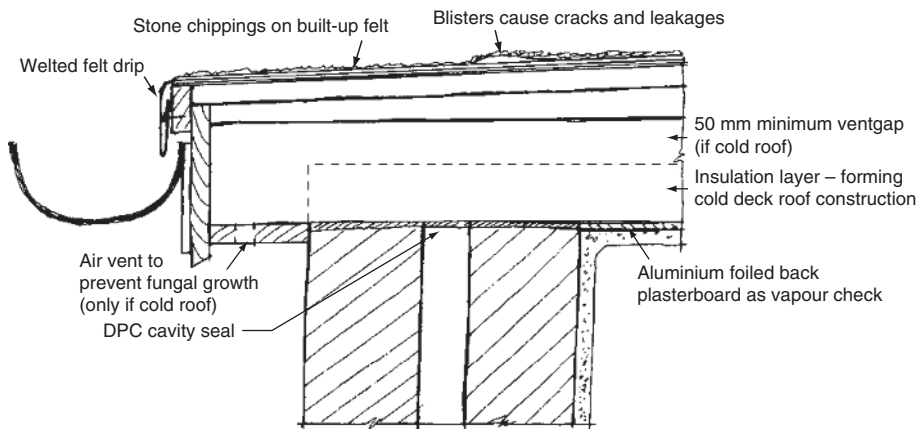
Figure 10.7 Built-up roofing – eaves detail

- (2) As mentioned in Chapter 8, condensation can present serious problems in roofs of this type. Moisture can be prevented from entering the roof by the provision of a vapour barrier such as plaster board and ventilation in the roof void to prevent fungal growth. The entrapped air or moisture between the layers of felt or between the felt and the substructure will cause the felt to lift in the form of 'blisters'. The blisters are not necessarily a sign of failure, but should be carefully examined to see whether any foot pressure has been applied to cause the blister to crack and form a passage for water penetration. One of the most common defects is to find that no provision has been made for ventilation and a vapour barrier. It is, therefore, important that the surveyor endeavours to ascertain the nature of the original construction (see Figure 10.7).

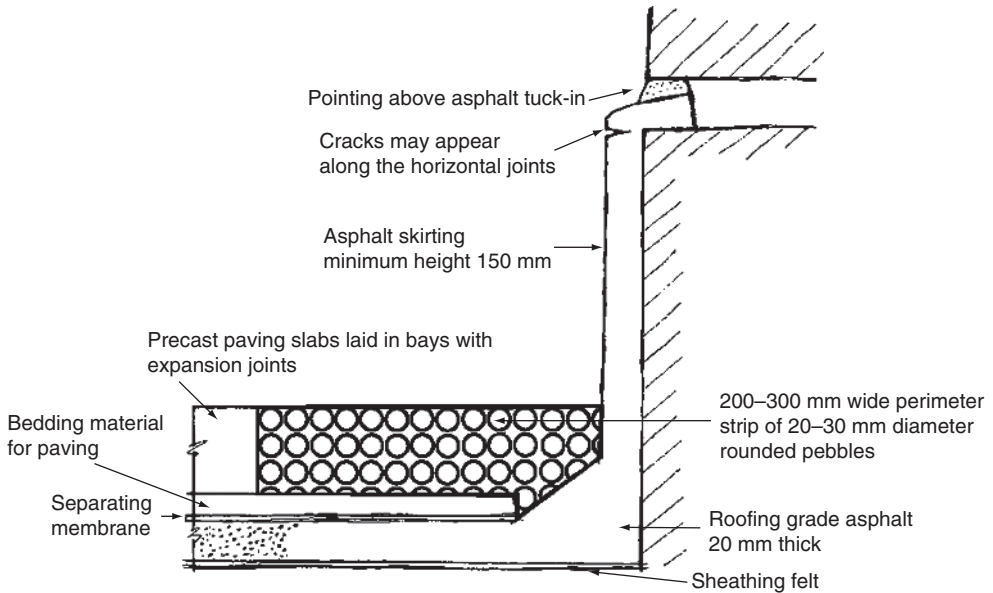
**Figure 10.8 Mastic asphalt to roof garden or car park roof**

The recognition during the past 50 years of the value of flat roofs as a means of providing car parking, roof gardens and playgrounds etc., has created a demand for roof coverings which combine water-resisting qualities with an attractive finish such as precast paving slabs preferably with solar reflective properties. The pavings should be laid in bays with expansion joints where necessary and a separating membrane should be provided beneath the paving as shown in Figure 10.8. The durability of asphalt can be affected in several ways and the most common defects the surveyor will have to investigate are described below:

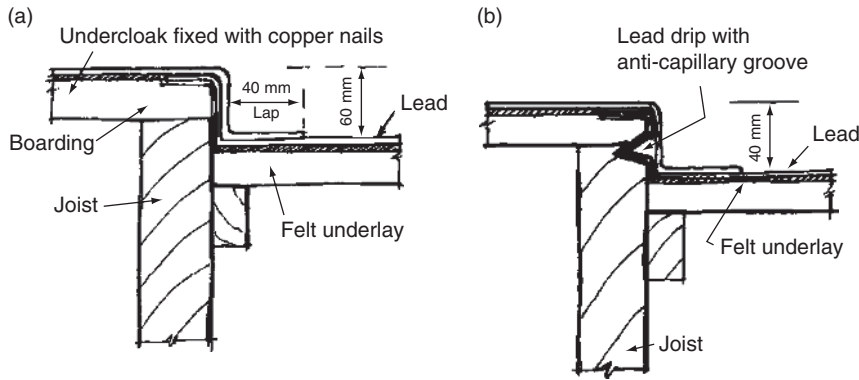
**Figure 10.9 (a) Lead drip. (b) Lead drip with anti-capillary groove**

- (3) One of the most common faults is due to inadequate drips. They are normally 60 mm deep as shown in Figure 10.9a but a minimum depth of 40 mm is permissible if an anti-capillary groove is provided in the vertical face of the drip. This groove prevents rainwater rising and penetrating through to the timber as shown in Figure 10.9b.

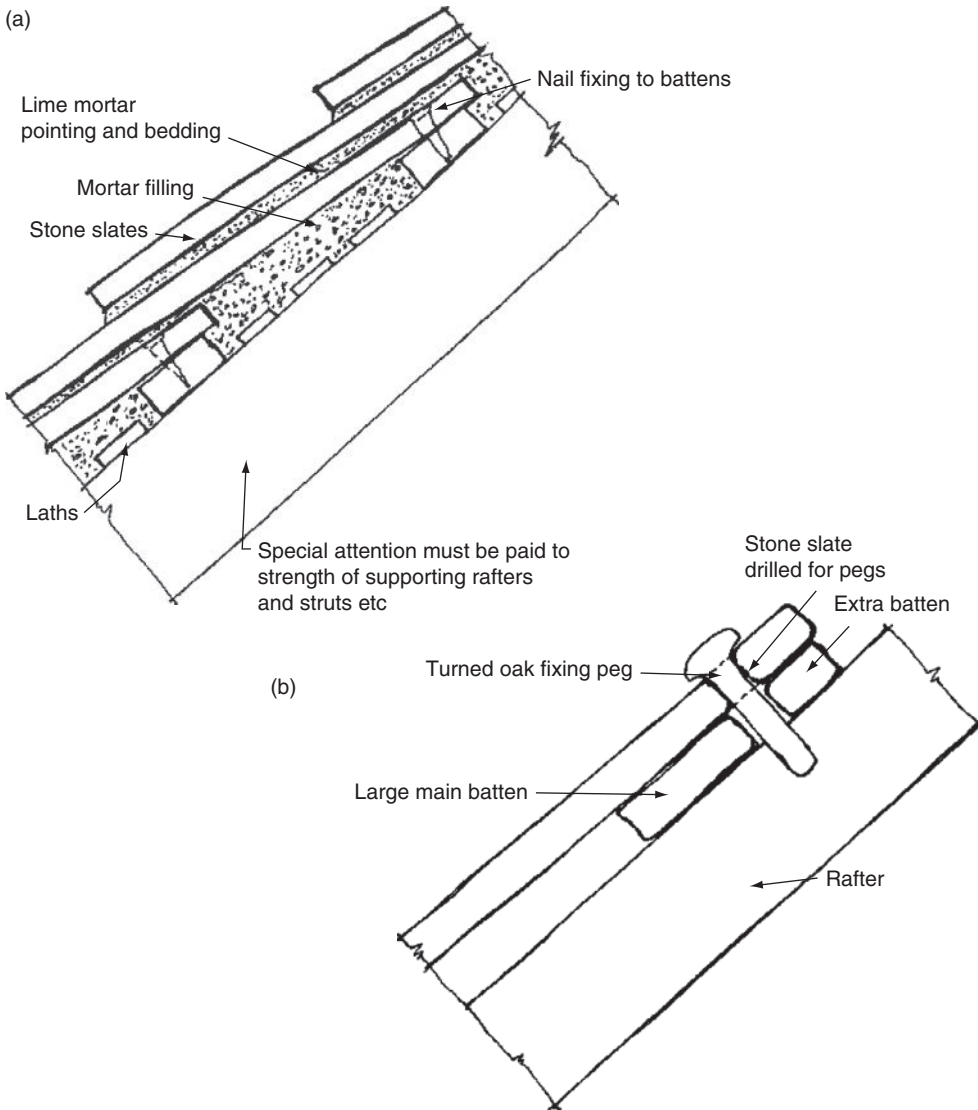
**Figure 10.10 (a) Stone slates sealed by bedding. (b) Tarred oak peg fixing**

Thicknesses vary between 16 or 19 and 25 mm and the colours are natural and differ in accordance with the locality of their quarry. Laying is usually carried out in random widths or random sizes laid in diminishing courses. The common method of fixing is by turned oak pegs in a drilled hole secured between two battens as shown in Figure 10.10b. The extra batten is used to prevent the peg from twisting out of position due to the weight of the slate. Alternatively, battens are laid on open rafters, plasterer's laths being laid between them parallel to the battens and rendered with lime mortar solid to the top face of the batten. The stone slates are then bedded, pointed and head nailed to the battens as shown in Figure 10.10a. Ridges and hips are usually finished with sawn stone angular cappings or half-round clay tiles bedded in mortar. Valleys are generally swept as open gutters. Close mitring is not particularly easy with this type of roof. Figure 10.11 shows a timber roof structure after stone slates have been removed.

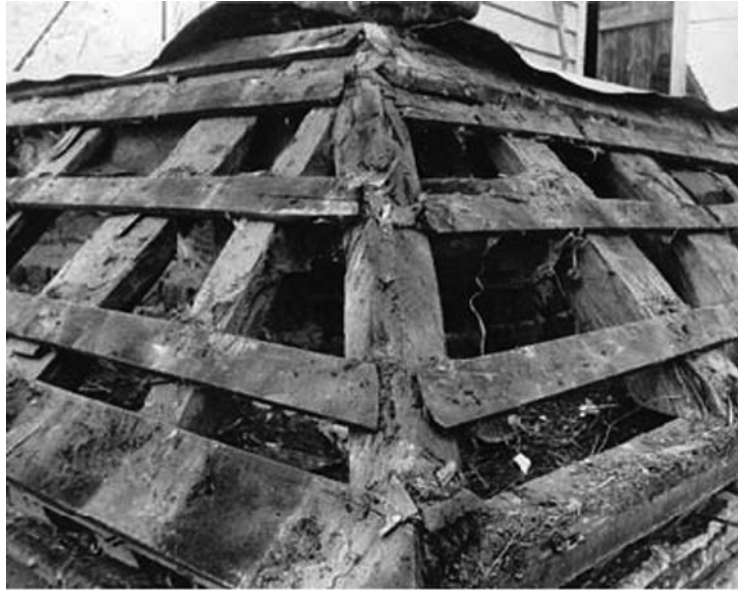
**Figure 10.11 Timber roof structure after worn stone slates have been removed**

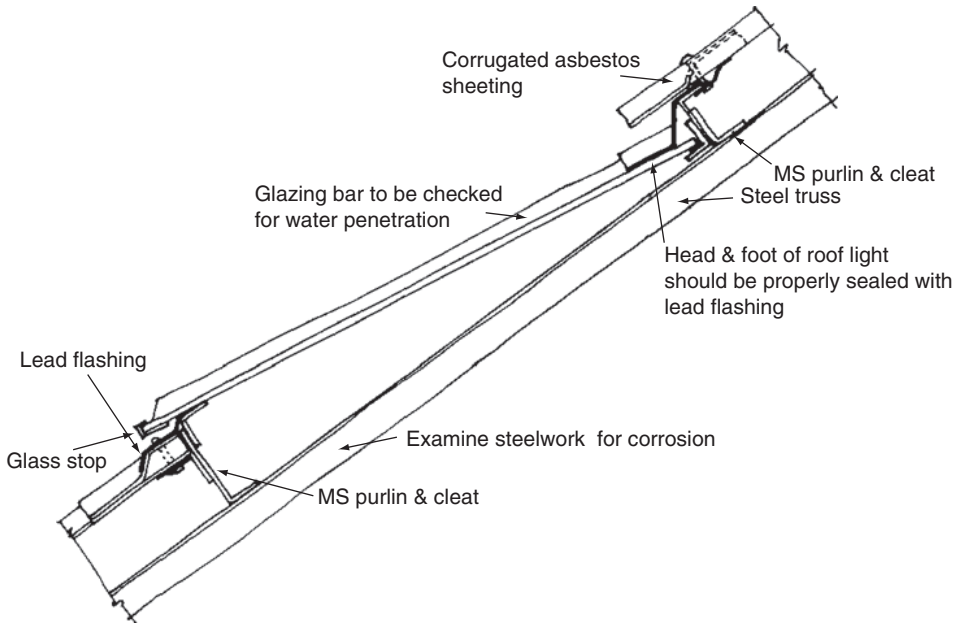
**Figure 10.12 Fixed roof glazing**

- Fixed roof glazing to pitched roofs is used in conjunction with asbestos sheeting or other types of covering and usually consists of patent glazing bars designed to accommodate single or double glazing secured to the roof purlins (Figure 10.12).

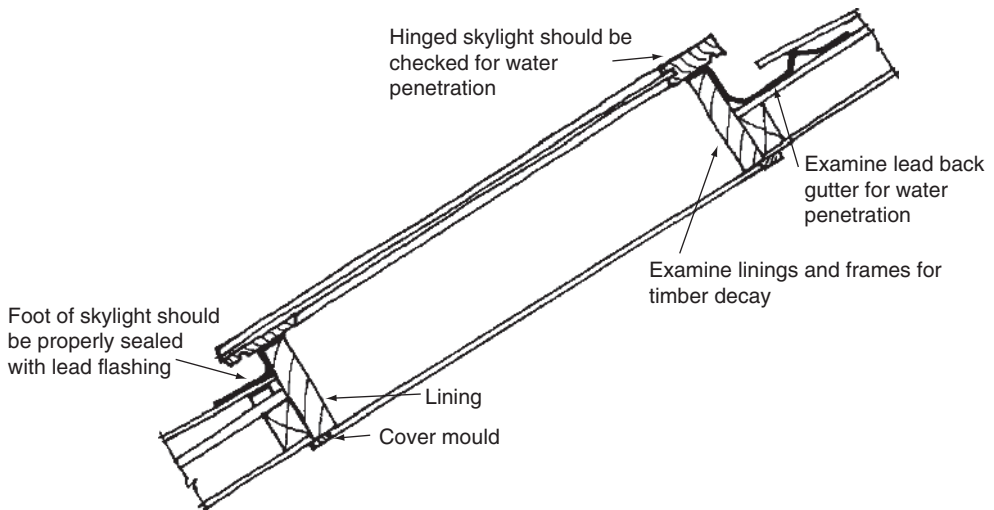
**Figure 10.13 Skylight detail**

- Skylights may be provided in pitched roofs to light a staircase, landing or attic. The skylight may be hinged or fixed (Figure 10.13).
- The traditional form of timber lantern light is still efficient and is found on the flat roofs of many old buildings (Figure 10.14). During the last 40 years they have largely been superseded by dome lights which are manufactured by

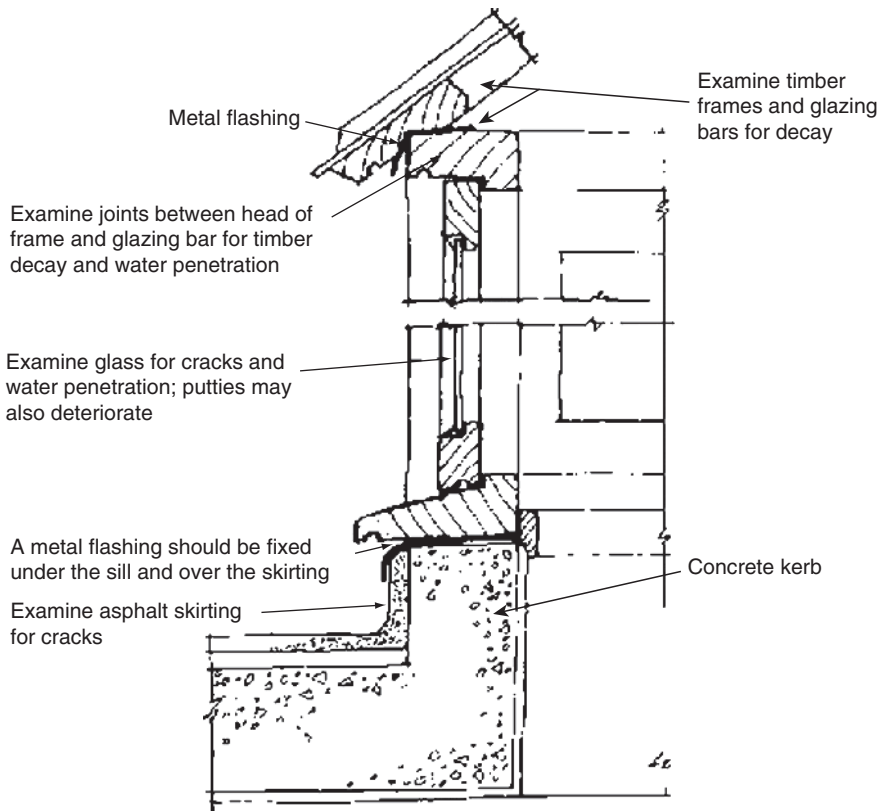
**Figure 10.14** Lantern light

- Skylights may be hinged or fixed, but if the light is hinged penetration of rain-water is likely.
- All forms of upstands to the lantern lights must be in sound condition and should have an angle fillet between roof and upstand. A metal flashing should be fixed under the sill and over the upstand covering as shown in Figure 10.14. Poor detailing in this area is a common cause of water penetration.

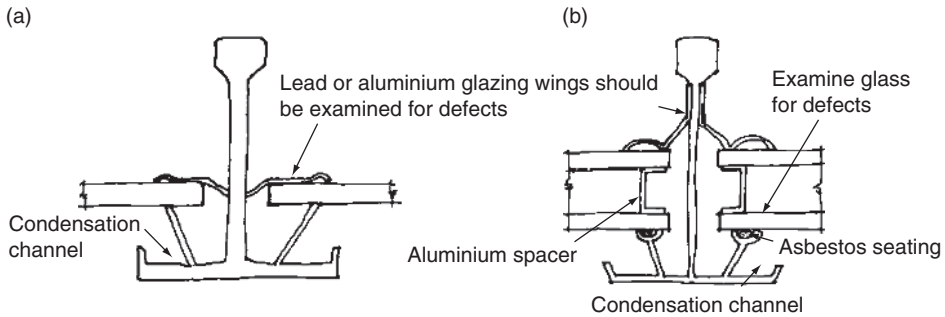
**Figure 10.15 (a) Aluminium glazing bar. (b) Aluminium double glazing bar**

For reasons of safety the glazing to roof lights is usually 6 mm wired glass or cast plate glass. The sheets are from 1–3 m in length and 610 mm in width. Where thermal insulation is important double glazing is used with an air space of 12–18 mm. In small skylights or lantern lights the glazing bars can be made of softwood or hardwood. They are liable to decay and regular maintenance is necessary especially in very exposed positions. There are several proprietary glazing bars in the form of metal T-sections consisting of steel or aluminium alloy sheathed in lead or PVC. The bars incorporate condensation channels and the glass is secured with aluminium spring cover strips or lead wings. The bars are normally trouble free and produce a durable watertight roof light. Figures 10.15a and b show examples of single and double glazing bars. The various items affecting the durability of the roof lights and requiring examination may now be considered:

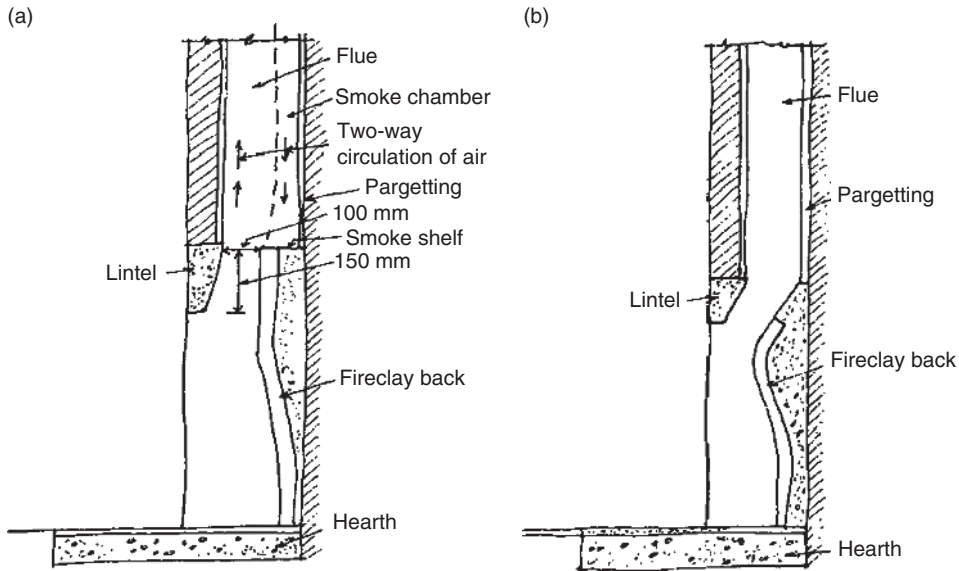
**Figure 11.1 (a) Section through fireplace designed on the principles of Count Rumford. (b) Fireplace design commonly adopted in modern work**

In practice of course, the surveyor will often find that these ideal conditions may not always occur. The fireplace and flue entry shown in Figure 11.1a has been designed on the Rumford principles (Billington & Roberts, 1982) and Figure 11.1b shows a section commonly adopted in modern work which is usually successful. The surveyor will often find that dwellings erected in the past 40 years have been fitted with precast throat units which ensure that the throat is formed to the correct dimensions.

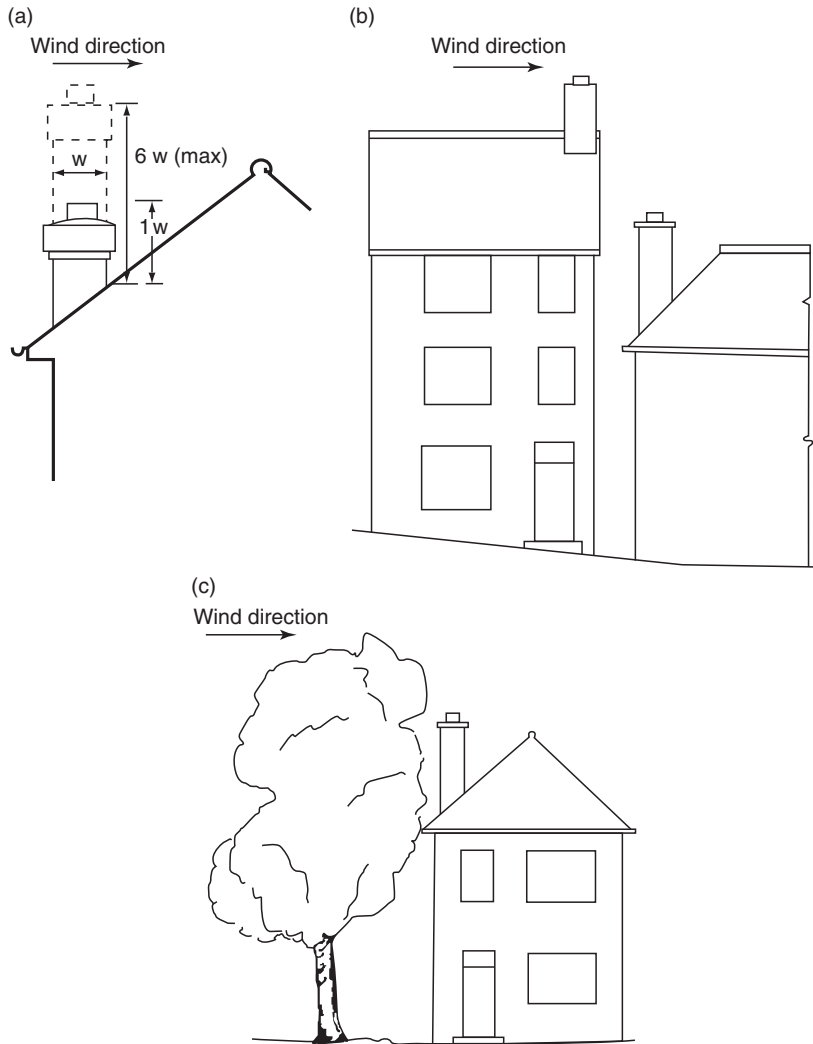
**Figure 11.2 (a) Chimney lower than ridge causing down-draught. (b) Chimney too low in relation to higher adjoining building. (c) Tree in too close proximity to chimney causing down-draught**

A steady blow back of smoke can also be due to unfavourable site conditions. As the wind strikes buildings and trees, areas of air pressure and suction are set up. The area of pressure is on the side which the wind strikes and the area of suction on the opposite side. These areas extend above the roof, whether the roof is flat or pitched. Where a badly placed chimney is in an area of high winds, the pressure may be greater than the upward pressure of the smoke rising up the flue, and therefore a down-draught will result. The main lesson to be learnt from this is that the chimney outlet should be high enough to avoid interference from pressure and suction. Where it is clear that the existing outlet is too low, the almost certain remedy is to raise it to bring the outlet above the disturbed area. If this is done by building up the chimney in the existing materials it is well to remember that no brick chimney should rise more than six times its width (see Figure 11.2a).

although above its own ridge. The lower chimney will probably suffer from down-draught. The remedy is to take the chimney up to a higher level which may make it necessary to install special bracing. A possible alternative is to recommend a change in the form of heating. Tall trees near a building may cause down-draught by creating areas of pressure and suction. A typical case is shown in Figure 11.2c. If it is impracticable to raise the chimney above the area of pressure, the tree should be lopped.

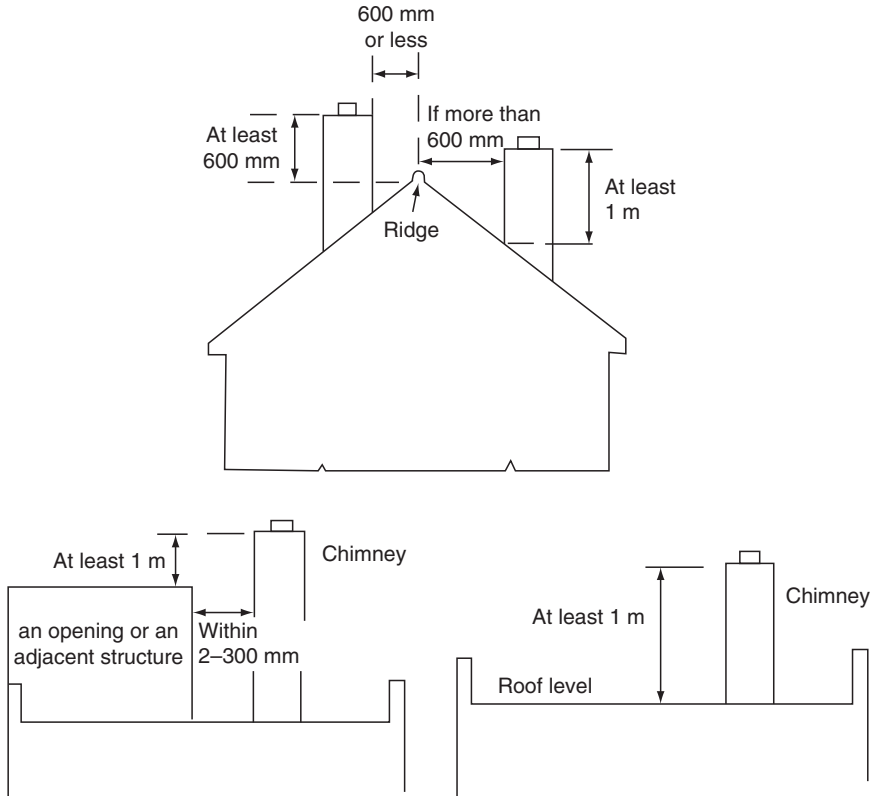
**Figure 11.3** Minimum chimney heights laid down in the Building Regulations for solid fuel and oil burning appliances

The building regulations require that the chimney outlet should be 1 m above the highest point of the intersection of the chimney stack and roof slope as shown in Figure 11.3. Adjacent buildings modify the areas of pressure and suction around the building. In some cases it is not sufficient to carry the chimney up 1 m above the ridge. A single storey building may have the ridge at a much lower level than that of the adjoining buildings. On steep hills one building may be lower than an adjoining building. In Figure 11.2b the building in the lower position has a chimney which is below the ridge level of the adjoining building

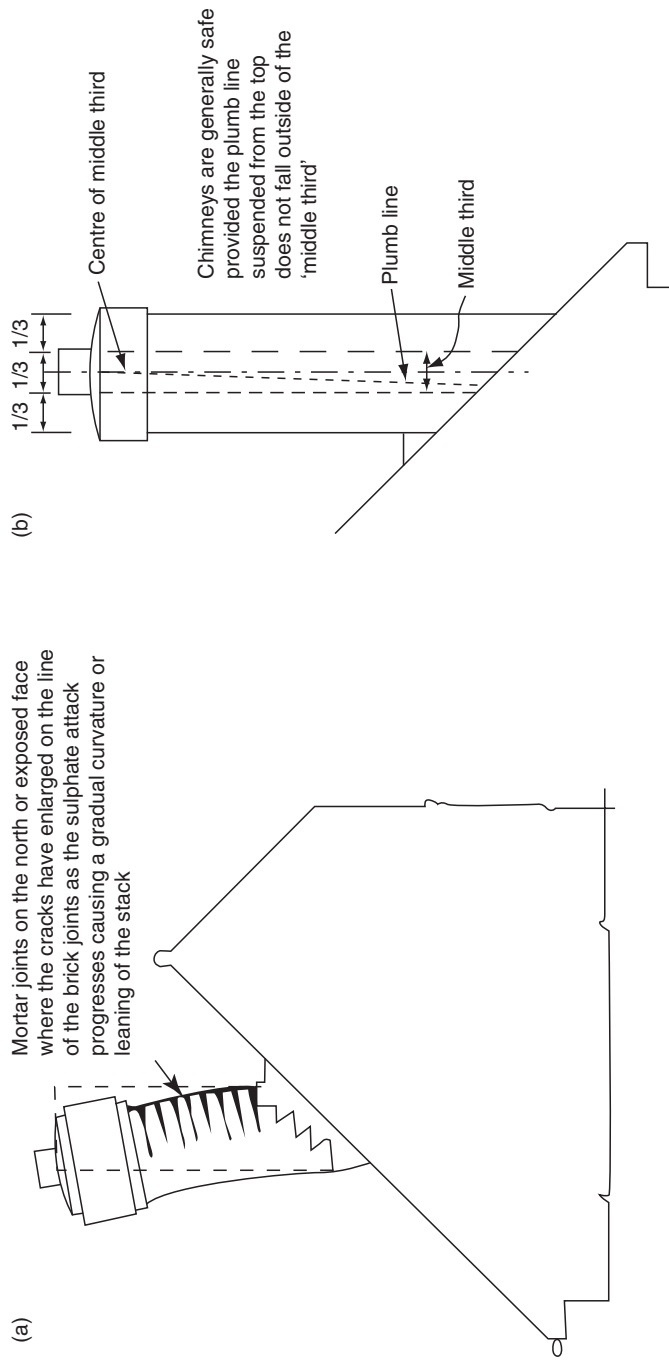
Figure 11.4 (a) Sulphate attack on a typical kitchen boiler flue. (b) Middle third rule

- (1) As already mentioned, sulphate attack causes the mortar to expand and this leads to a gradual curvature or leaning of the stack which can be extensive on rendered stacks. The lining or pargetting can also be attacked by the products of combustion as they rise up the flue. Sulphate attack on a typical kitchen boiler flue is shown in Figure 11.4a where the shrinkage cracks have enlarged on the horizontal brick joints as the sulphate attack progresses. A chimney stack which has begun to lean is generally safe provided a plumb line suspended from the top of the stack does not pass outside the 'middle third' of its area as shown in Figure 11.4b. If the rate of lean appears excessive the surveyor should recommend that the stack should be demolished to the level at which it appears reasonably perpendicular and rebuilt using a sulphate-resisting cement. If the chimney is old and is to be used in conjunction with a gas appliance and is not protected with a flue liner, the rebuilding of the stack will provide a good opportunity to install a flexible liner.

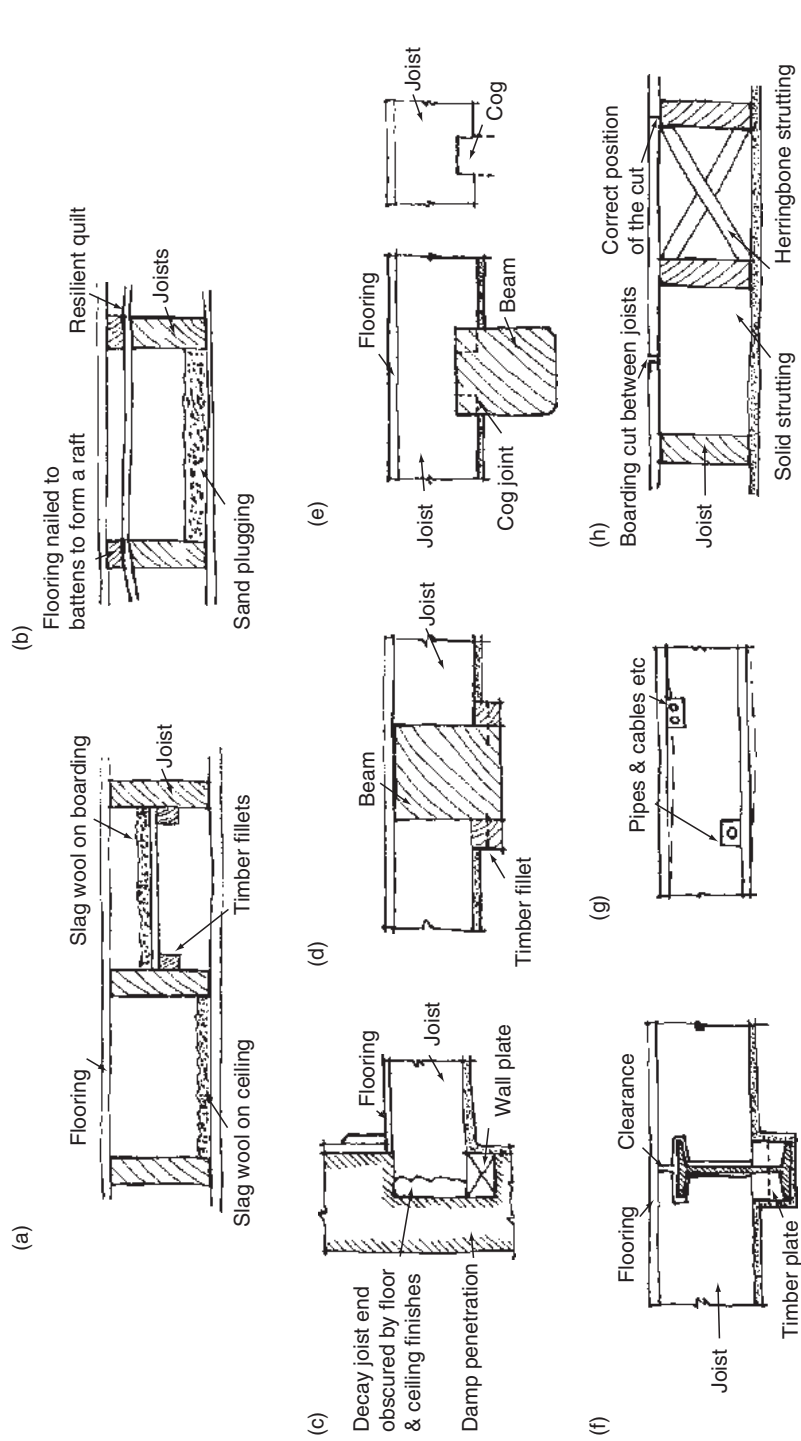
Figure 12.1 (a) Two methods of sound insulation between floors. (b) 'Floating floor' for sound insulation. (c) Joists built into solid wall without an air space. (d) Joist resting on fillets nailed to bottom edge of beam. (e) Method of cogging joists over timber beam. (f) Typical notching when RSJs are used. (g) Deflection due to excessive notching. (h) Floorboard jointing and strutting details

can be strengthened. It is better practice to cog the floor joists over the beam as shown in Figure 12.1e. Figure 12.1f shows a typical notching where the beam consists of a rolled steel joist. The timber joists are supported on timber plates secured to the web of the RSJ, but are kept clear of the rest of the RSJ to allow for expansion and contraction of the timber. In some cases the top of the joists are flush with the top of the RSJ causing the floorboard situated over the top flange to curl due to the fact that the only fixing is the tongue and groove in the jointing of the floorboard.

- (5) The centre of the span should be checked for some form of strutting. Although strutting is usually fitted between joists, it may happen that in very old timber floors it has been omitted, in which case undue vibration will occur. This is due to the joist tending to tip sideways under movement, especially if the floorboards have not been nailed to every joist. Also the end wedges between the wall and the last joist may have been omitted or have fallen out. If this is the case, considerable improvement can be effected by taking up the flooring and inserting a row of solid strutting down the centre of the span (see Figure 12.1h).

- (6) Another problem which could be attributed to deflection in old floor joists is that excessive notching of the joists may have been made to accommodate gas pipes, electrical cables or water pipes (see Figure 12.1g). If the surveyor feels uncertain on this point it is well to consult the British Standard Code of Practice BS 5268-2: 2002 which sets out rules concerning safe notching in joists.

The surveyor will sometimes find that the ends of the boards meet between joists forming a cantilever as shown on the left-hand side of Figure 12.1h and will spring under weight. The cut should be made at the middle of the joists as shown on the right-hand side of Figure 12.1h.

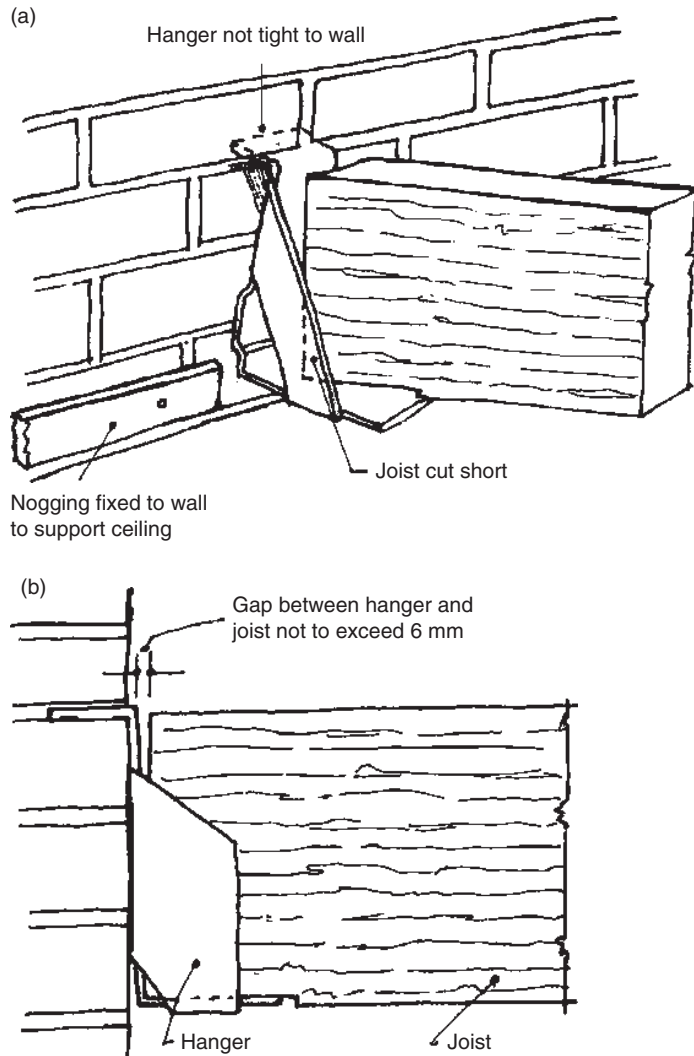
**Figure 12.2 Use of metal joist hangers: (a) incorrect positioning; (b) correct positioning**

- (8) In modern properties metal joist hangers have been used extensively. Unfortunately, recent surveys have found instances where the hangers or joists have failed due to one or more of the following causes (see Figures 12.2a and b).

- Hangers should be tight against the face of the masonry.
- Incorrect grade of hanger used. It is important that hangers are not used with masonry of lower strength than the hanger grade marking. Hangers should comply with BS 6178 Part 1 and are made for minimum masonry crushing strengths.
- Sometimes joists are cut short leaving a large gap between joists and back plate of hanger. This may cause hangers to move and the floor to settle.
- Check to ensure that no damaged or corroded hangers have been used.
- Check that the undersides of the joists are properly notched to accommodate the hanger flanges.

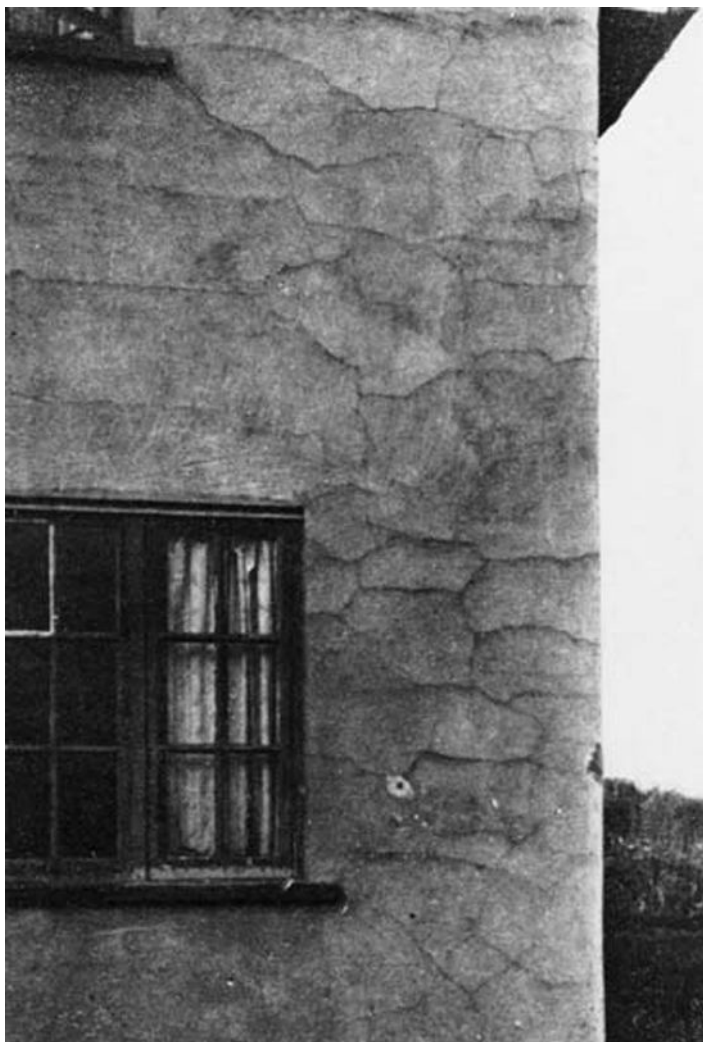
**Figure 13.1** Cracked rendering as a result of sulphate action

- Rendering consisting of cement and sand without the inclusion of lime and applied with a floated finish will often produce 'map' patterns. In exposed conditions this type of rendering will lead to loss of adhesion due to frost action and provide damp conditions necessary for sulphate attack. Figure 13.1 shows cracking of rendering as a result of sulphate action.

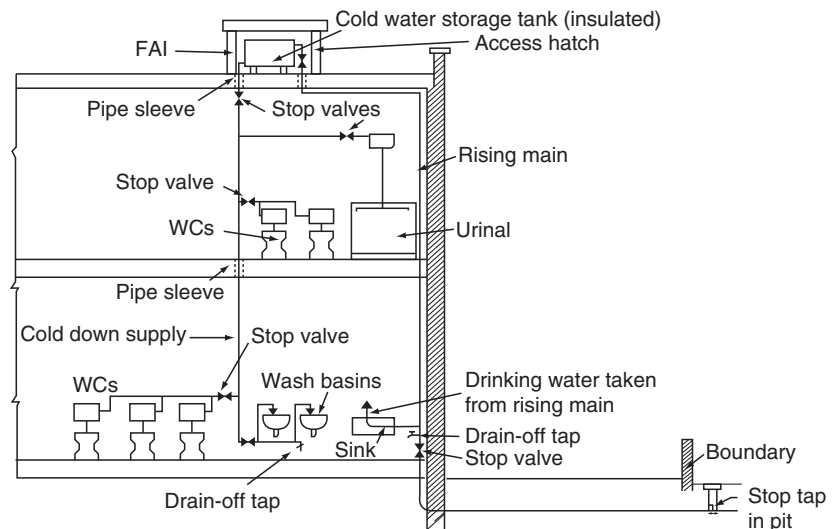
**Figure 14.1** Layout of cold water supply to small office block

The distribution of cold water through a building so that draw-off points can be adequately served depends on the requirements of the local water authority and the available pressure on the mains (Figure 14.1).

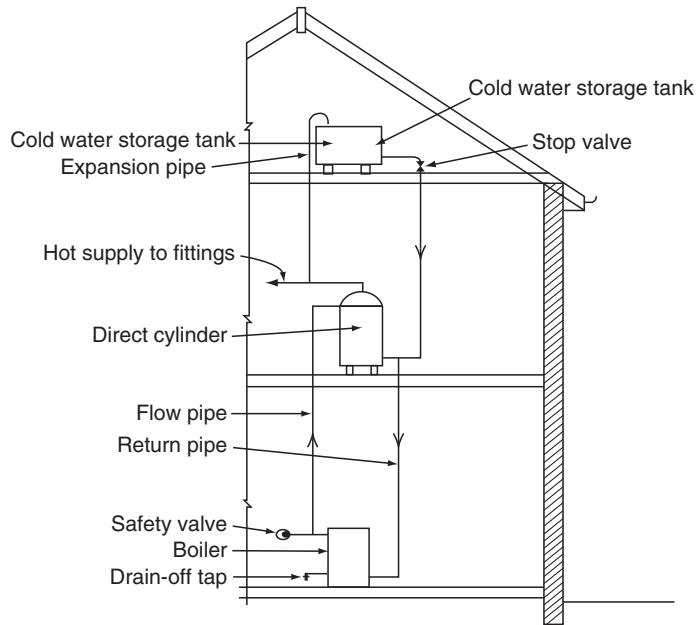
**Figure 14.2** Layout of direct heating system

In direct heating systems the principal components are boiler; flow and return pipes; hot water storage cylinder; cold water supply pipe; expansion pipe and draw-offs (see Figure 14.2). Furring of pipes in this type of system is common in 'hard water' areas.

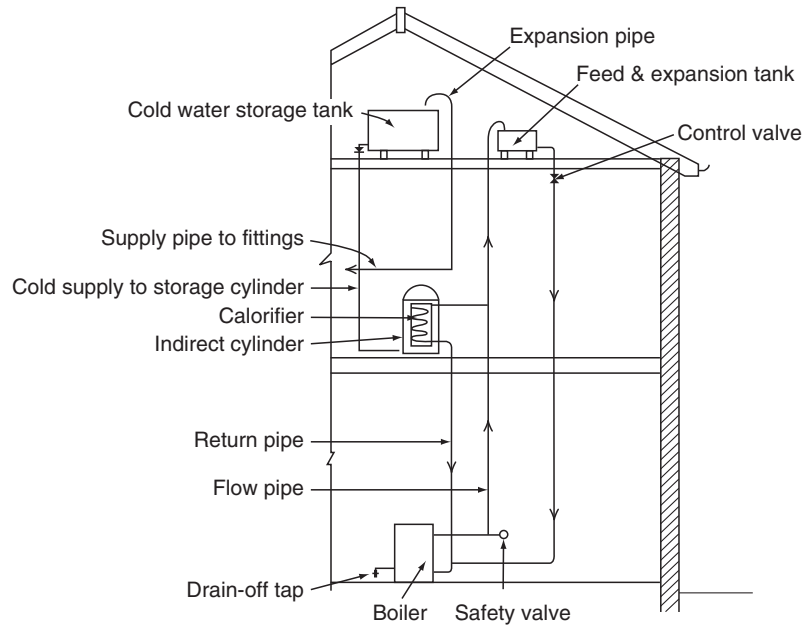
**Figure 14.3** Layout of indirect heating system

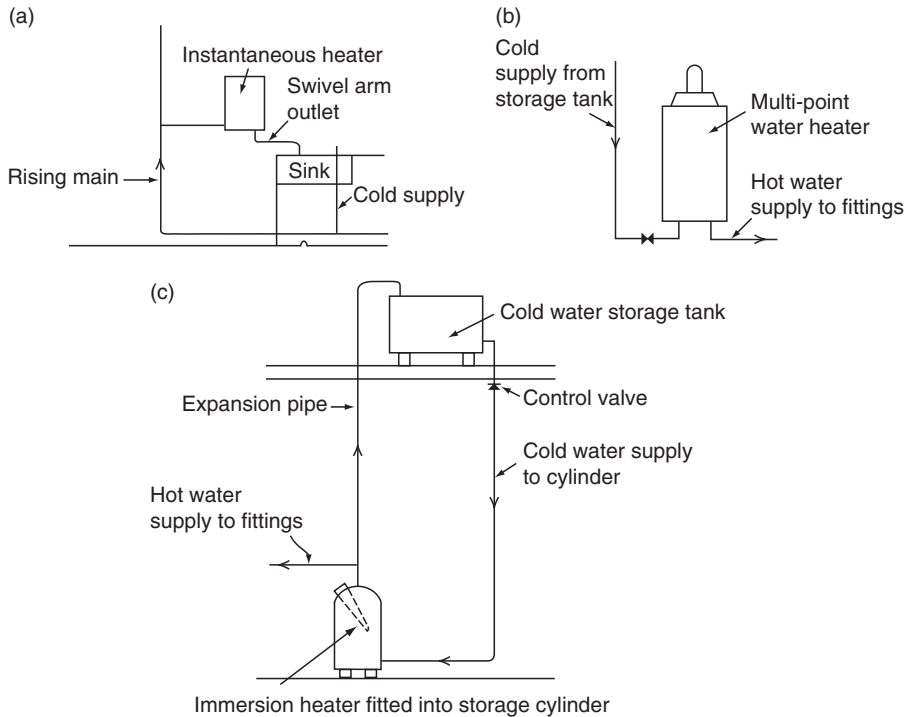
**Figure 14.4** (a) Wall mounted instantaneous heater. (b) Wall mounted multi-point heater. (c) Heating water by electric immersion heater

Wall mounted water heaters can be heated by gas or electricity. The instantaneous type is usually found above a sink unit in domestic properties and does not take up valuable floor space (Figure 14.4a). The water is heated at a single point and is supplied through a swivel arm outlet. The multi-point heaters can be heated by

gas or electricity. They receive the cold supply from a cold water storage tank which then supplies hot water to several fittings (Figure 14.4b).

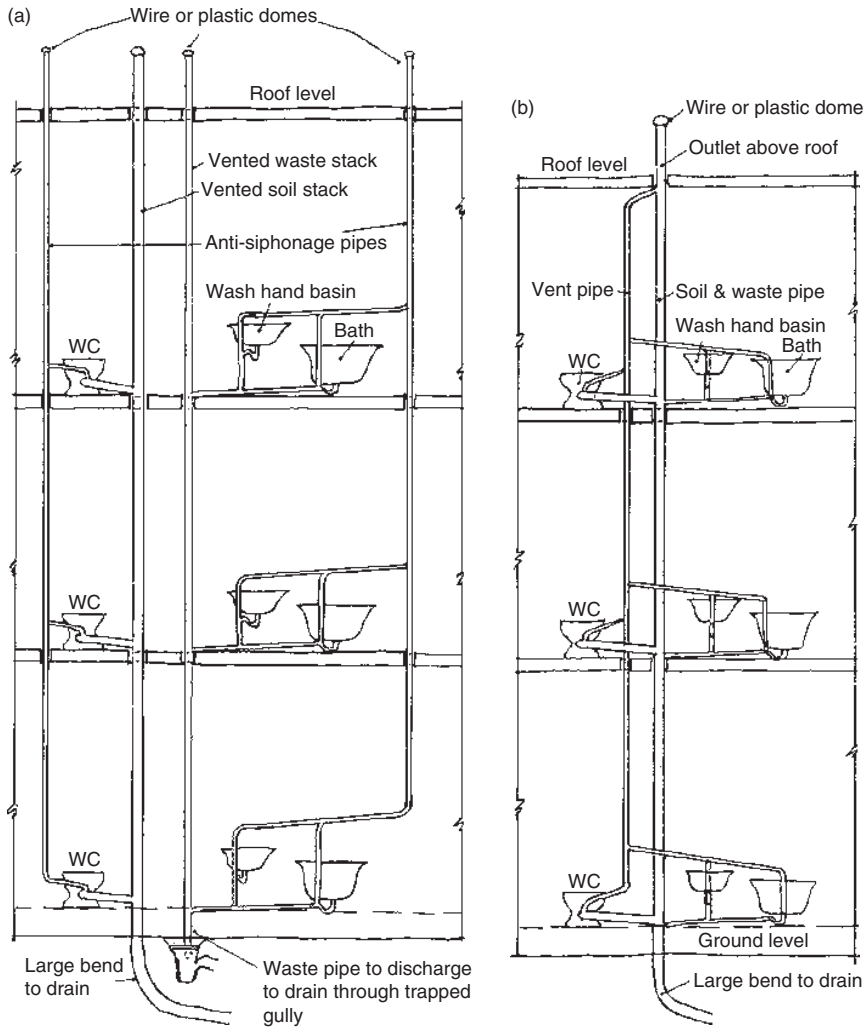
Figure 14.5 (a) Two pipe system for block of flats. (b) One pipe system

drain through a trapped back inlet gully, and the discharge from the water closets is direct to the drain. This system has a disadvantage in regard to the present day use of detergents and is now seldom used (see Figure 14.5a).

In this system the soil and waste are conveyed together in one pipe with ventilating pipes connected to each fitting and sized according to the loading of the installation. The main stack is connected directly to the drain (see Figure 14.5b).

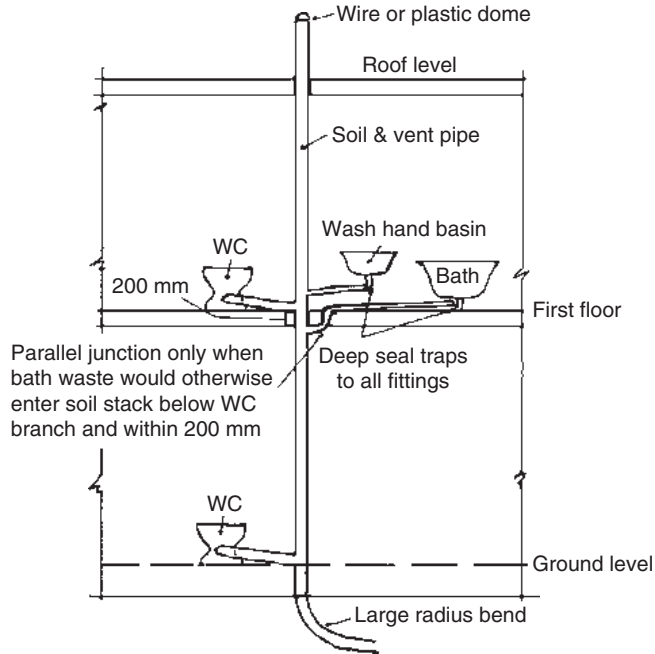
**Figure 14.6 Single stack system**

This is a much simpler system, does not employ separate ventilating pipes and is commonly used although it is based on strict rules which must be observed, e.g. deep seal traps must be used on all fittings (see Figure 14.6).

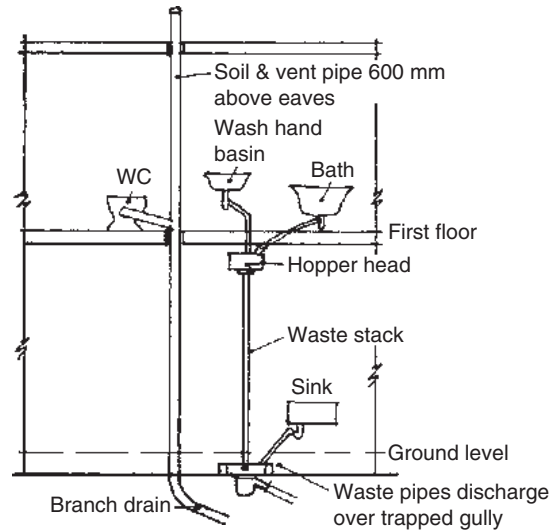
**Figure 14.7 Disposal of soil and waste water in older domestic properties**

In many domestic properties built before World War II the surveyor will find that the waste pipes from fittings above ground level, such as baths, basins and showers, discharge into hopper heads and the sinks at ground level discharge over a trapped gully. The WC is usually connected to a ventilated soil pipe. The waste pipe and hopper are not a satisfactory method and will often be found to be partially blocked with slimy soap and hair etc., and in very cold weather the waste water will freeze and possibly fracture the pipes (see Figure 14.7).

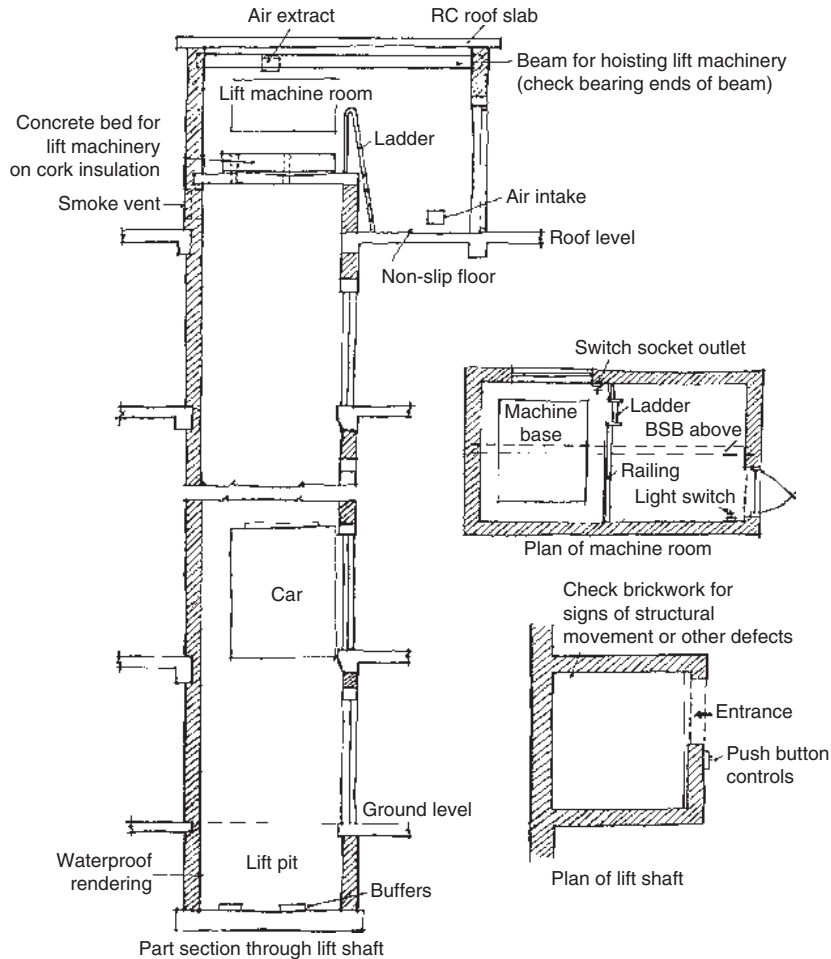
**Figure 14.8** Typical lift shaft and machine room showing 'builders' work'

There are three main areas requiring the surveyor's attention: the lift pit, shaft and machine room. The first operation on site will involve the lift engineer who will shut off all push button controls at all levels so that the surveyor and engineer can use the lift without interference from the landing call points (see Figure 14.8).

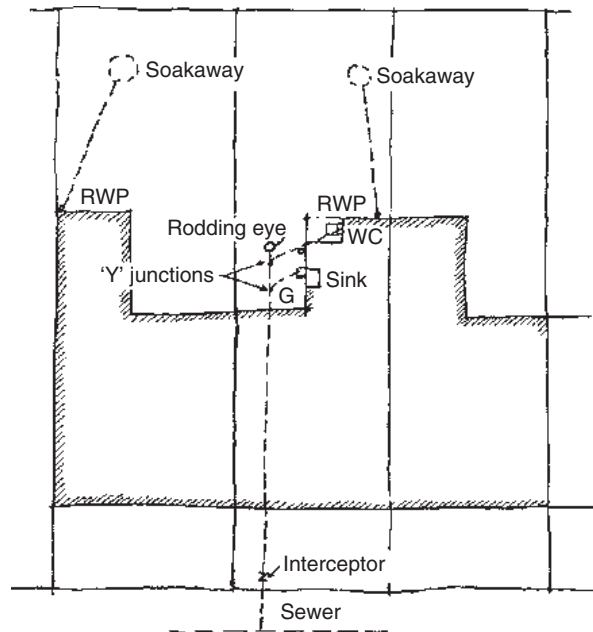
**Figure 15.1** Soil drainage system to terraced housing erected before 1900

If inspection chambers are not visible on site, the possibility that they may have been covered up by raised flower beds, pavings or rubbish should not be ruled out. If, however, inspection chambers cannot be located, there is a strong possibility that the building is still equipped with the original system which was probably installed some time between 1850 and 1880. Such a system was usually laid in 4" or 6" salt glazed pipes with clay joints and without any form of concrete bed. In the case of terraced houses, the most common layout was a straight run under the house from the outside WC to the sewer. This meant that the soil branch drain connected to the WC outlet and vented to the open air and went directly to the main drain while a second pipe took the waste water from the kitchen sink to an outside trapped gulley. Sometimes the WC connection entered the main run with a 'Y' junction, the main run then being extended via an easy-bend up to yard level where it was capped off with a rodding eye. However, it was fairly common practice to form a junction by cementing the end of a 4" branch pipe into a hole cut into a 6" main drain (see Figure 15.1).

Drainage systems of the kind shown in Figure 15.1 are seldom found today. They do not satisfy any of the requirements of the current Building Regulations in that they are unlikely to be watertight and not laid to a self-cleansing fall. The surveyor can safely assume that, if no inspection chambers can be found, a new drainage system must be provided as the system will certainly be condemned by the Environmental Health Officer. Where inspection chambers are found on nineteenth century properties similar to that shown in Figure 15.2 it is usually an indication that the drains have been relaid at a more recent date. An examination of the type and condition of the brickwork and channels can give an indication of the age of the system.

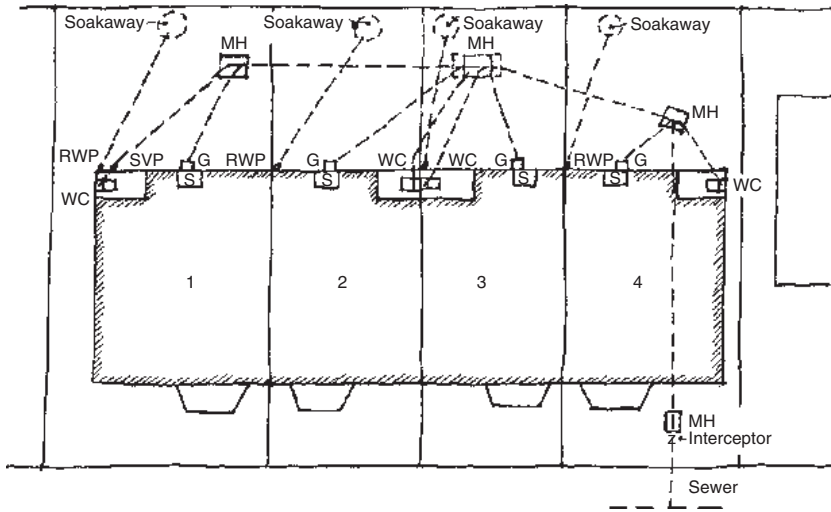
Figure 15.2 Soil and surface water system to terraced housing erected after 1900

Alternatively, where several houses were in one ownership, the drains were collected into a main run at the rear of the terrace before being discharged under the last house in the terrace and thence to the sewer (see Figure 15.2). Towards the end of the century the local authorities usually insisted on inspection chambers at every change of direction, but this was not always adopted and pipes were often laid in curves. The Public Health Act 1875 was the first Act to regulate the construction and ventilation of sewers. It was, therefore, considered necessary to disconnect the house drain from the sewer by means of an intercepting trap. Some of the early types of trapped gulleys and interceptors introduced were inefficient and simply consisted of a shallow bend with an unreliable water seal. These fittings often became blocked and were difficult to rod. Joints between pipes were often badly formed and in surface water drains they were almost non-existent.

In some cases it will be found that, although there is no inspection chamber on the property, the drains are in fact connected into an inspection chamber in an adjoining property, as shown in houses 2 and 3 in Figure 15.2. No particular problems should arise from this unless the properties belong to different owners. Should this be the case a 'drainage agreement' will have to be entered into by the various owners, whereby joint responsibility is accepted for the repair of common

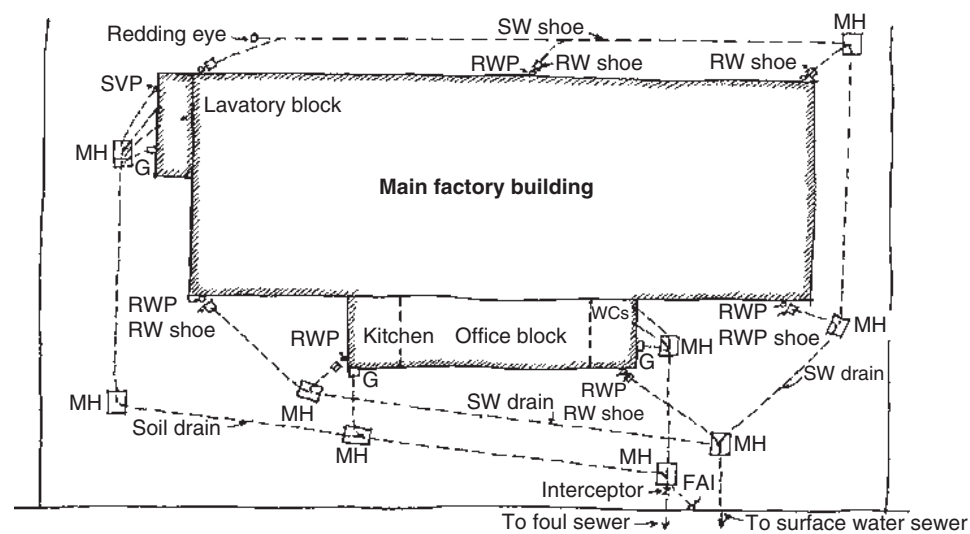
Figure 15.3 Typical separate system layout for a small factory

It may well be found that the surface water drainage is on a 'separate system' either to a surface water sewer or to a soakaway within the curtilage of the site as shown in Figures 15.1, 15.2 and 15.3. Care must be taken not to get the systems inadvertently interconnected. 'Separate systems' were adopted by many local authorities in large towns in order to avoid overloading the sewage treatment plant. They will not allow rainwater pipes or yard drainage to be connected to the foul sewer. However, some local authorities allow the soil and surface water to discharge into the same sewer as shown in Figure 15.4.
