# BUILDING SURVEYS & REPORTS

*4<sup>th</sup> Edition*

**James Douglas BSc, MRICS, MBEng, FHEA  
and Edward A. Noy FASI, ARSH**

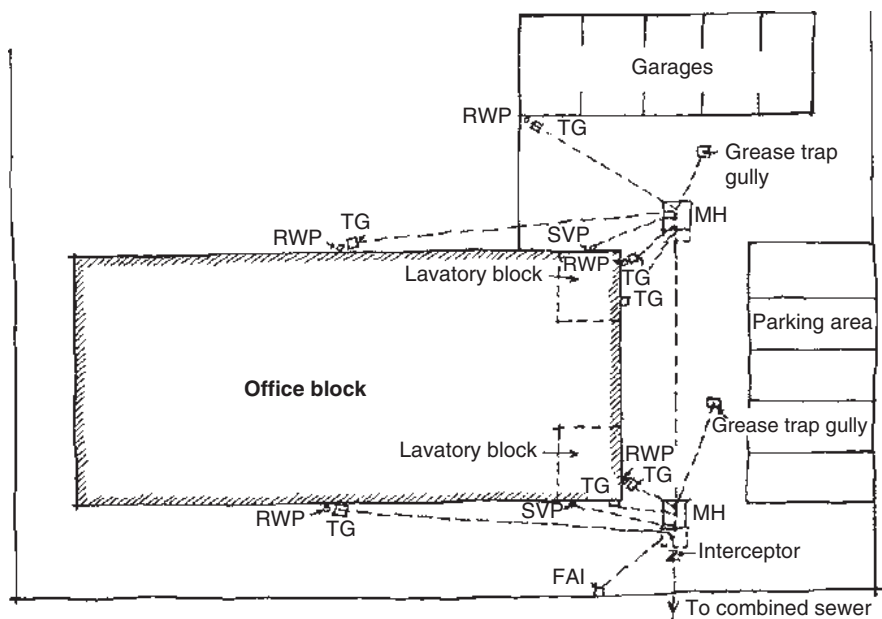
Figure 15.4 Typical combined system for small commercial building

It may well be found that the surface water drainage is on a 'separate system' either to a surface water sewer or to a soakaway within the curtilage of the site as shown in Figures 15.1, 15.2 and 15.3. Care must be taken not to get the systems inadvertently interconnected. 'Separate systems' were adopted by many local authorities in large towns in order to avoid overloading the sewage treatment plant. They will not allow rainwater pipes or yard drainage to be connected to the foul sewer. However, some local authorities allow the soil and surface water to discharge into the same sewer as shown in Figure 15.4.

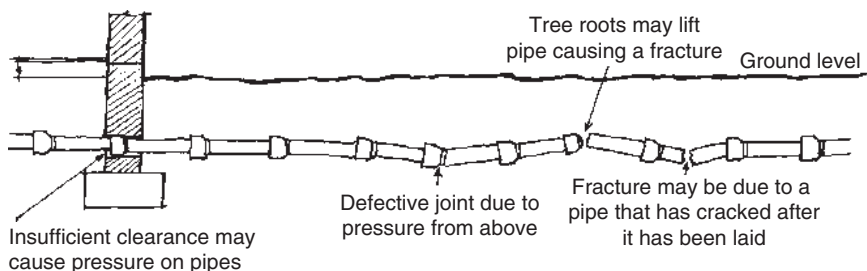
Figure 15.5 Defects due to movement of ground through settlement, shrinkage or tree roots

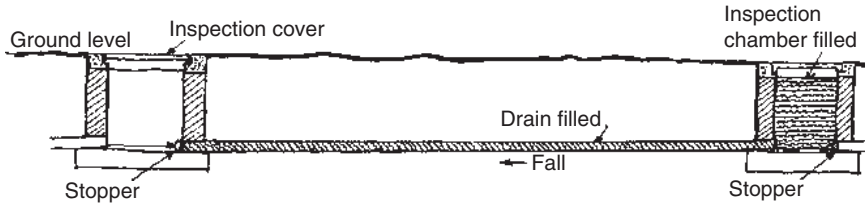
**Figure 15.6** Water test applied to section of drain between two inspection chambers

The only certain method of demonstrating that a drain will hold water is to fill it with water and note if the level drops. This can usually be done by gaining access to the drain at the lowest inspection chamber and stopping the inlet with an expanding stopper. Another stopper should be fitted to the inlet (or to each inlet if there are more than one) at the next inspection chamber higher up. These positions are shown in Figure 15.6 which is a section through a drain being tested. The higher inspection chamber is then filled with water and the distance from the top of the cover frame to the top of the water carefully measured and then left for about 1.5–2 hours. If the water level in the chamber goes down by any appreciable extent a leakage is indicated. There will be a slight lowering of the water level even

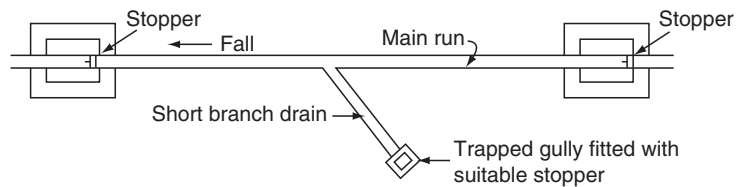
**Figure 15.7** Water test applied to main and branch drain

Short branches connected to a main drain between inspection chambers as shown in Figure 15.7 should be tested with the main drain. The gully should be fitted with a suitable stopper and any confined air in the gully should be drawn off as the pipe fills with water, using a rubber tube passed through the seal of the gully. The shorter the lengths tested at one time the better, as the job of opening the ground and searching for defects can be confined to those sections in which defects are indicated by test.

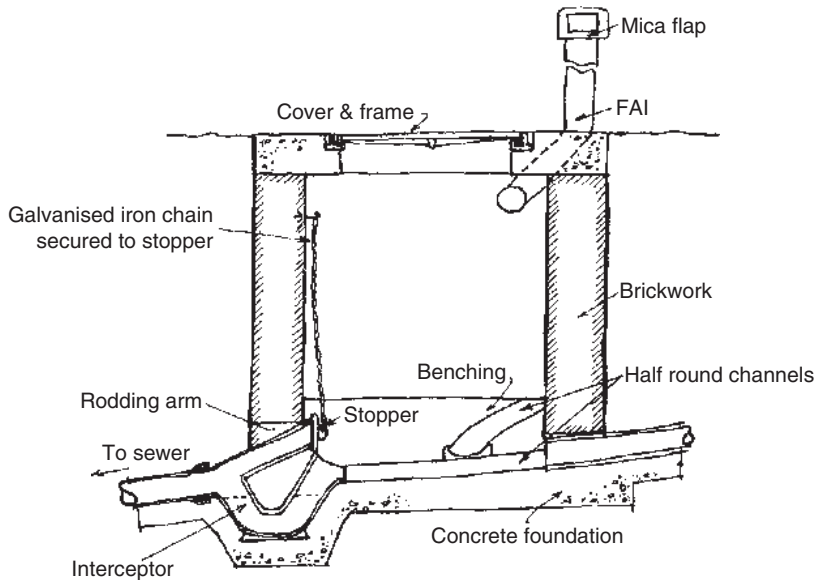
**Figure 15.8** Section through interceptor and inspection chamber

The interior of each inspection chamber should be carefully examined and the construction and condition of the following parts noted (see Figure 15.8):

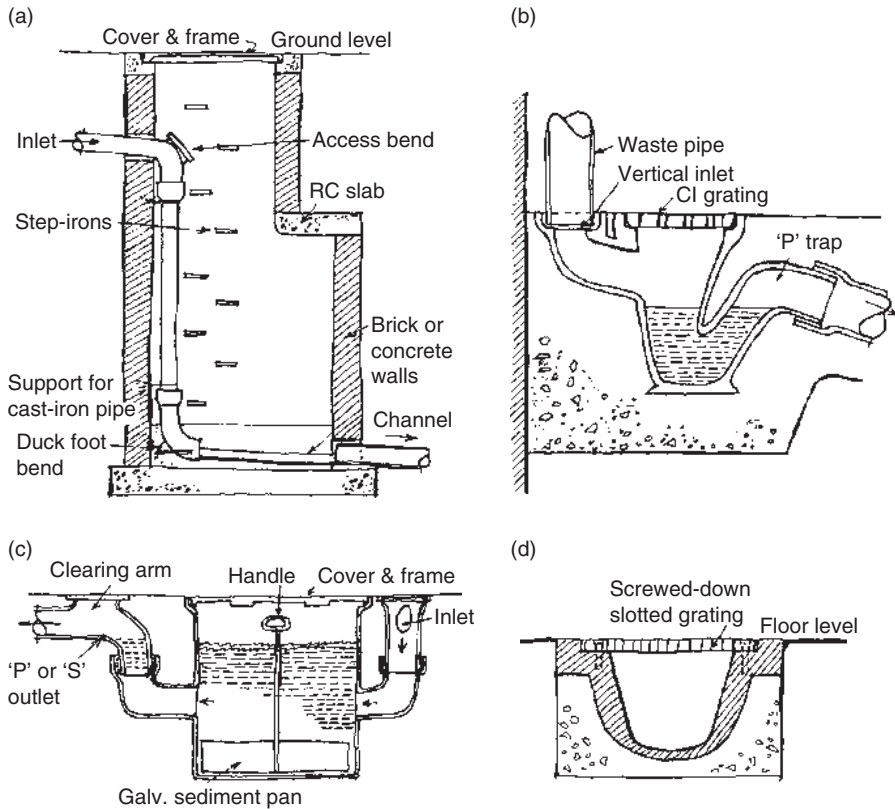
**Figure 15.9** (a) Section through back-drop inspection chamber. (b) Back inlet gully. (c) Grease trap. (d) Drainage channel

An inspection chamber incorporating a vertical drop for the purpose of connecting to a sewer or drain at high level to one at a lower level is known as a back-drop inspection chamber, or tumbling bay. The vertical drop is usually constructed outside the chamber, but may be constructed inside provided there is sufficient space in the chamber as shown in Figure 15.9a. If the vertical drop is constructed

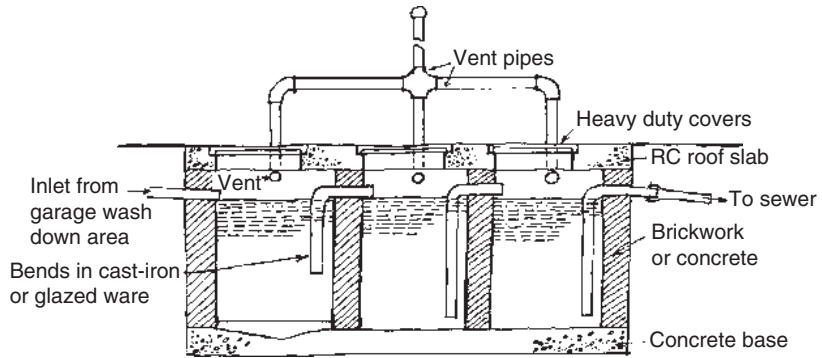
**Figure 15.10 Petrol interceptor**

Where there is a risk of pollution from petrol or oil spillage from garage wash downs entering a drain communicating with a sewer, a suitable interceptor should be incorporated in the system. For a single domestic garage a deep gulley trap fitted with a perforated lifting tray is usually sufficient. For a large number of garages or a filling station, a brick or concrete structure consisting of three chambers is necessary, as shown in Figure 15.10. The chambers allow for any petrol that may be present to rise to the surface and evaporate into the atmosphere through the vent pipes. The construction details are similar to brick inspection chambers, but many petrol interceptors in modern buildings are constructed of precast concrete or prefabricated in glass reinforced polyester (GRP). GRP interceptors are factory manufactured, rot proof, impact resistant and are usually installed in a concrete surround. The condition and construction of the following parts of the interceptor should be noted:

- Inspection chamber covers and frames should be checked as described in Section 15.15. The majority of covers will consist of the heavy duty type.
- The vent pipe should be taken up to a height of not less than 2.4 m so as not to cause a nuisance. If the vent pipes are secured to a building, the outlet should not be less than 900 mm above the head of any window or other opening within a horizontal distance of 3 m.
- The first chamber should contain a shorter bend as shown in Figure 15.10. The purpose of the shorter bend is to allow for the accumulation of grit etc. without blocking the end of the pipe.

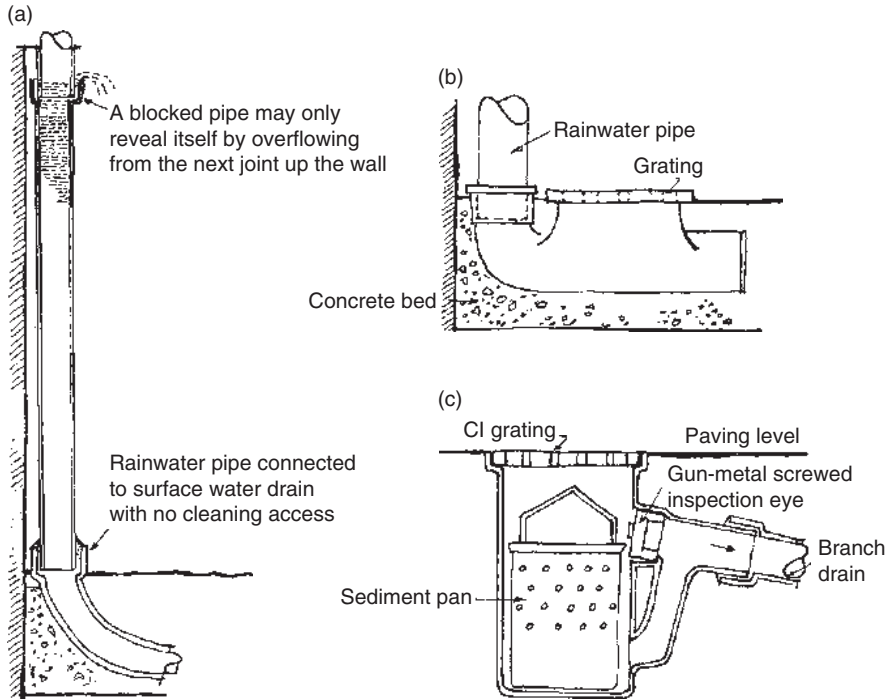
**Figure 15.11** (a) Rainwater pipe connected direct to surface water drain. (b) Rainwater shoe. (c) Yard gulley

Where surface water is discharged into a combined or separate sewer, trapped gulleys are invariably found at the feet of rainwater pipes as shown in Figures 15.3 and 15.4. In low density areas, where the discharge is to soakaways on the site, rainwater shoes, sometimes referred to as trapless gulleys, may be used. However, in many domestic properties the bottom of the rainwater pipe is jointed direct to the socket of the surface water drain as shown in Figure 15.11a. This method has several disadvantages because the state of the drain is unknown, and having no cleaning access the silt will gradually build up in the rainwater pipe and drain. This build up will not be noticed until the rainwater overflows from the next joint up the wall.

The type of gulley illustrated in Figure 15.11c is designed to take surface water from yards, pavings and garage wash down areas. There are several variations some of which are fitted with a perforated sediment pan to facilitate the removal of grit and mud. The pans should be periodically emptied, but in the writer's experience this operation is seldom carried out. If there is a build up of silt or other matter, this should be noted. In such cases it is advisable to recommend that the branch drain from the yard gulley is cleared by rodding.

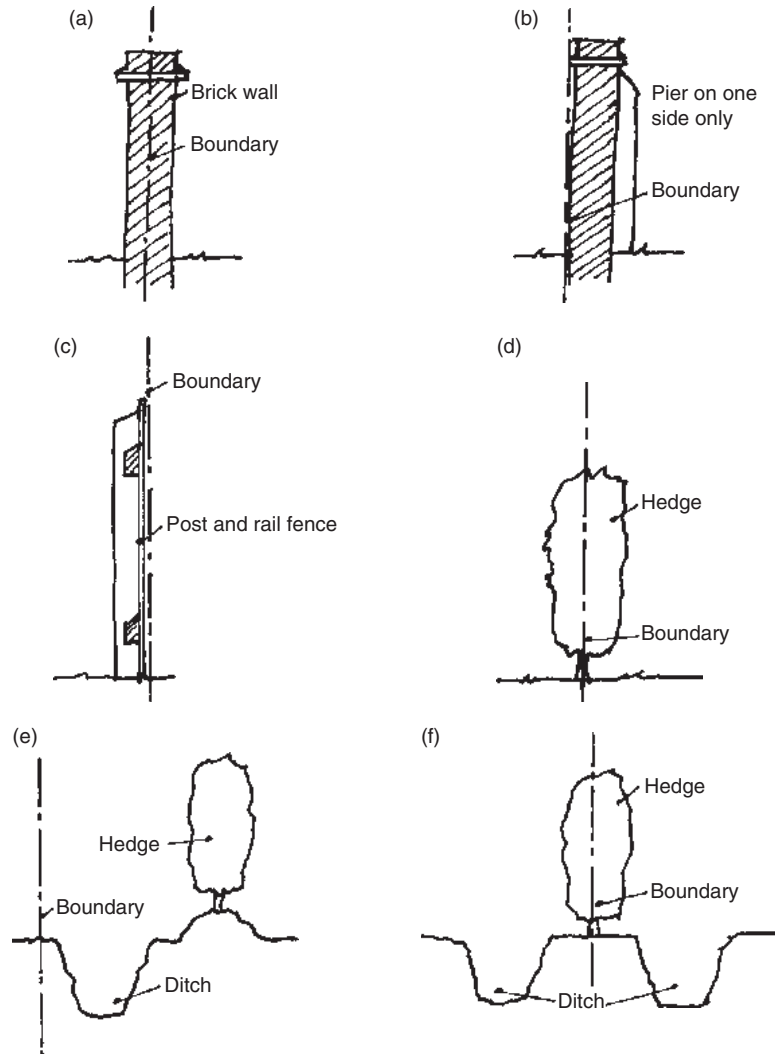
**Figure 15.12 Presumed ownership of boundary features**

Brick, stone or concrete block walls separating the properties of different owners, when built on the line of junction of two properties are usually deemed to be shared by the respective owners and are known as 'party fence walls'. A considerable number of terraced houses built before 1900 were provided with this type of boundary wall which is usually 1.5–2 m high. Section 38 of the Law of Property Act 1925 provides that party fence walls shall be treated as being severed vertically, but that each owner shall have a right to have his part of the wall supported by the other (Figure 15.12a). This means that neither can remove his part of the wall if this would mean that the other part collapses. Occasionally, projecting piers indicate ownership since they are invariably built on the land of the owner of the wall. In such cases the actual boundary line may be the far face of the wall (Figure 15.12b).

Unlike walls, fences generally belong wholly to one owner. The facts that have a distinct bearing on the ownership of fencing are still valid. An owner must erect a fence entirely on his land and therefore places the posts and rails on his ground with the boarding fixed on the outside (Figure 15.12c). Thus, the face of the fence defines the boundary line even though the owner of the fence must sometimes enter upon the neighbouring ground to drive the nails into the woodwork.

- Where two properties or fields are separated by a hedge or ditch there is a presumption that the boundary is the centre of the hedge or ditch (Figure 15.12d).
- If the properties are separated by an artificial ditch alongside a bank with a hedge on it there is a presumption that the boundary is along the edge of the ditch furthest from the hedge (Figure 15.12e).
- If there is a ditch on either side of the hedge the ownership of the hedge must be proved by acts of ownership. No presumption operates, because the original landowner's actions in digging the ditch or planting the hedge cannot be logically deduced. However, Ordnance Survey practice is to take the centre line of the hedge as the boundary feature (Figure 15.12f).

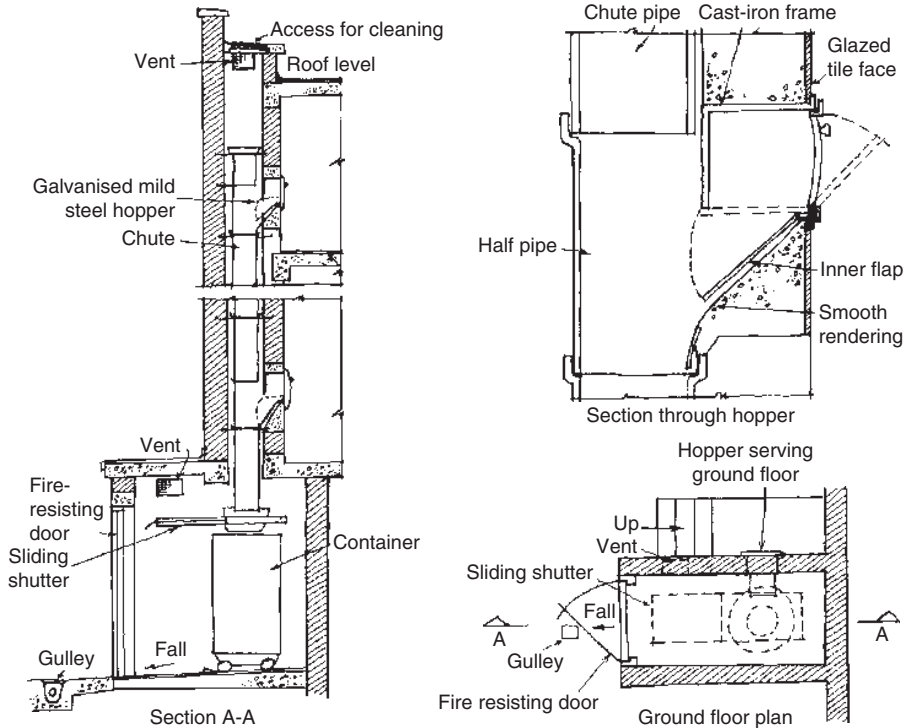
**Figure 15.13 Typical refuse chute**

The problem of refuse disposal in large blocks of flats and in some commercial buildings is usually overcome by refuse chutes. Figure 15.13 shows many of the standard features of a refuse chute and storage chamber which are required by the Building Regulations. The chute consists of a vertical pipe with a minimum diameter of 457 mm although some older types will be approximately 375 mm. The pipes must be constructed of non-combustible impervious materials such as salt glazed ware or vitreous enamelled iron, though in modern buildings spun concrete is used. The chute runs from top to bottom of the building and has an inlet hopper on each floor. At ground floor level the chutes discharge into a wheeled container in a specially constructed chamber consisting of a brick structure with a concrete roof slab and floor fitted with a fire-resisting door. Adequate ventilation is a necessity and both chamber and chute must be ventilated as shown in Figure 15.13.

- Hoppers for access to the chute at each floor level are usually galvanised mild steel. When open, an inner flap closes thus shutting off the main chute. When the hopper is in the closed position the inner flap drops allowing the contents to fall into the chute. Hinges and fastenings should be checked for ease of working. The hopper should have a surround at least 300 mm wide on the external face consisting of glazed tiling or other impervious material.
- The chute must be ventilated at the top and so positioned as not to transmit foul air in such a manner as to become prejudicial to health.

- A hinged cover for access at the top of the chute for cleaning is desirable, as shown in Figure 15.13.
- The chamber containing the wheeled container must have a fire resistance of 1 hour and be impervious to moisture. The floor of the chamber should be laid to a fall towards a trapped gulley situated immediately outside the chamber to enable the floor to be washed down. The construction of the walls, floor and roof should be checked as described in Chapters 5, 6 and 7.

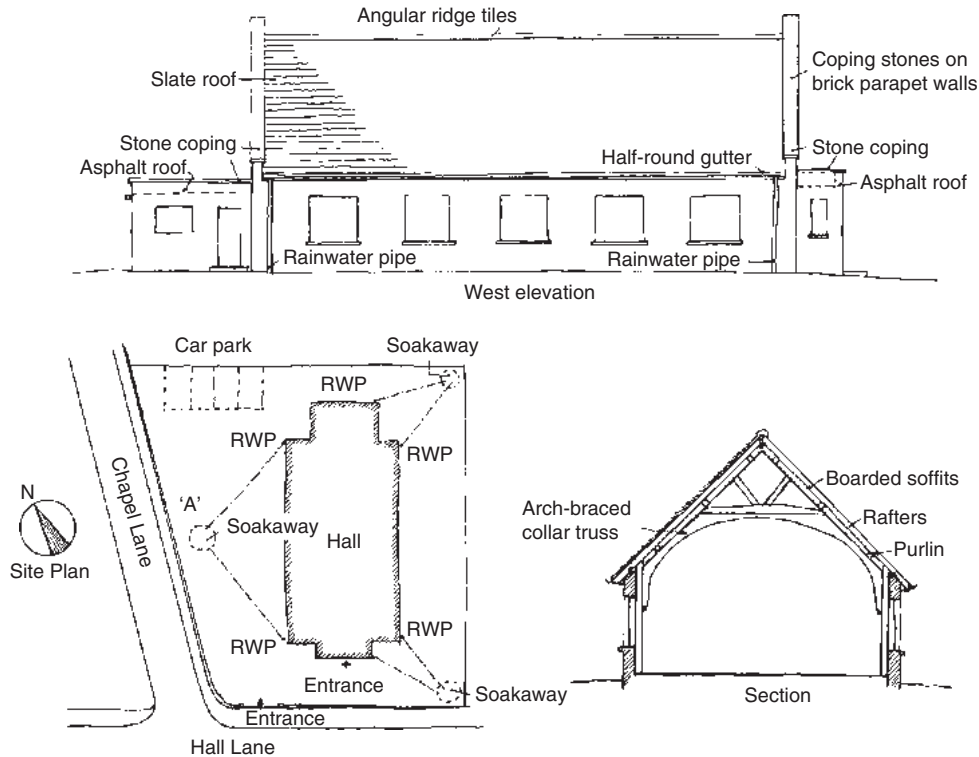
**Figure AVI** Details of roof and surface water drainage system referred to in Appendix VI

- (a) That all rainwater gutters are replaced with 125 mm half round PVC system. All gutter outlets to be fitted with plastic balloons to prevent possible blocking by leaves and other debris.
- (b) That all rainwater pipes are replaced with 76 mm diameter PVC pipes with all necessary offsets and fixing clips.
- (c) The softwood fascia board to both sides of the main roof to be replaced and treated with a preservative before fixing.

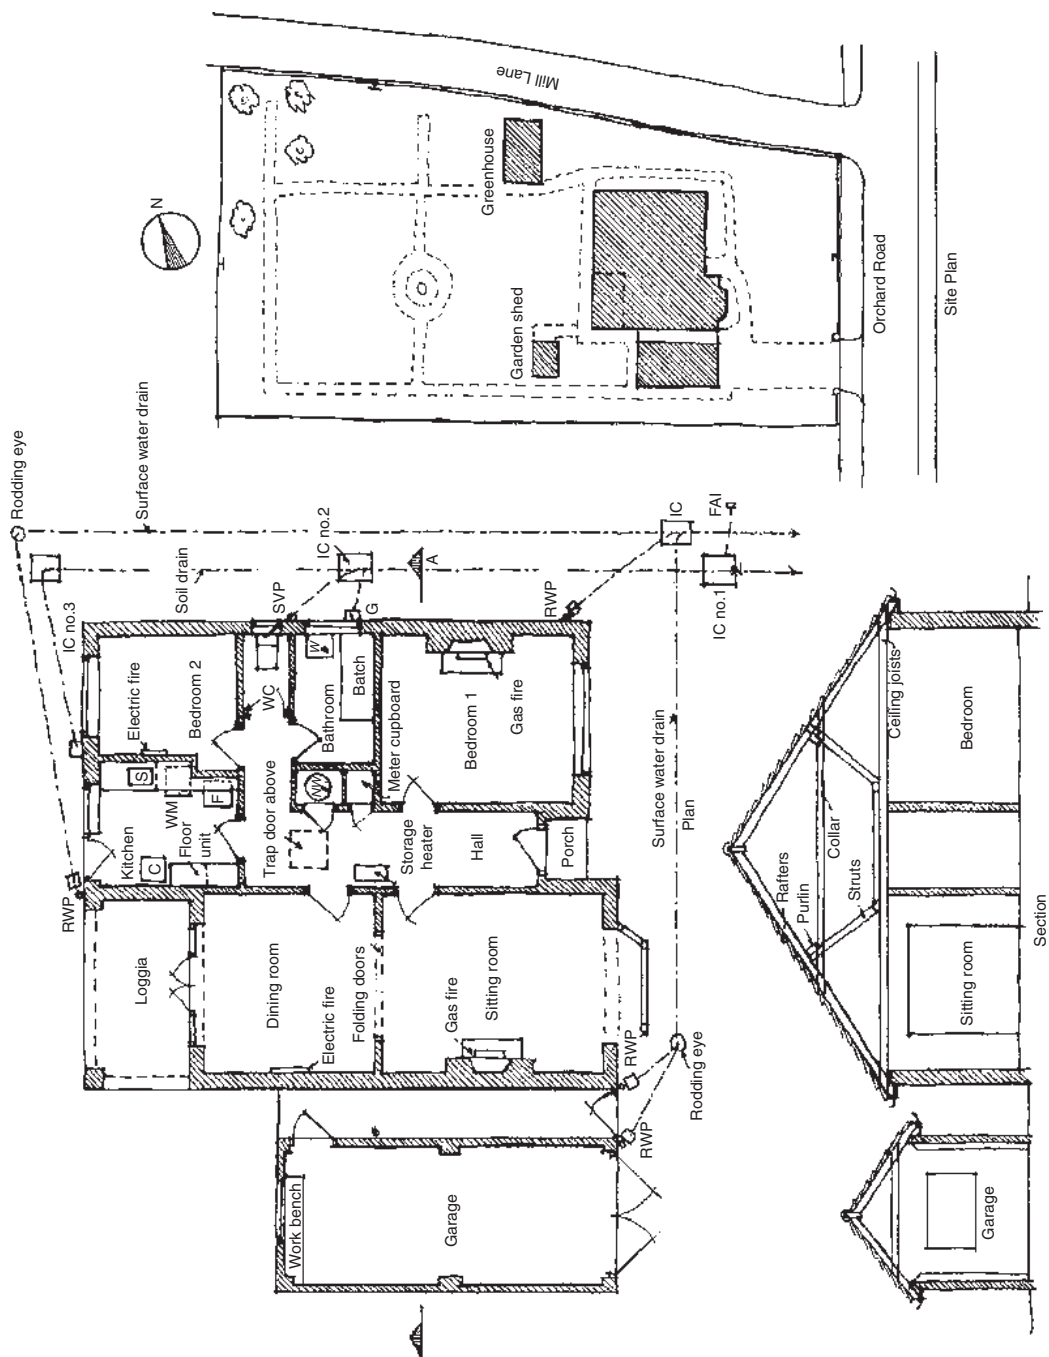
Figure AVII Plan of detached bungalow referred to in the report (Appendix VII)
